# WISSAHICKON CREEK STREAM ASSESSMENT STUDY LOWER WISSAHICKON WATERSHED

Philadelphia Water Department Office of Watersheds 2010

Wissahickon Creek Watershed Stream Assessment Report Lower Wissahickon Watershed

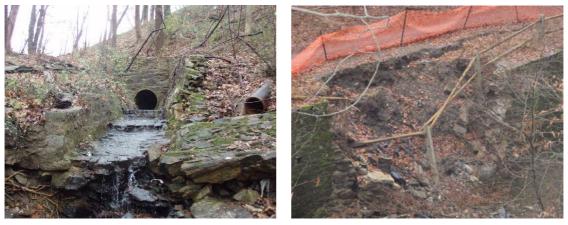
Figure 3-34: Degraded section of WScha280 (left). Degraded section of WScha142 (right).

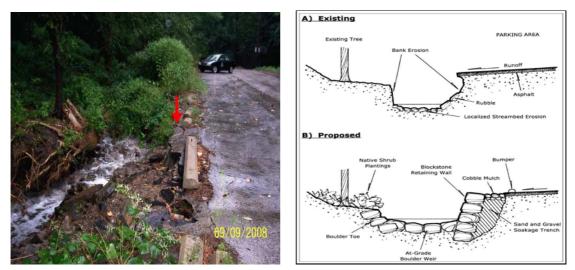
Figure 3-100: Bank erosion caused by parking lot runoff (left); schematic of restored condition (right).

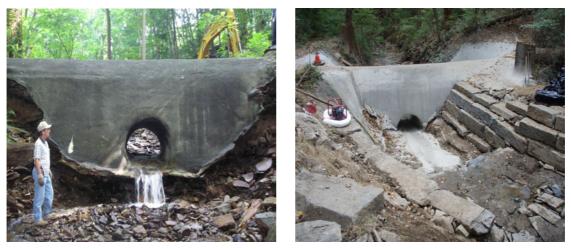
Figure 3-101: Upstream view of WScul116 pre-construction (left); Downstream view of WScul116 post-construction (right).

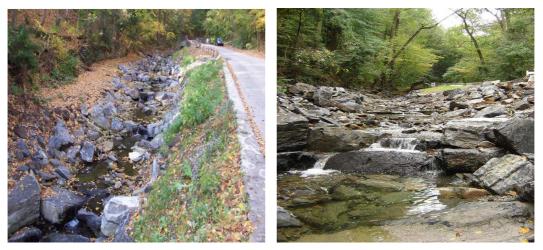
Figure 3-102: View of boulder step-pool system looking upstream (left): scour pool at the base of the step-pool system (right).

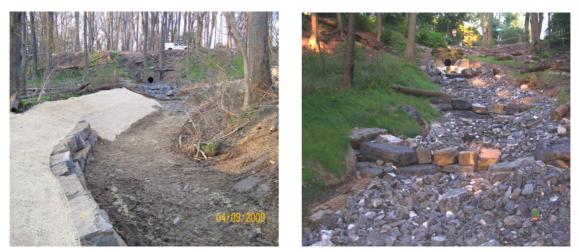
Figure 3-103: WSout513 conveyance channel during (left) and after (right) construction

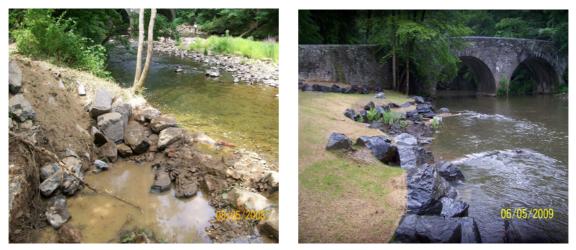
Figure 3-105: DSR bank in reach WSMS110 following emergency repairs (left); DSR bank following bank stabilization and instream flow structure installation (right).
