APPENDIX B
INFRASTRUCTURE PHOTOS

Reach WSTM02 Infrastructure Photos

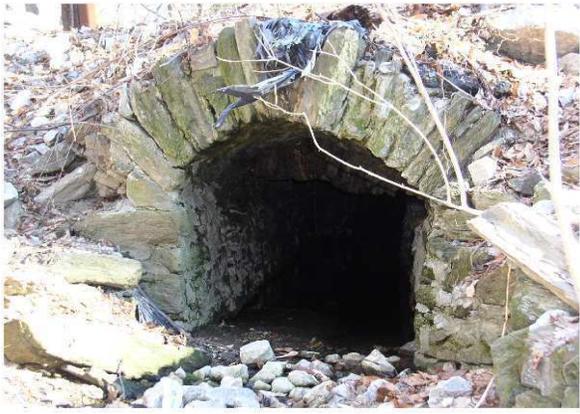
Infrastructure ID: WScul102 Culvert

Condition	Material	Dimension (ft)	Length (ft)	Location
Fair	Stone		19.0	Valley Green Rd

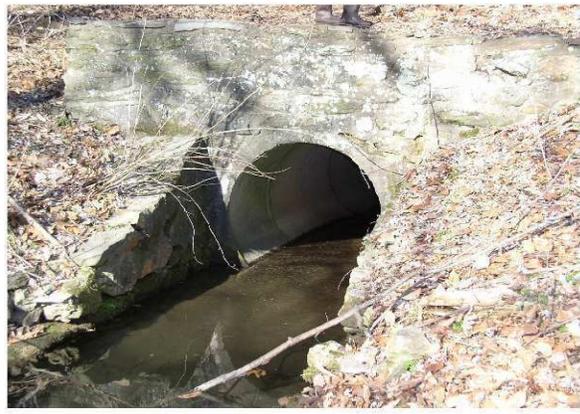
Infrastructure ID: WScul104 Culvert

Condition	Material	Dimension (ft)	Length (ft)	Location
Fair	Concrete	5.0	643.0	Parallel to Valley Green Rd

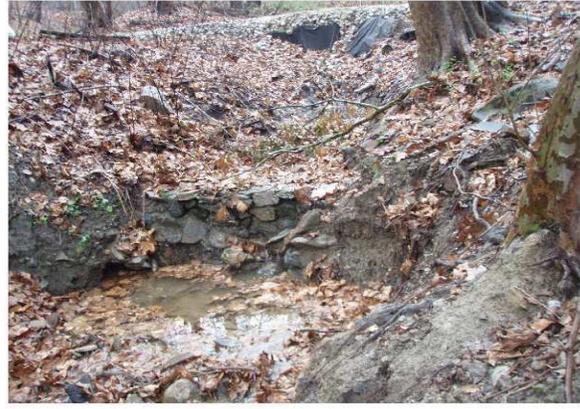
Infrastructure ID: WSdam144 Dam

Condition	Material	Width (ft)	Length (ft)	Height Exposed (ft)
Fair	Stone	6.0	2.0	4.0

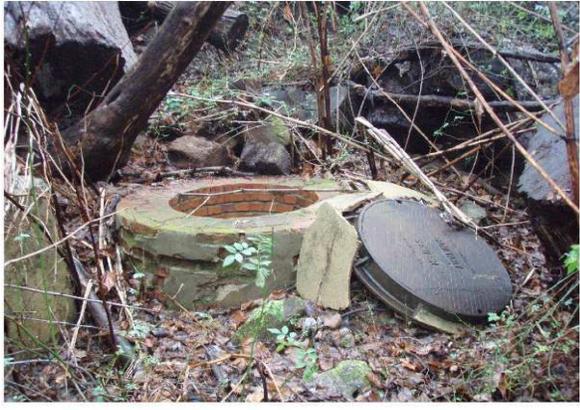
Infrastructure ID: WSman057 Manhole

Condition	Location	Height Exposed (ft)
Poor	DSL	2.0

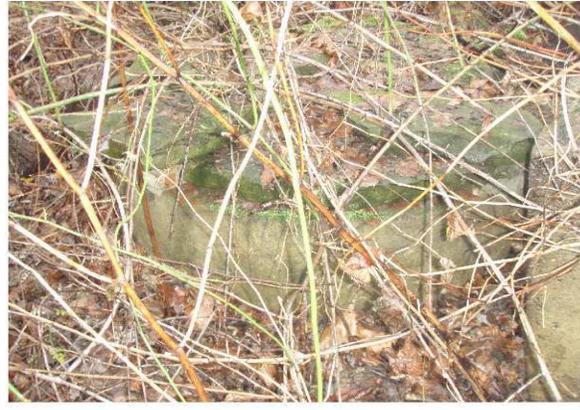
Infrastructure ID: WSman058 Manhole

Condition	Location	Height Exposed (ft)
Fair	DSL	2.0

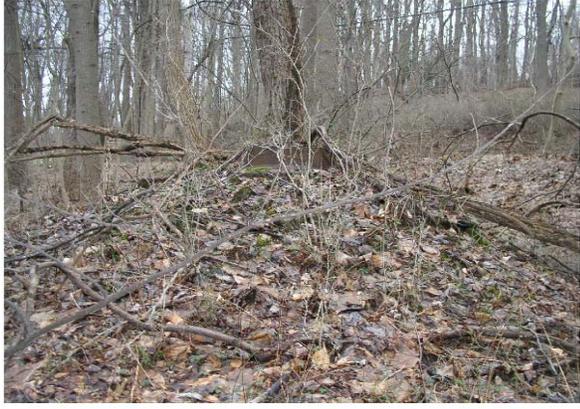
Infrastructure ID: WSman030 Manhole

Condition: Fair Location: DSL Height Exposed (ft): 0.166

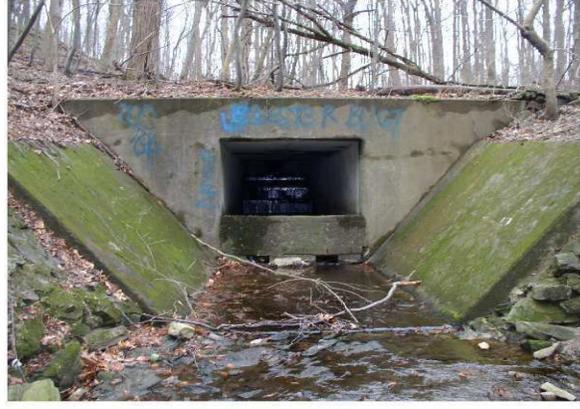
Infrastructure ID: WSout473 Outfall

Condition: Fair Material: Concrete Location: DSR Flow: Steady Flow Appearance: Clear Dimension (ft): 3.0 x 5.0

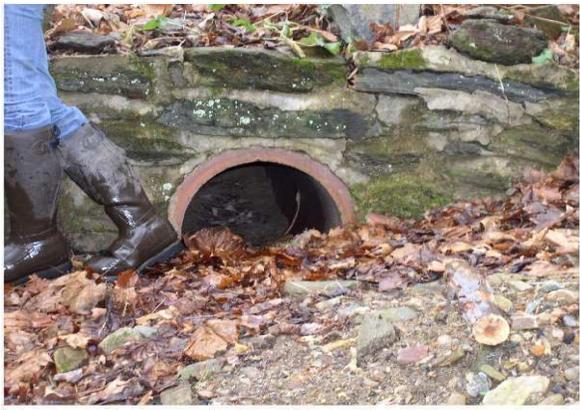
Infrastructure ID: WSout471 Outfall

Condition: Fair Material: Clay/Terra Location: DSR Flow: None Flow Appearance: Dimension (ft): 1.5

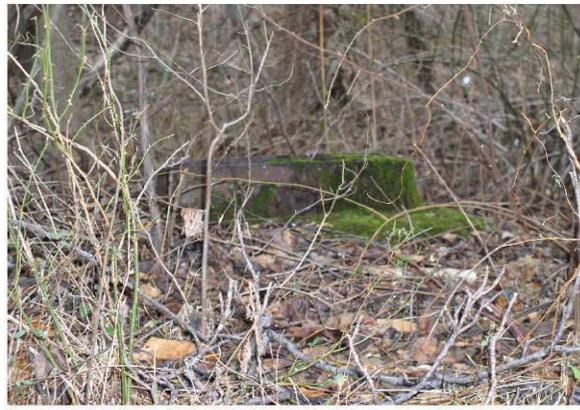
Infrastructure ID: WSman029 Manhole

Condition: Fair Location: DSL Height Exposed (ft): 0.166

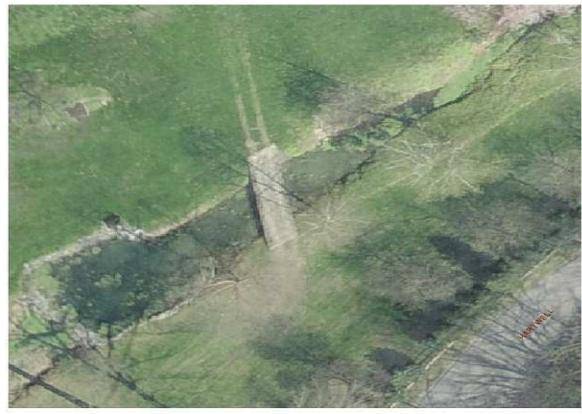
Infrastructure ID: WSbri464 Bridge

Condition	Material	Dimension (ft)	Length (ft)	Location
Fair	Concrete	4.0 x 34.0	8.0	Between Hartwell Ln and St Andrews St

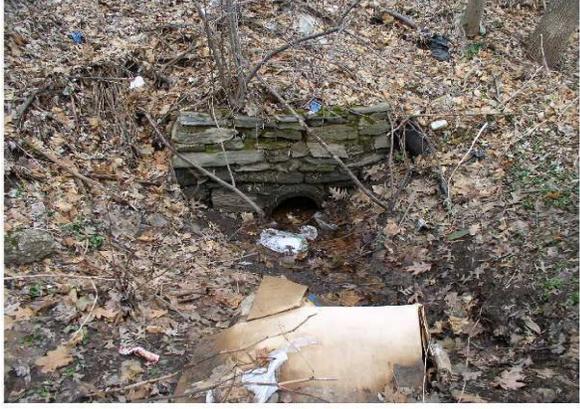
Infrastructure ID: WSout480 Outfall

Condition	Material	Location	Flow	Flow Appearance	Dimension (ft)
Fair	Concrete	DSR	None		1.333

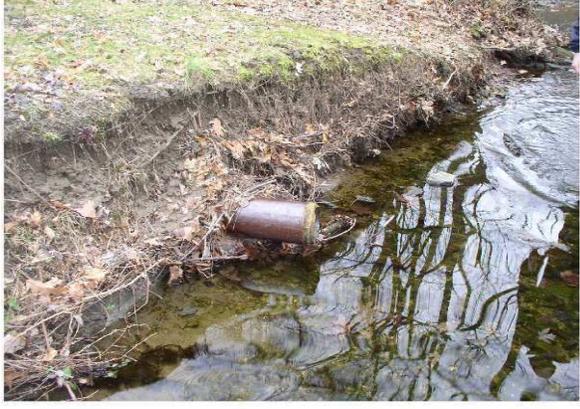
Infrastructure ID: WSout481 Outfall

Condition	Material	Location	Flow	Flow Appearance	Dimension (ft)
Fair	ClayTerra	DSL	None		0.833

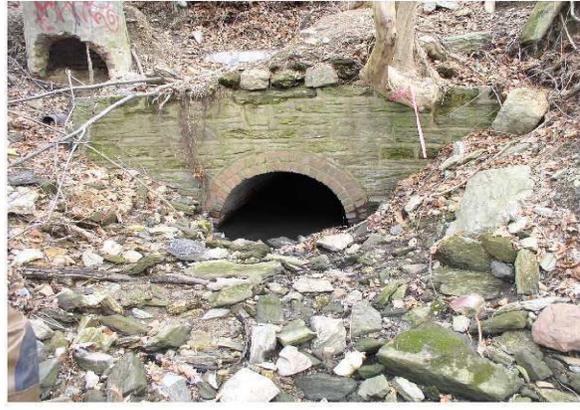
Infrastructure ID: WSout491 Outfall

Condition	Material	Location	Flow	Flow Appearance	Dimension (ft)
Fair	Stone	DSL	Intermittent	Gray	4.0

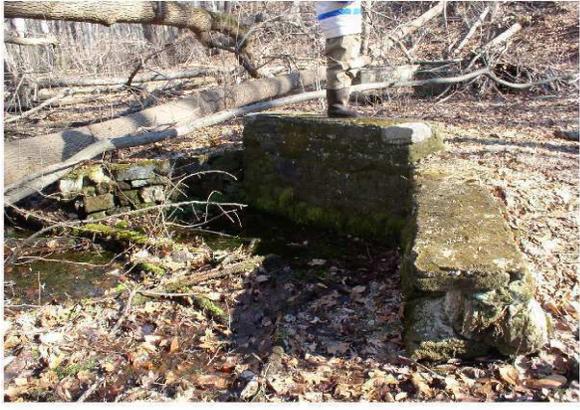
Infrastructure ID: WSout515 Outfall

Condition	Material	Location	Flow	Flow Appearance	Dimension (ft)
Fair	Other	DSL	Trickle	Clear	2.0
