# FIS Profile

POQUESSING CREEK

FEDERAL EMERGENCY MANAGEMENT AGENCY  
CITY OF PHILADELPHIA, PA  
(PHILADELPHIA CO.)

## PHOTOGRAPHIC LOG

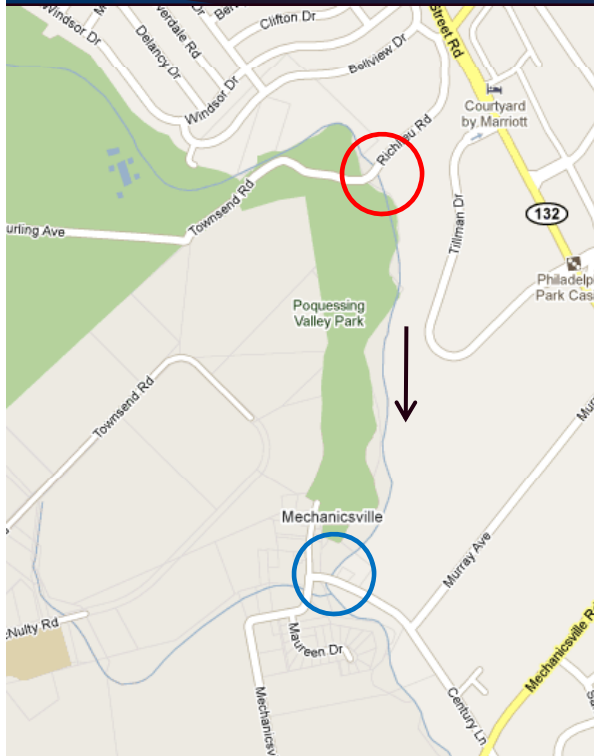
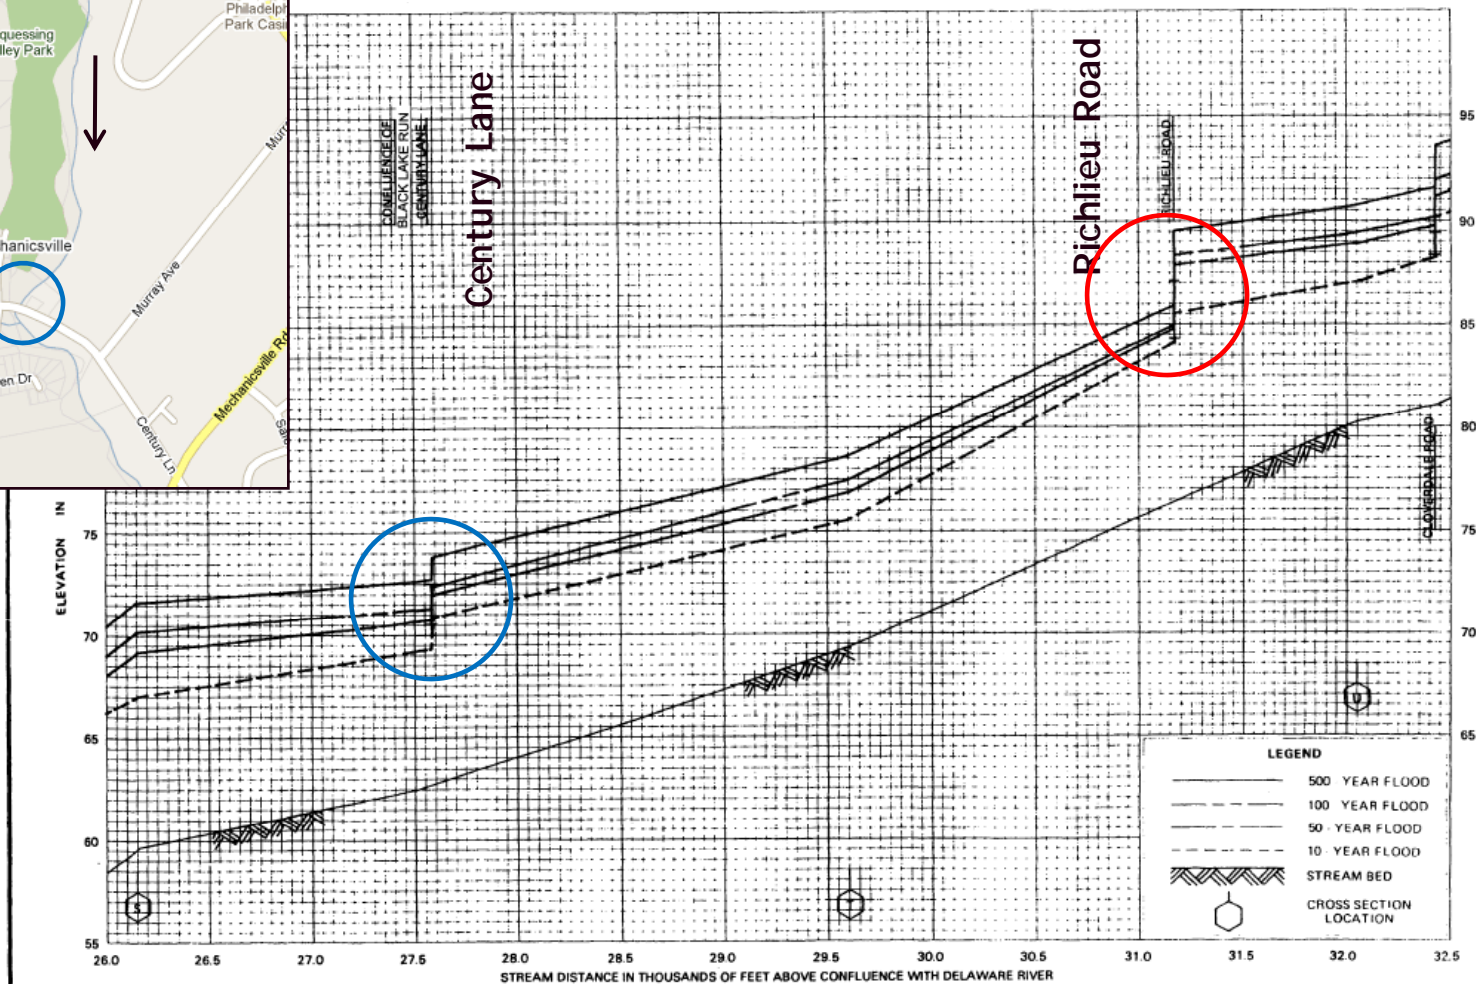
- Example of bridge with backwater
- Richlieu Road and Century Lane both show substantial backwater

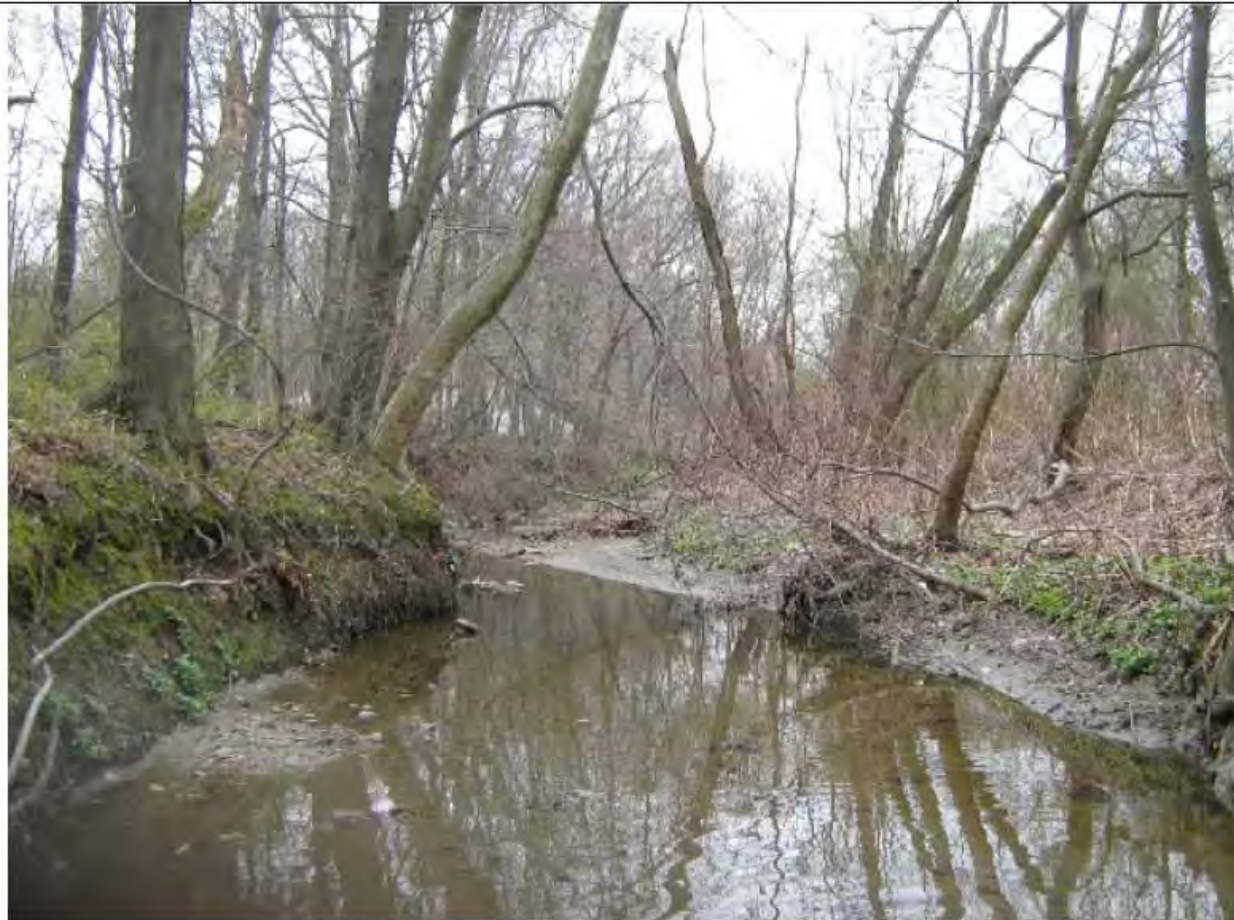
1

Upstream

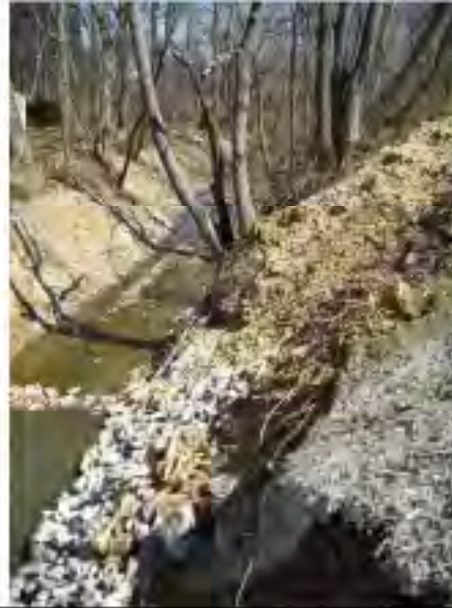
Photo No.  
3

Downstream - Right bank  
(foreground) and Left bank  
(background)

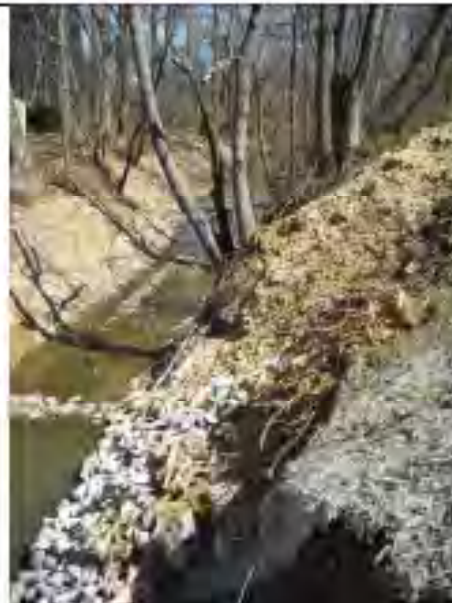
Photo No.  
4

Downstream - Right bank  
(foreground) and Left bank  
(background)

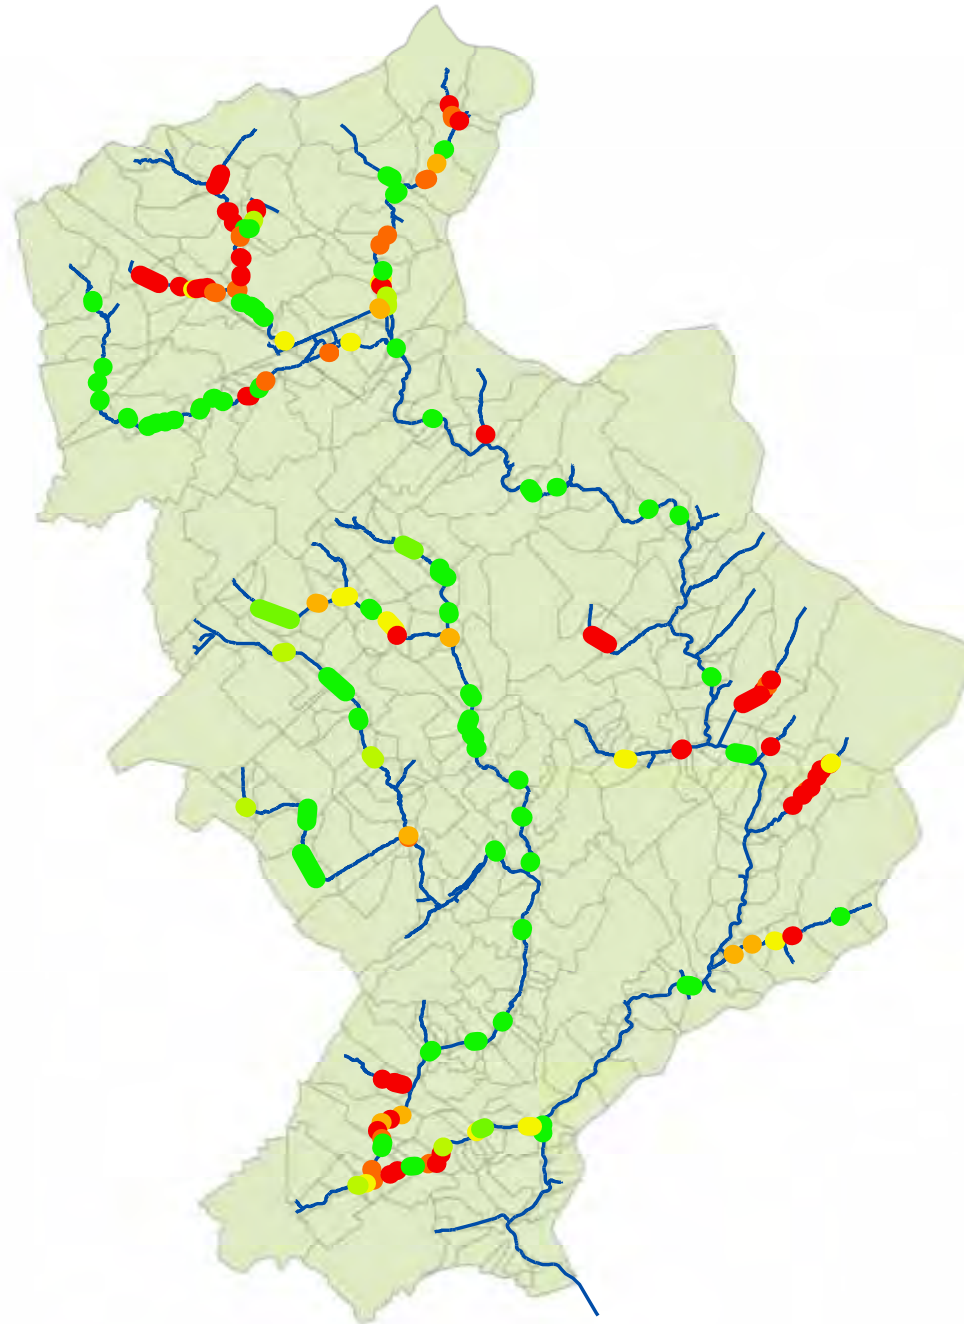
### Poq Constrictions

- < 1 year
- < 5 year
- < 10 year
- < 25 year
- < 50 year
- < 100 year
- > 100 year
