STREAM RESTORATION

Bells Mill Stream Restoration

Watershed Project Registry

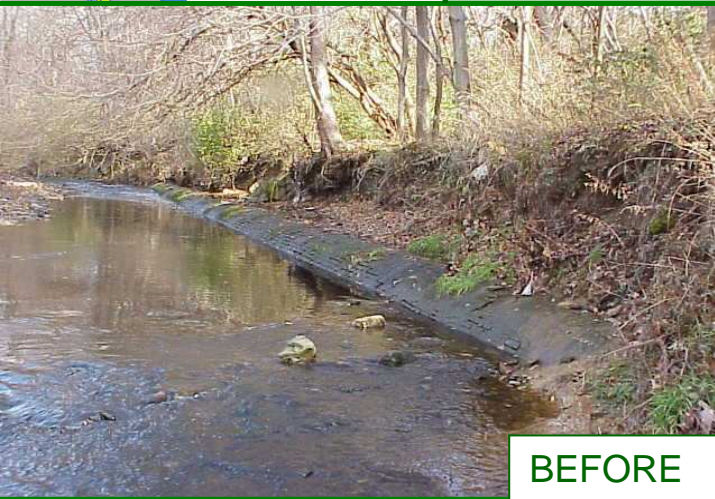
BEFORE

In most cases, exaggerated stormflow has caused banks to erode and the channel to incise at an accelerated rate. Stream bank stabilization will make use of standard rock vanes, "J" vanes, cross vanes, wing deflectors, root wads, grade control measures and live branch layers. These types of modifications will stabilize banks

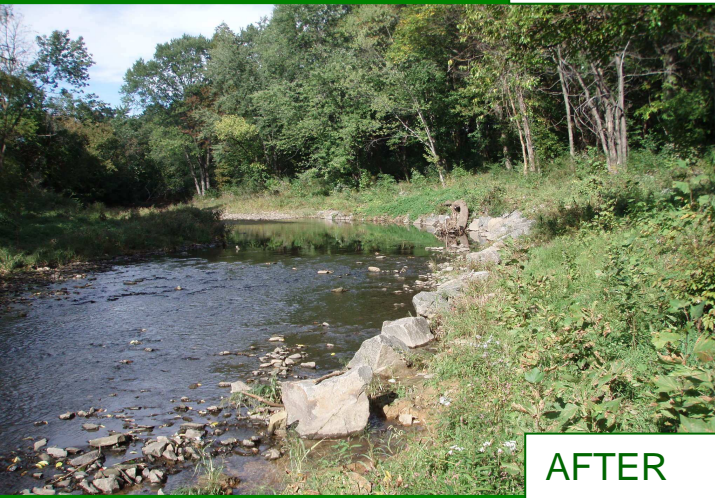
AFTER

The stream channel should be designed to accommodate a range of flows by constructing a low flow channel within a larger high flow channel. The low flow channel will provide aquatic communities with habitat that effectively manages baseflow. The high flow channel will provide a lower velocity refuge for organisms during storm events. Once restoration is complete, a stable, sustainable environment will allow a reintroduced macroinvertebrate community to thrive. Improvements to the number, health, and diversity of the benthic invertebrate and fish species are ideal goals for stream restoration.

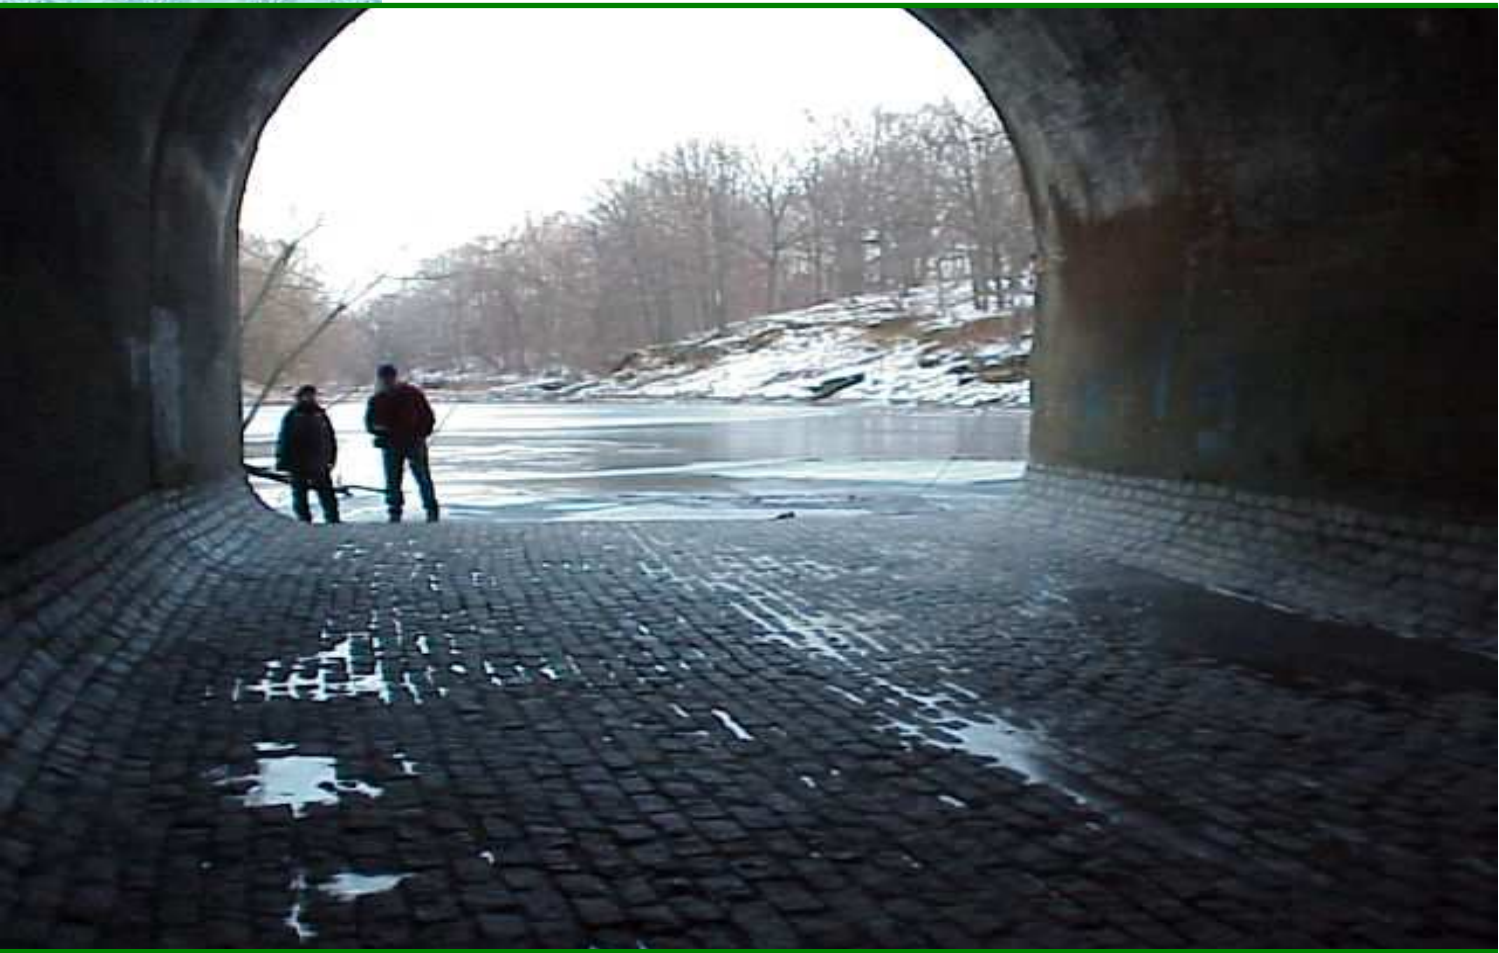
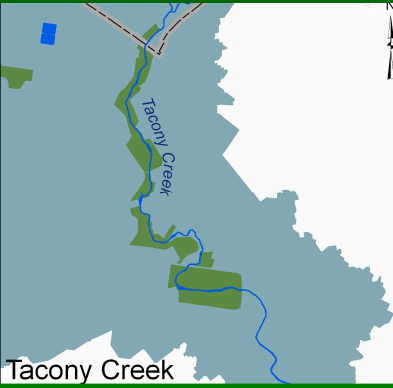
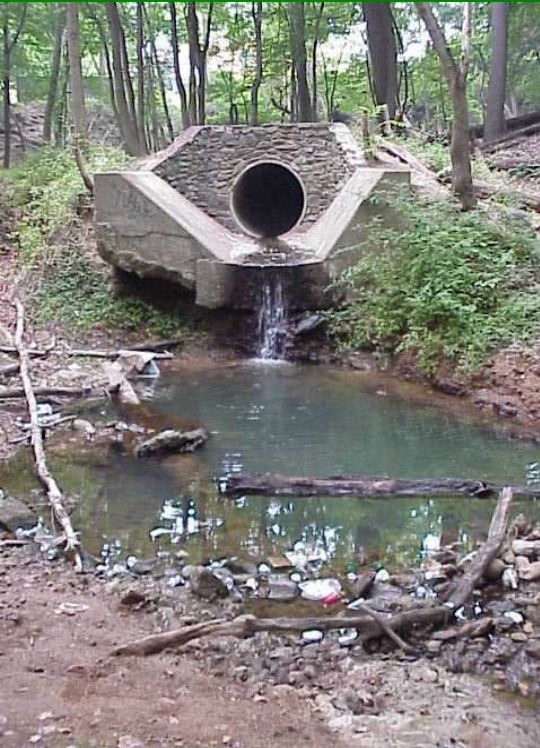
Tacony Creek

stream segments deficient in baseflow make very poor habitats for all but the most tolerant generalist species. Streambank erosion, including erosion around PWD infrastructure, was observed along the Tacony Creek.
