FISH PASSAGE

Overview

Pennypack Rock Ramp Fish Passage

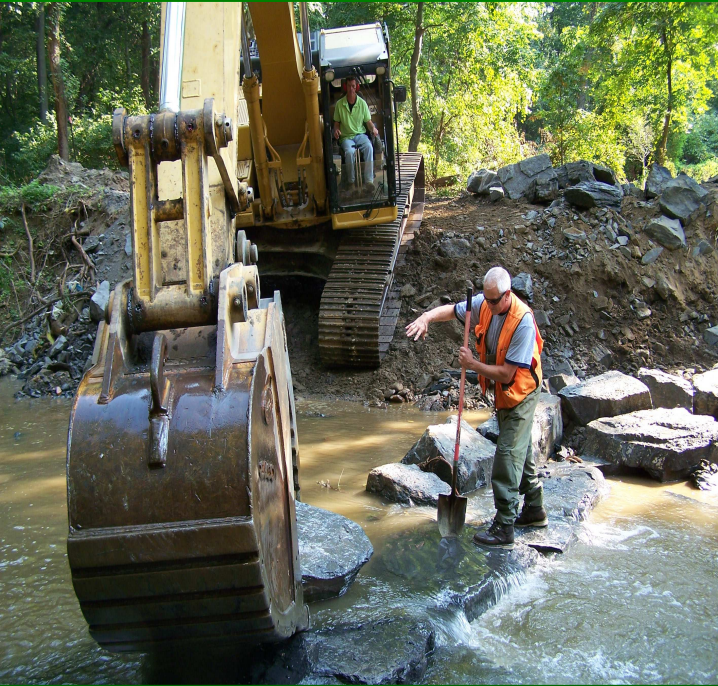
Pennypack Rock Ramp Dam

Following the wave of momentum created by the removal of three dams on Pennypack Creek, all owned by Fairmount Park Commission (FPC), the Philadelphia Water Department (PWD) constructed a rock ramp fish passage at a PWD sanitary sewer line that crosses the Pennypack. PWD also completed stream bank stabilization and riparian plantings in the project area. This will restore access to approximately 4.5 miles of suitable spawning habitat for migratory fishes as well as enhance stream habitat for resident fish populations.

PWD has completed phase one of the physical monitoring activities planned for the rock ramp, by installing a stream gage and recording stream stage to correlate to the nearby Rhawn St. USGS gage station. A detailed post-construction survey of the rock ramp has been conducted which was used to create a River2D hydraulic model of the rock ramp. PWD has estimated velocity vectors within the rock ramp at varying river flow conditions and has compared physical conditions to fish swimming behavior.

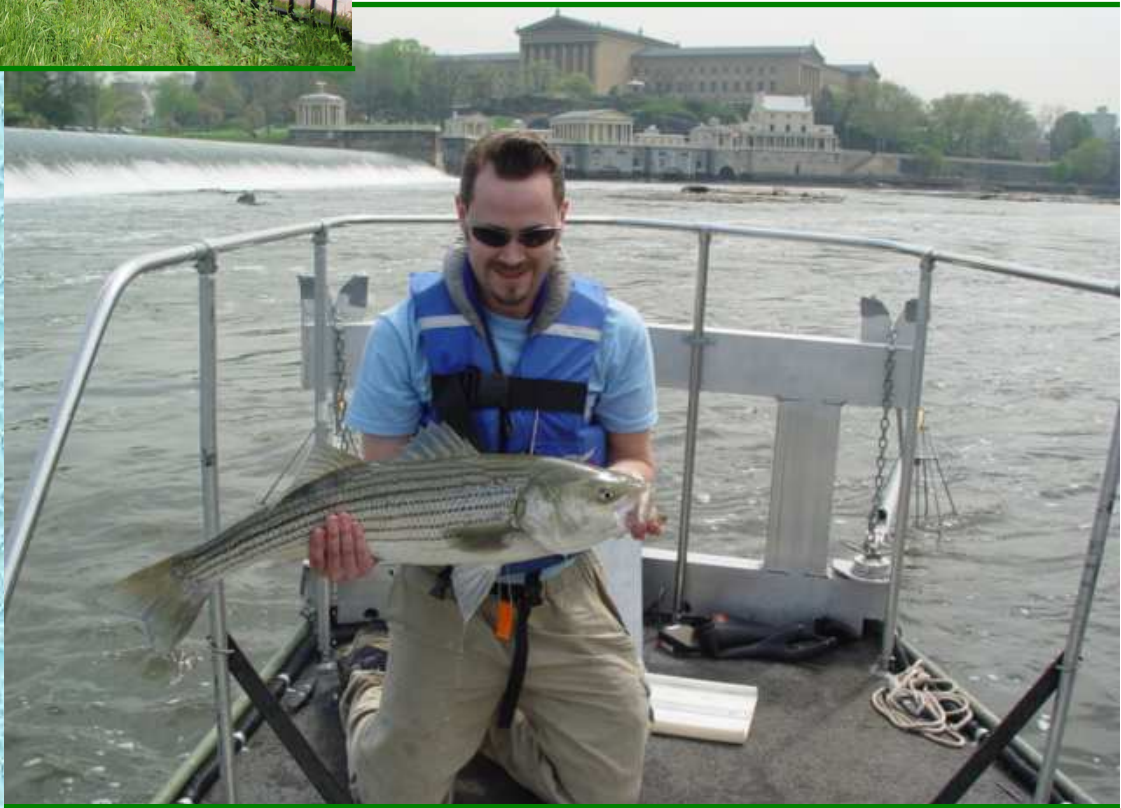
1 A fish following its instinct to swim upstream in the Schuylkill River encounters the turbulent water of the Fairmount Dam's spillway. A current of water, produced by the fishway, flows into the river from the fishway entrance, serving as a guide for the fish, and attracting them to swim through the entrance into the first chamber.

2 The water, pouring through the slots connecting each chamber, guides the fish through the fishway. The water levels, in each chamber, are slightly higher than the chamber before it, allowing the fish to gradually bypass the dam. Additional chambers were added to the fishway, decreasing the effort required by the fish to swim from one chamber to the next.

3 The slots between adjacent chambers maintain the varied water levels throughout the fishway. The slots were widened to ease the passage of fish through the fishway.

4 Live images are captured by a camera through a window in one chamber of the fishway, which are then transmitted to the web and to the Fairmount Water Works Interpretive Center across the river. The live camera feed can be accessed at www.fairmountwaterworks.org.

5 Fish exit the fishway through the gate and swim into the waters beyond the Fairmount Dam.

slots between the chambers of the fishway have been widened, the flow through the chambers has been modified, and the entrance and exit channels have been redesigned, in hopes of increasing the variety of species and the numbers of fish using the fishway. It has been estimated by a U.S. Fish and Wildlife Service expert, that with these improvements to the fishway, 200,000 to 250,000 American shad per year may utilize this structure during upstream migrations. It has been estimated that the Schuylkill River has habitat to support 700,000 to 800,000 shad.
