Welcome to PWD's Fifth Quarterly Water Quality Update for the Monoshone Creek.

Sampling The Monoshone Creek: A One-Year Review of Water Quality Monitoring and Infrastructure Inspections

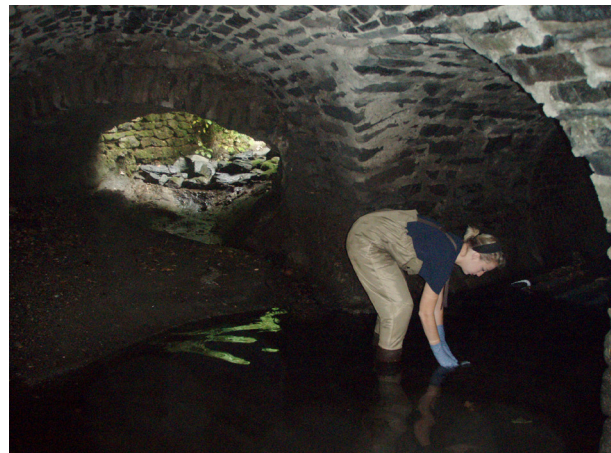
Figure 1. PWD scientist collecting water samples at Outfall 5.

The goal of this program was to develop a uniform and robust data set that quantified differences in water quality from the upstream "headwater" outfall to downstream Historic RittenhouseTown (figure 1). In total, PWD field staff collected 26 discrete samples at Outfall 5 and Historic RittenhouseTown between 2009 and 2010 (n=52 total sample events).
