Poquessing Creek Watershed ACT 167 STORM WATER MANAGEMENT PLAN

Watershed Plan Advisory Committee (WPAC) Westing No. 3

March 30, 2011

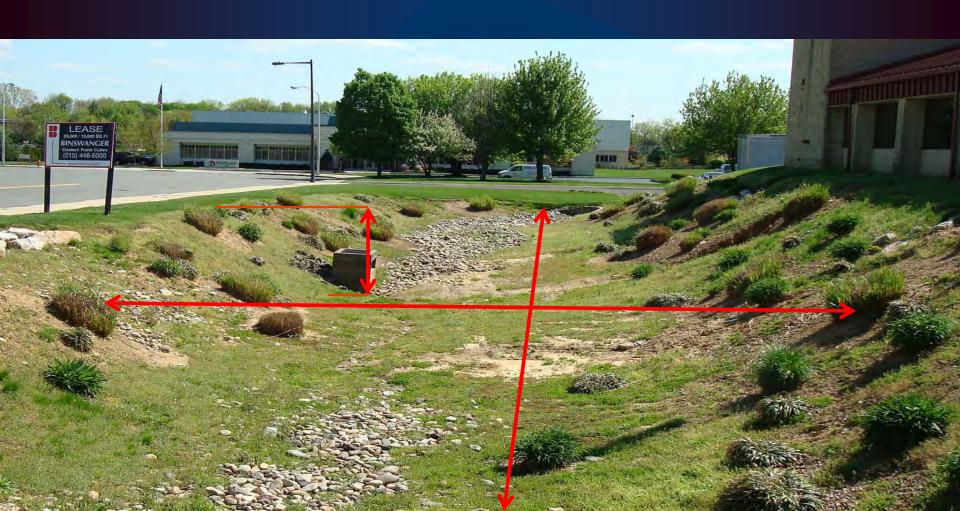
- Basin data collected
 - Length, Width and Depth
 - Inflow pipe sizes and quantity
 - Outfall structure type & size

- Basin data used to determine amount of runoff volume that can be detained
 - Determine potential retrofit ideas

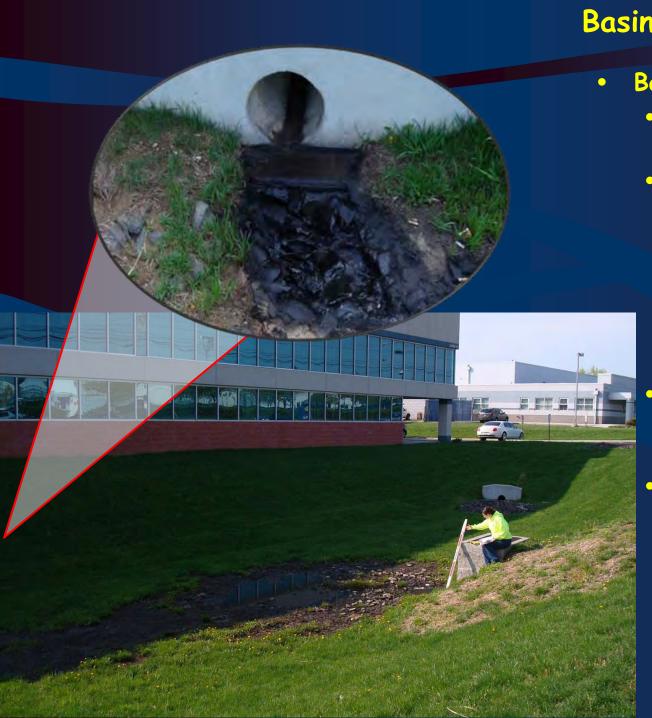
Basin Photos

- Basin off Townsend Rd
 - Two inlets flow directly to outfall
 - One inlet has oily fluid draining to basin
 - Further
 investigation
 needed to
 determine source
 and cause
 - Divert/Treat flow to eliminate water quality impacts
 - Plant native vegetation in basin

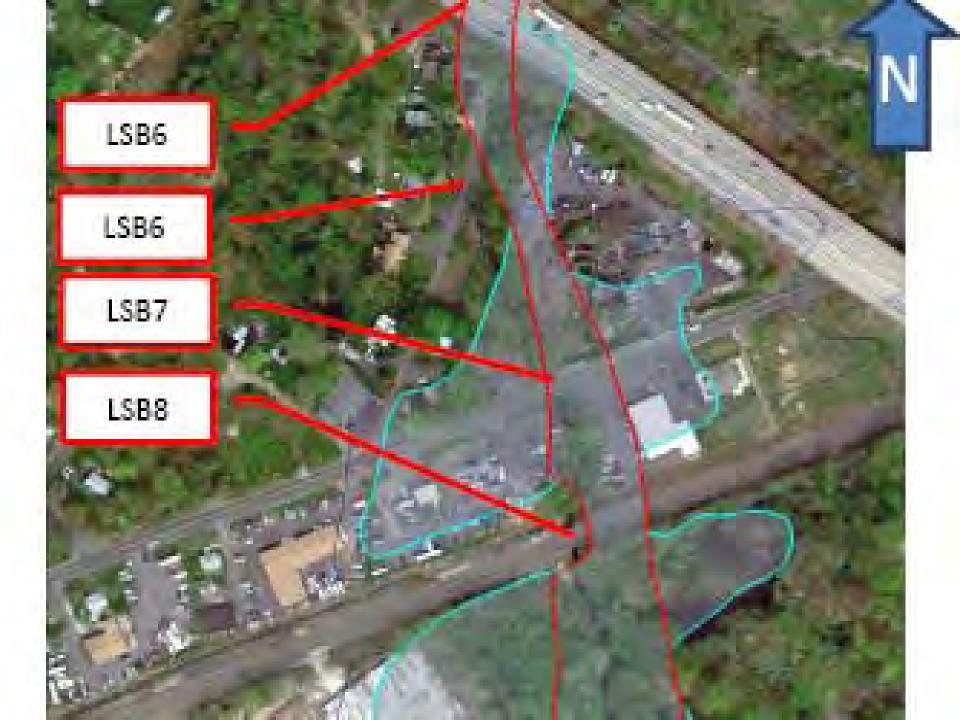
Proplem Area - Map ID: PH-F22 Comments Number of Buildings Residential 2 Inundated Commercial Type of problem (Highlighted): 1 High Volume 2 Backwater from bridge/culvert PH-F22 Comments High volume and backwater from BEB5 causes flooding of this residential area.

- Example of problem areas showing locations of inundated buildings
 - Problem PH-F22 is just upstream of Century Lane as shown in the previous slide
 - Backwater from the bridge and high volume cause flooding of these 2 structures
- Used Bing and Google to capture aerials

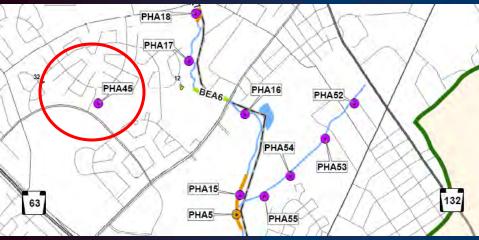
- Invasive species have overgrown everything in the overbank area
 - Remove invasive species and replant native species
- There is also severe undercutting of the banks as seen in the photos to the right
 - Regrade stream and plant native species to protect the bank
 - Reduce the amount of runoff

Poquessing Watershed Act 16	57 Problem Area Inventory			
Problem Area - Map ID:	PHA45	Comments			
Municipality:	Philadelphia	This problem area was reported by the			
Stream name:	Trib to Poquessing Creek	Philadelphia Water Department. The problem area is located along a tributary to Poquessing			
Inspected By/Date:	DJS/BAK 10-28-2010				
Checked By/Date:	PAD	Creek . The reach stability was reported as			
Type of Problem (highlighted):		intermediate and the bank erosion was classified as high.			
1	Flooding				
2	Deficient Bridge/Culvert

Description The banks of this tributary are experiencing significant erosion. Banks were also reported as being overgrown with invasive species.

The degradation of the streambanks has lead to subsequent sediment deposits in downstream portions of the tributary. Banks were also reported as being overgrown with invasive species.

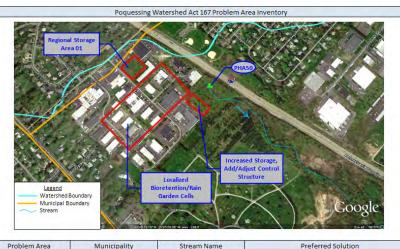
PHA-50 | Lower Shouthampton | UNT Poquessing Creek |
Description: This problem area was reported by the Philadelphia Water Department. The subject channel is located in Lower
Southampton Township at the outfall of a large commericial/industrial area. The reach stability was reported as actively degrading and
the bank erosion was classified as high. The upstream drainage area is highly impervious with limited stormwater managment facilities
This is resulting in high flow rates and volumes that is causing significant erosion in the downstream channel at the problem area

The banks of this tributary are experiencing significant erosion. As evident from the picture above, the channel has been eroded approximately 10-12 feet below the normal channel depth. Banks were also reported as being overgrown with invasive species.

- This shows a detailed problem area.
 - Significant erosion along an UNT to Poquessing Creek in Lower Southampton Township
 - Possible Solutions include the construction of storage areas (detention, infiltration) within
 and immediately downstream of the commercial /industrial area and localized bioretention/
 rain garden cells within the developed area

- Stream Stabilization: Stabilize existing stream bank to limit further erosion and decrease sediment trasnport downstream.
- Regional Storage Area 01 (Bioretention, Infiltration, Dentention) within Commerical Area: Increase storage capactity of green space within commerical area and enhance with additional vegetation to promote biofiltration/transporation. Increase water quality and decrease peak rate by treating stormwater at the source.
- Increased Storage, Add/Adjust Control Structure: This area appears to already be depressed and have some sort of outlet structure. Storage could be increased in this area, and an outlet structure could be added/adjusted to better control relase rates from this area.
- Localized Bioretential/Rain Garden Cells: Several small pockets of open space within the commerical area could be converted to bioretention/rain garden BMPs that will help

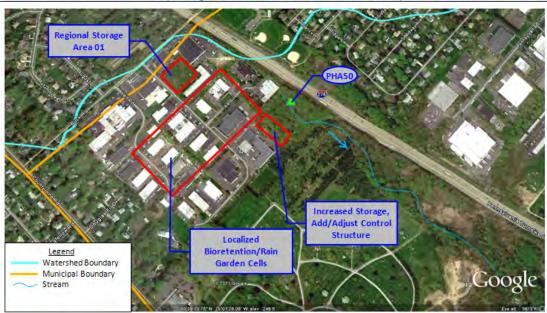
Description: This problem area was reported by the Philadelphia Water Department. The subject channel is located in Lower Southampton Township at the outfall of a large commericial/industrial area. The reach stability was reported as actively degrading and the bank erosion was classified as high. The upstream drainage area is highly impervious with limited stormwater managment facilities This is resulting in high flow rates and volumes that is causing significant erosion in the downstream channel at the problem area location.

- This shows a detailed problem area.
 - Severe erosion along Poquessing Creek and shared stream/pond embankment
 - IMMEDIATE action needs to be taken to prevent the pond embankment from collapsing
 - Possible solutions in this area include bank rehabilitation/stabilization.

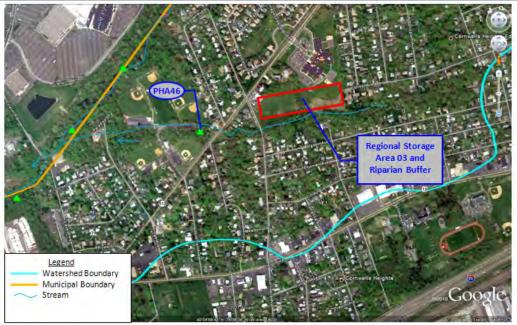
- Significant Erosion of an UNT to Poquessing Creek in Bensalem.
- Possible solutions include construction of a regional storage area(detention, infiltration) and riparian buffer enhancement.

Description: This problem area was reported by the Philadelphia Water Department. The problem area is located to the west of Hulmeville Rd along a tributary to Poquessing Creek. The reach was reported to be actively degrading and the bank erosion was classified as high. The contributing drainage area consists mainly of residential developments with limited stormwater management controls. This development has diminished riparian buffers along the stream, and is likely the causing the high flows and velocities that are causing the streambanks to erode.
