# WISSAHICKON CREEK STREAM ASSESSMENT STUDY LOWER WISSAHICKON WATERSHED

Philadelphia Water Department Office of Watersheds 2010

Wissahickon Creek Watershed Stream Assessment Report Lower Wissahickon Watershed

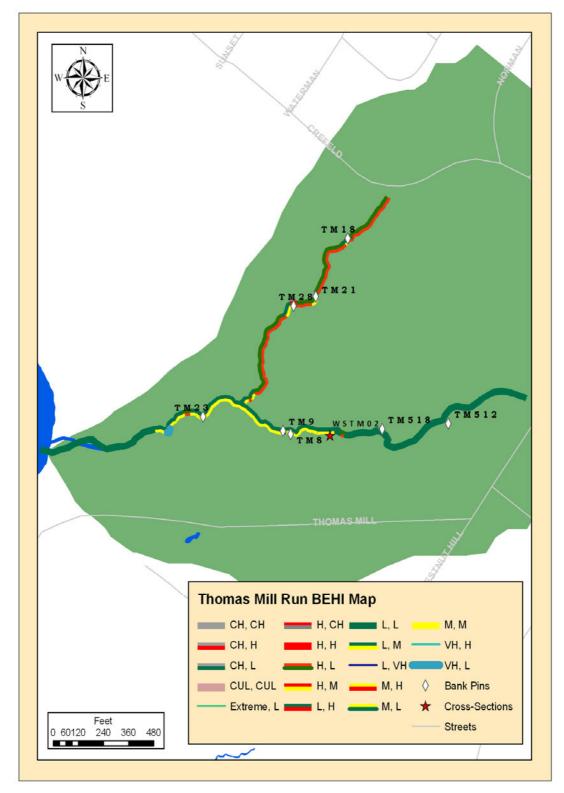
Figure 3-4: Thomas Mill Run Watershed BEHI Ratings and Bank Pin Locations

There were nine bank pin locations along Thomas Mill Run (Figure 3-4). The calculated erosion rates are included in Table 3-2. The spatial distribution of BEHI assessment results were represented graphically (Figure 3-4) for each of the segments assessed on Thomas Mill Run. Each bank within a respective segment was assessed and rated separately; however, channelized and culverted segments were not assessed as they confer a high degree of protection from bank erosion.

Bank erosion was observed to be most prevalent in the small tributary to Thomas Mill Run on which the entire DSL bank had high rates of erosion (Figure 3-4) - the main channel however, was observed to have limited erosion. The scores for both the left and the right banks were rated as "marginal" although both banks compared favorably to the Small Tributary averages which were also rated as "marginal." The erosion observed on the unnamed tributary to Thomas Mill Run was significant in that Thomas Mill Run was ranked among the most-erosion prone tributaries in the Lower Wissahickon. The erosion rate (normalized to stream length) was the second highest in the Lower Wissahickon at (79 lb/ft) after Gorgas Run where an erosion rate of (81 lb/ft) was estimated.

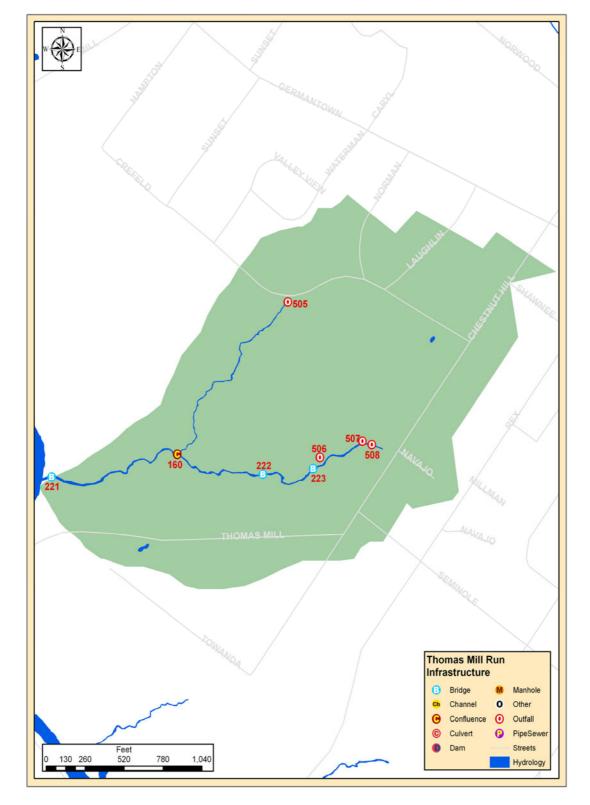
Figure 3-5: Thomas Mill Run Infrastructure Locations

Thomas Mill Run is a small tributary to the Wissahickon Creek that flows almost entirely within Fairmount Park. This stream has only a few infrastructure elements which is a direct result of the tributary's location within the Park. Despite the benefit of its location, Thomas Mill Run exhibits some of the impairments associated with urban streams given its proximity to development in the form of residential neighborhoods that surround the stream channel. The most predominant infrastructure elements in the watershed were stormwater outfalls. The number of headwater outfalls (Table 3-4) on this stream indicates that it is heavily influenced by stormwater discharges in the upstream-most segments of WSTM02 (Figure 3-5).

WSout505 had an area of five square feet and conveyed no dry weather flow. This outfall was the headwaters for a tributary (unnamed tributary A) to the main stem of Thomas Mill Run. The tributary channel was observed to be intermittently dry, as there was only flow in the channel during wet weather events. These unfavorable flow conditions can cause channel instability and degrade instream habitat from frequent erosion and sedimentation. The channel did however convey the stormwater flows away from Crefeld Avenue effectively.

Similarly, the main stem of Thomas Mill Run is impacted by stormwater runoff discharged from outfalls (WSout506, WSout507 and WSout508). There was a small amount of steady dry weather flow observed at the headwaters of the main stem. The headwaters emanated from WSout508, a four foot diameter outfall, which conveyed drainage from Chestnut Hill Avenue. The size of this outfall indicates that during wet weather events the discharge from this outfall has the potential to be substantially larger. The other two outfalls, WSout507 and WSout506, had no dry weather flow but were in degraded condition. WSout506 was partially blocked by a build-up of sediment and debris. The three bridges on Thomas Mill Run (WSbri221, WSbri222 and WSbri223) were small although they constricted flow within the channel. The bridges were built along the stream to connect the Fairmount Park trails parallel to the channel. WSout507 was the only piece of infrastructure identified as being in poor condition. The bank that once supported the pipe eroded which exposed the pipe leading to the outfall; subsequently, the pipe collapsed due to the lack of proper support.

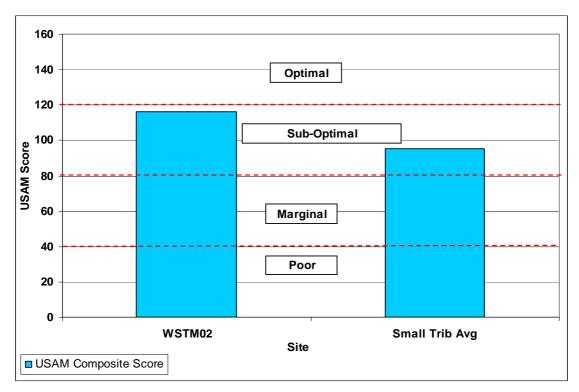
Figure 3-8: Thomas Mill Run USAM Results

Most of reach WSTM02 is located entirely within Fairmount Park. About 485 feet of the main stem channel, upstream of outfall WSout506 and up to the headwaters, was outside of Fairmount Park. The watershed was completely forested; however, the surrounding land use was residential. As such, Thomas Mill Run receives large volumes of runoff from its very small drainage area (0.07 mi<sup>2</sup>), which is notable given the relatively small bankfull channel in WSTM02 (10.4 ft<sup>2</sup>). The WSTM02 reach received a USAM composite score of 116/160 (Figure 3-8).

The mean scores for both the *Overall Stream Condition* USAM component as well as the *Overall* USAM score were all classified as "suboptimal" (Table 3-6). Conditions within the Thomas Mill Run watershed's buffers and floodplains were considerably better than conditions observed within the stream channels as the *Overall Buffer and Floodplain Condition* was rated as "optimal". The watershed scores for the both USAM components as well as the composite USAM score compared well against the respective Small

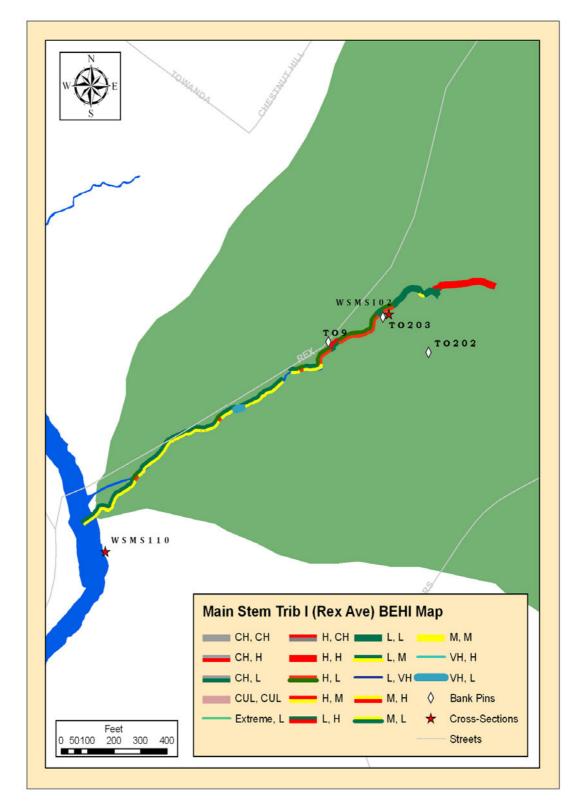
Figure 3-12: Tributary I - Rex Avenue Watershed BEHI Ratings and Bank Pin Locations

There were three bank pin locations along WSMSI – Tributary 1 (Figure 3-12). The calculated erosion rates are included in Table 3-10. The spatial distribution of BEHI assessment results were represented graphically (Figure 3-12) for each of the segments assessed on WSMSI – Tributary I. Each bank within a respective segment was assessed and rated separately; however, channelized and culverted segments were not assessed as they confer a high degree of protection from bank erosion.

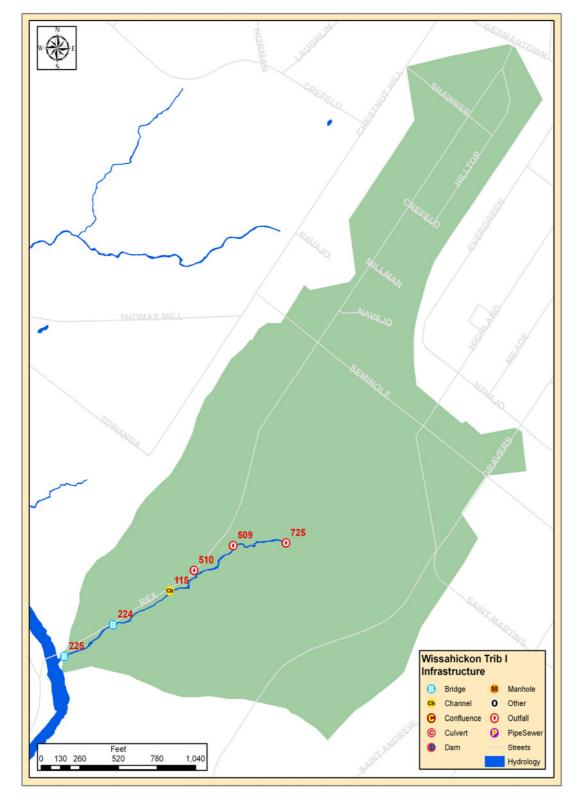
Figure 3-13: Tributary I Infrastructure

Wissahickon Tributary I is located within Fairmount Park adjacent to Rex Avenue and north of Gravers Lane. The most prominent piece of infrastructure on this stream is WSout509 (W-085-02), which is the largest outfall (4.5 foot diameter) on the tributary. It conveys stormwater drainage from Germantown Avenue and the nearby streets through a 54-inch diameter pipe directly to Tributary I. This outfall was observed to have a dry weather baseflow, which was a major contributing factor to the impairment of this tributary.

The high flows from WSout509 and to lesser extent outfalls WSout725 and WSout510 have impacted many aspects of the stream's physical and biological health. The eroding banks and "flashy" flow regime have spawned emergency repair and bank restoration projects to improve the condition of the stream. WSchal15 was most likely a temporary structure constructed to provide immediate protection to the eroding bank in the vicinity of the channel; to prevent Rex Avenue from collapsing into the stream, and possibly to keep the stream from exposing the water main sewer and sanitary interceptor that run parallel to Rex Avenue. Just downstream of this channelized portion, the 15-inch Wissahickon High Level Interceptor crosses underneath the stream. There were no infrastructure elements found to be in poor condition. WSchal15 was in fairly poor condition; however, it appeared to be a temporary structure.

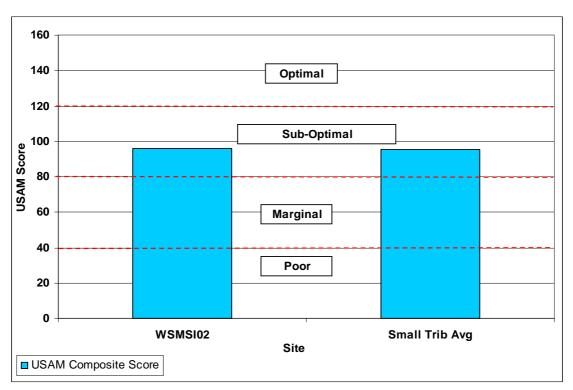
Figure 3-15: Tributary I - Rex Avenue USAM Results

The headwaters of reach WSMSI02 began as flow from a privately owned outfall, WSout725, which was located within Fairmount Park. The channel was relatively small with a bankfull cross-sectional area of only 11.4 ft<sup>2</sup>. The substrate distribution was dominated by gravel (61%) although cobble and a limited amount of boulders were also observed. The channel was characterized by a moderate width to depth ratio (13.8) and moderate degree of entrenchment (ER=1.4). As such, reach WSMSI02 was classified as a B4 type channel. The USAM composite score for the reach was 96/180 (Figure 3-15).

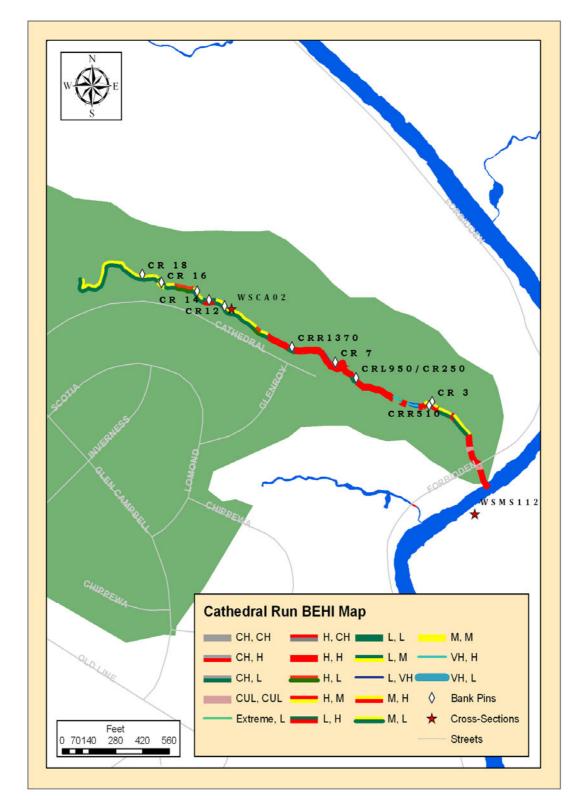
Figure 3-19: Cathedral Run Watershed BEHI Ratings and Bank Pin Locations

There were 10 bank pin locations along Cathedral Run (Figure 3-19). The calculated erosion rates at each bank pin location are included in Table 3-18. The spatial distribution of BEHI assessment results were represented graphically (Figure 3-19) for each of the segments assessed on Cathedral Run. Each bank within a respective segment was assessed and rated separately; however, channelized and culverted segments were not assessed as they confer a high degree of protection from bank erosion.

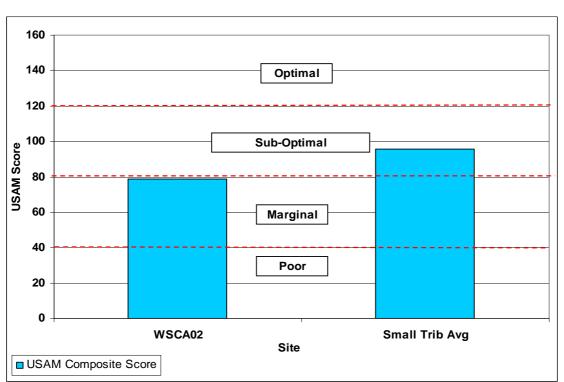
Figure 3-22: Cathedral Run USAM Results

The headwaters of reach WSCA02, located about 75 feet north of Cathedral Road, began as a zero order stream at the base of a steep swale that receives runoff from Courtesy Stables as well as WSout726. The WSCA02 channel was rather small with a bankfull cross sectional area of 6.9 ft<sup>2</sup>, although the drainage area for the reach (0.19 mi<sup>2</sup>) was relatively small as well. WSCA02 was dominated by gravel (55%) with cobble and boulders observed in much smaller proportions. A relatively high width to depth ratio was observed for WSCA02 as well as a moderately entrenched channel (ER=1.7). The reach was classified as a B4 type channel. The USAM composite score for the reach was 79/160 (Figure 3-22).

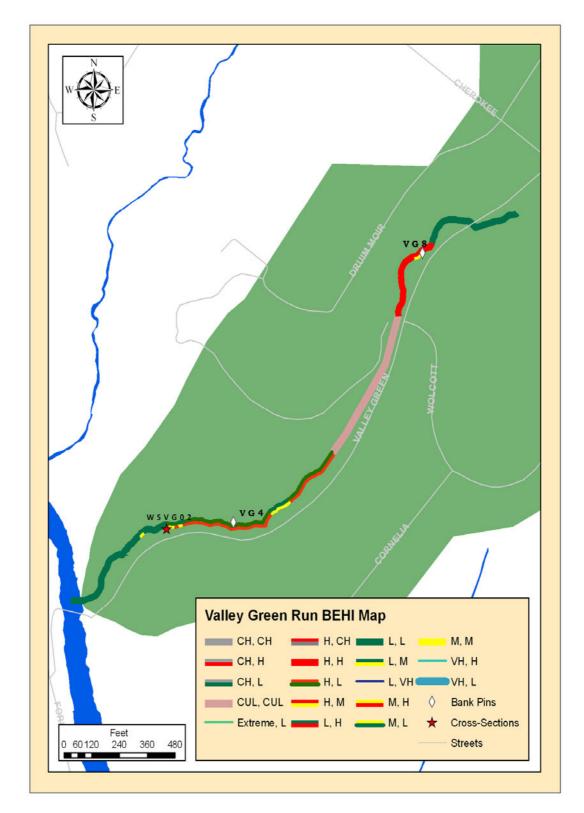
Figure 3-26: Valley Green Run Watershed BEHI Ratings and Bank Pin Locations

There were two bank pin locations along Valley Green Run (Figure 3-26). The calculated erosion rates are included in Table 3-26. The spatial distribution of BEHI assessment results were represented graphically (Figure 3-26) for each of the segments assessed on Valley Green Run. Each bank within a respective segment was assessed and rated separately; however, channelized and culverted segments were not assessed as they confer a high degree of protection from bank erosion.

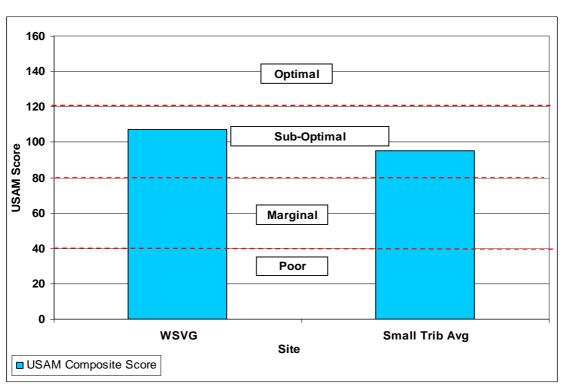
Figure 3-29: Valley Green Run USAM Results

The headwaters of reach WSVG02 began as flow from a privately owned outfall, WSout522, about 200 feet southwest of Cherokee Road. The total length of the main stem channel was 2,849 feet. The bankfull channel was rather small (6.9 ft<sup>2</sup>) with an estimated bankfull capacity of 34.3 cfs. The bankfull discharge to drainage area ratio for WSVG02 was 180.5 cfs/mi<sup>2</sup>, which was slightly below the median observation for the Lower Wissahickon Basin (185.6 cfs/ mi<sup>2</sup>). The observed stream bed substrate distribution had a nearly equal proportion of gravel (44%) and cobble (37%), with sand (16%) and boulder (1%) particles represented in much smaller proportions. The stream was characterized by a relatively high width to depth ratio (18.9) and a moderately entrenched channel (ER=1.4) such that the reach was classified as a B4/a channel type. The USAM composite score (Figure 3-29) for the reach was 107/160.

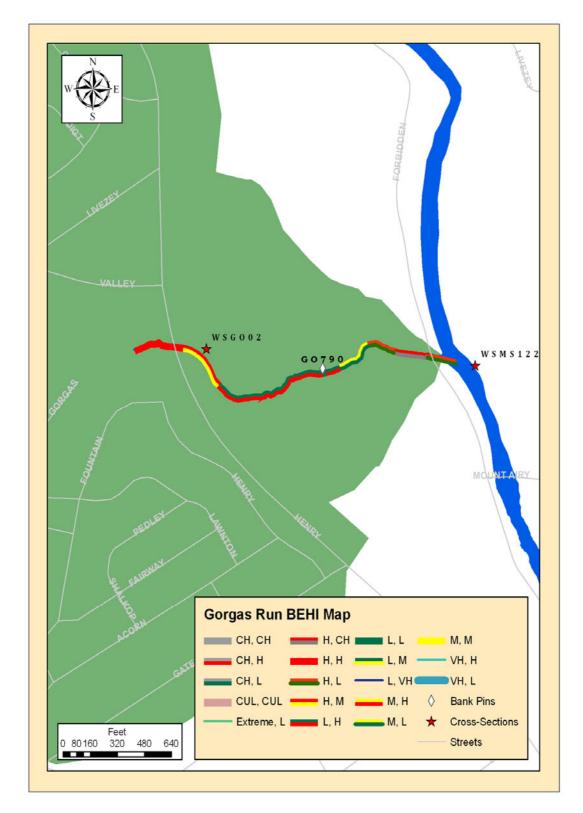
Figure 3-33: Gorgas Run Watershed BEHI Ratings and Bank Pin Locations

There was one bank pin location along Gorgas Run (Figure 3-33). The calculated erosion rates are included in Table 3-34. The spatial distribution of BEHI assessment results were represented graphically (Figure 3-33) for each of the segments assessed on Gorgas Run. Each bank within a respective segment was assessed and rated separately; however, channelized and culverted segments were not assessed as they confer a high degree of protection from bank erosion.

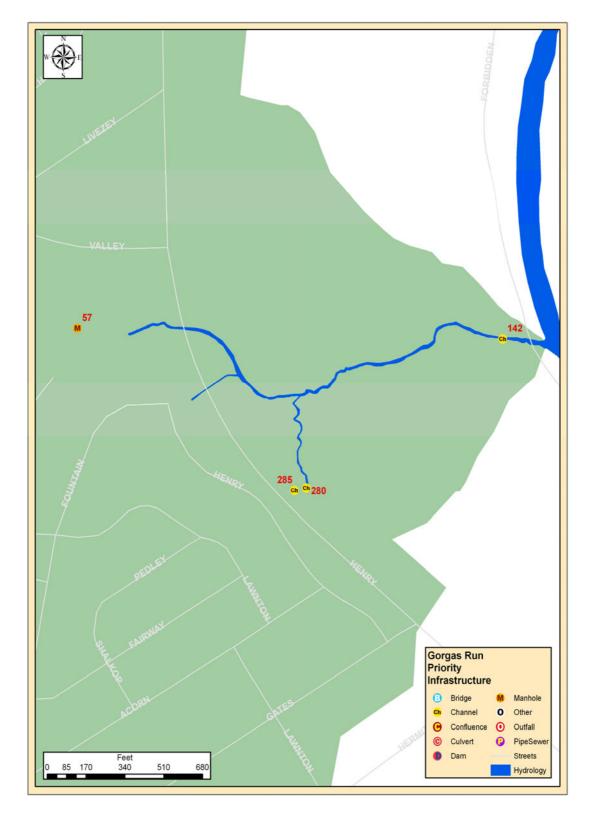
Figure 3-36: Gorgas Run Priority Infrastructure Locations

Priority infrastructure (Figure 3-36) on Gorgas Run included WScha280 (Figure 3-34), WScha285, WScha142 (Figure 3-34), and WSman57 which had no manhole cover and an exposed pipe orifice.

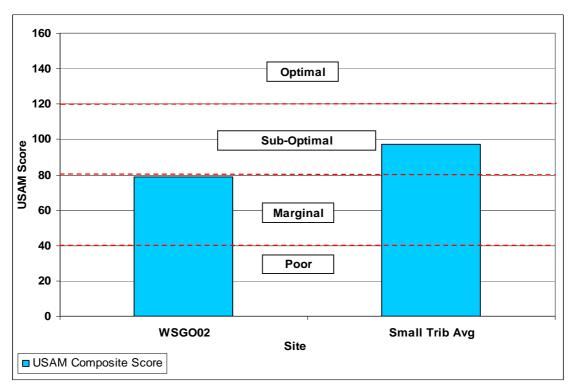
Figure 3-38: Gorgas Run USAM Results

The headwaters of reach WSGO02 begins approximately 230 feet upstream of WSout566 (W-067-01) and Henry Avenue. The channel is fed mainly by runoff from Gorgas Road as well as the trail adjacent to the channel. The main stem channel had a bankfull channel capacity relatively larger than the other small Lower Wissahickon tributaries; however the Gorgas Run drainage area (0.6 mi<sup>2</sup>) was also larger than that of the other small tributaries. The bed substrate within the reach was dominated by cobble (62%) with gravel and boulder comprising the remainder of the substrate distribution. Reach WSGO2 was characterized by a deeply entrenched (Entrenchment Ratio=1.1), moderate gradient (slope of 2.9%) channel and a relatively high width to depth ratio (20.9) which classified the reach as an F3b channel type. The USAM composite score for the reach was 79/160 (Figure 3-38).

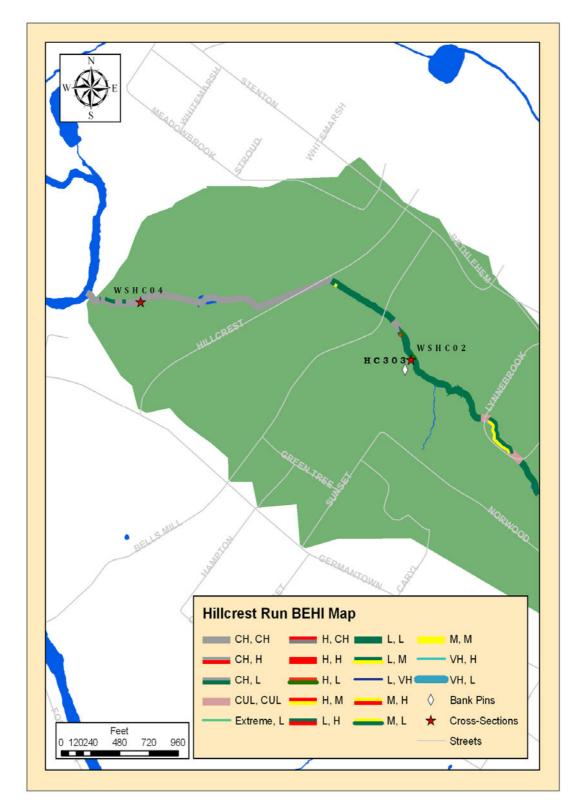
Figure 3-42: Hillcrest Run Watershed BEHI Ratings and Bank Pin Locations

There was one bank pin location along Hillcrest Run (Figure 3-42). The calculated erosion rates are included in Table 3-42. The spatial distribution of BEHI assessment results were represented graphically (Figure 3-42) for each of the segments assessed on Hillcrest Run. Each bank within a respective segment was assessed and rated separately; however, channelized and culverted segments were not assessed as they confer a high degree of protection from bank erosion.

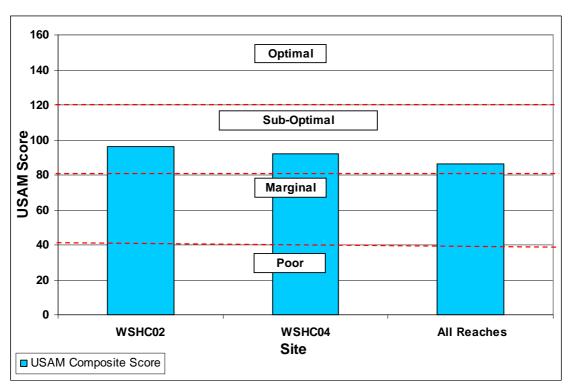
Figure 3-46: Hillcrest Run USAM Results

The headwaters of reach WSHC02 originated from an outfall, WSout469, located 485 feet from the intersection of Chestnut Hill Avenue and Norwood Avenue. There was a small tributary (530 feet) on reach WSHC02, of which the confluence with the main stem of Hillcrest Run was located 300 feet upstream of cross section WSHC02. In total, reach WSHC02 was 4,135 feet in length and ended at the culverted segment of the reach above Hillcrest Avenue. Reach WSHC02 was characterized by a low width to depth ratio (8.5), a moderately entrenched channel (ER=1.8) and a relatively steep slope (4.7%) which classified the channel as a B4a stream type based upon the Rosgen classification system. The composite USAM score (Figure 3-46) for reach WSHC02 was (96/160).

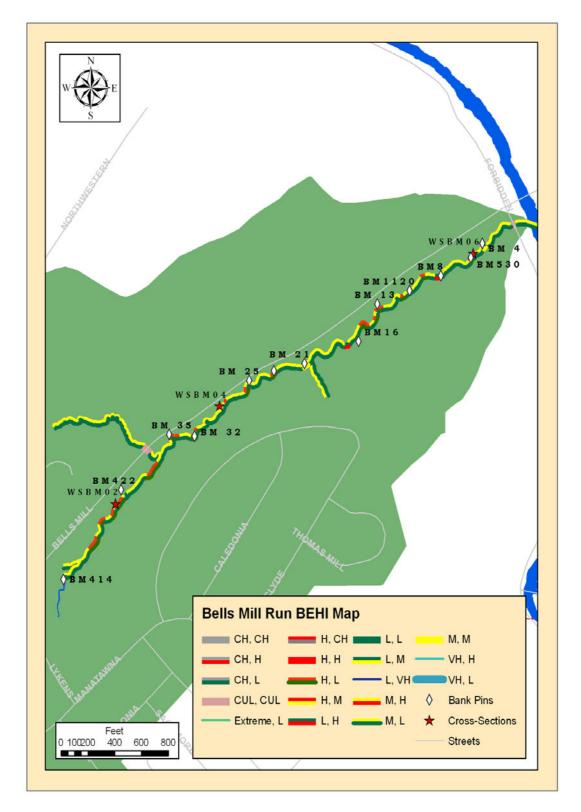
Figure 3-50: Bell's Mill Watershed BEHI Ratings and Bank Pin Locations

There were 13 bank pin locations along Bell's Mill Run (Figure 3-50). The calculated erosion rates are included in Table 3-50. The spatial distribution of BEHI assessment results were represented graphically (Figure 3-50) for each of the segments assessed on Bell's Mill Run. Each bank within a respective segment was assessed and rated separately; however, channelized and culverted segments were not assessed as they confer a high degree of protection from bank erosion.

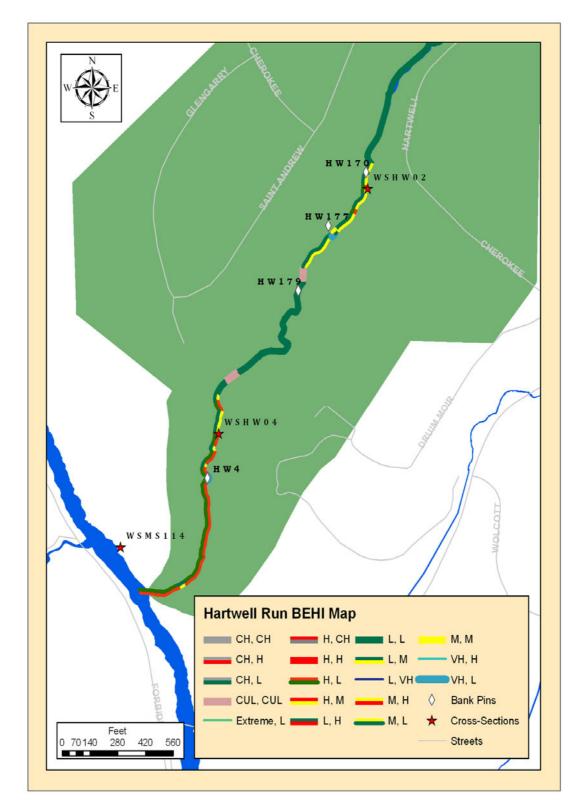
Figure 3-58: Hartwell Run Watershed BEHI Ratings and Bank Pin Locations

There were four bank pin locations along Hartwell Run (Figure 3-58). The calculated erosion rates are included in Table 3-58. The spatial distribution of BEHI assessment results were represented graphically (Figure 3-58) for each of the segments assessed on Hartwell Run. Each bank within a respective segment was assessed and rated separately; however, channelized and culverted segments were not assessed as they confer a high degree of protection from bank erosion.

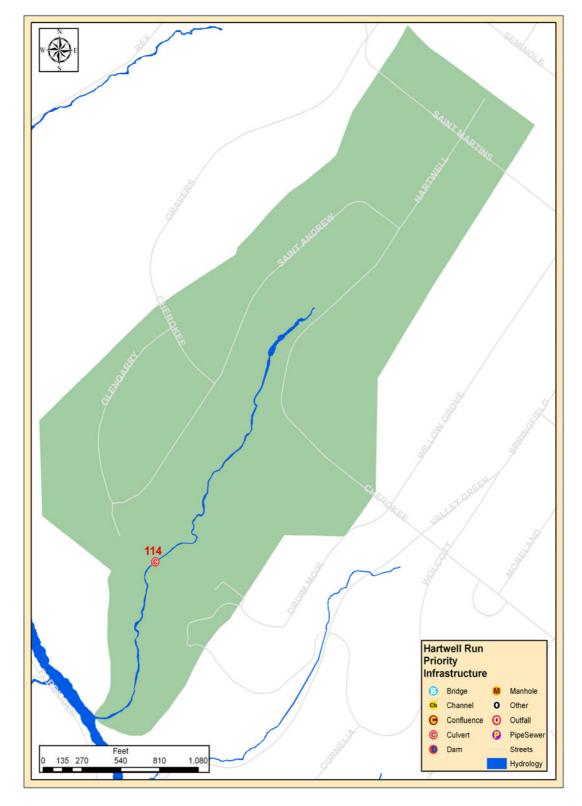
Figure 3-60: Hartwell Run Priority Infrastructure

Downstream in reach WSHW04, the channel was heavily influenced by stormwater. Increased flow from urban development has exceeded the capacity of the two culverts (Wscul13 and WScul114) in the reach. The culverts were built several decades ago and were not designed to transmit the current flow regime; therefore, these culverts can impede the downstream movement of water and sediment. At WScul116, which was constructed to protect the 45-inch Wissahickon High Level Interceptor, this occurred to such an extent that flow swept over the top of the culvert rather than through which caused substantial scour and mass slumping of the bank downstream of the culvert. PWD is currently modifying WScul116 so that it will no longer impede streamflow.

While a large portion of the flow came from the residential area upstream, WSout578 (W-076-07) in the upstream portion of WSHW04 conveyed stormwater from a 42-inch diameter pipe which drained St. Andrew Road and Glengarry Road. The majority of the infrastructure in the upstream residential area of WSHW02 was in good condition and only one infrastructure element, WScull14, was identified as being in poor condition.

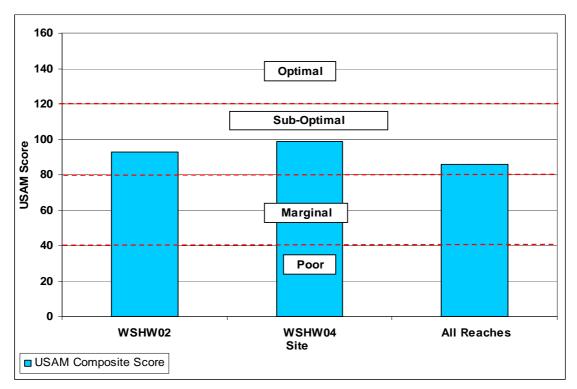
Figure 3-62: Hartwell Run USAM Results

Reach WSHW04 began 230 feet downstream of WScul113. There was one dam (WSdam116) on the reach; however the impoundment caused by WSdam116 was considerably smaller than the upstream impoundments in reach WSHW02. The reach had a gradient (6.6%) and width to depth ratio (14.7) comparable to that of WSHW02; however, the reach WSHW04 channel exhibited a much higher degree of entrenchment (ER=1.1). The reach was classified as a B4a type stream channel and had a composite USAM score of 99/160.

The mean scores for both of the individual USAM components as well as the overall USAM score were all classified as "suboptimal" (Table 3-62). Average conditions within the Hartwell Run watershed's buffers and floodplains were considerably better than conditions observed within the stream channels. The watershed averages for each

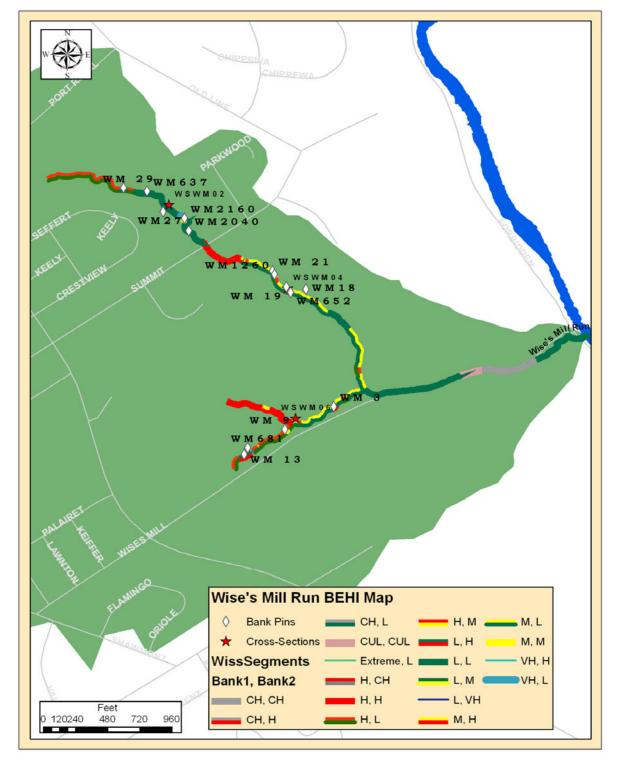
Figure 3-66: Wise's Mill Run Watershed BEHI Ratings and Bank Pin Locations

There were 13 bank pin locations along Wise's Mill Run (Figure 3-66). The calculated erosion rates are included in Table 3-66. The spatial distribution of BEHI assessment results were represented graphically (Figure 3-66) for each of the segments assessed on Wise's Mill Run. Each bank within a respective segment was assessed and rated separately; however, channelized and culverted segments were not assessed as they confer a high degree of protection from bank erosion.

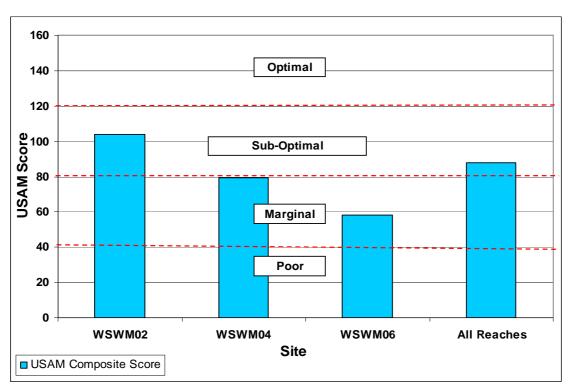
Figure 3-69: Main Stem Wise's Mill Run USAM Results

Reach WSWM02 began as flow from WSout571 (W-075-01) which was located on the grounds of the Summit Park East Apartment Complex on Henry Avenue. The reach flowed through Fairmount Park for 1,271 feet and ended at culvert WScul501 on Summit Avenue. The substrate particle size distribution was dominated by gravel (54%) although cobble substrate (42%) was present in considerable amounts throughout the reach. Reach WSWM02 had a relatively shallow slope (2.7%) compared to the other Wise's Mill reaches. It was characterized by a high width to depth ratio (30.8) and a deeply entrenched channel (ER=1.3), which classified the reach as a B4 stream channel. The composite USAM score (Figure 3-69) for the reach was (104/160).

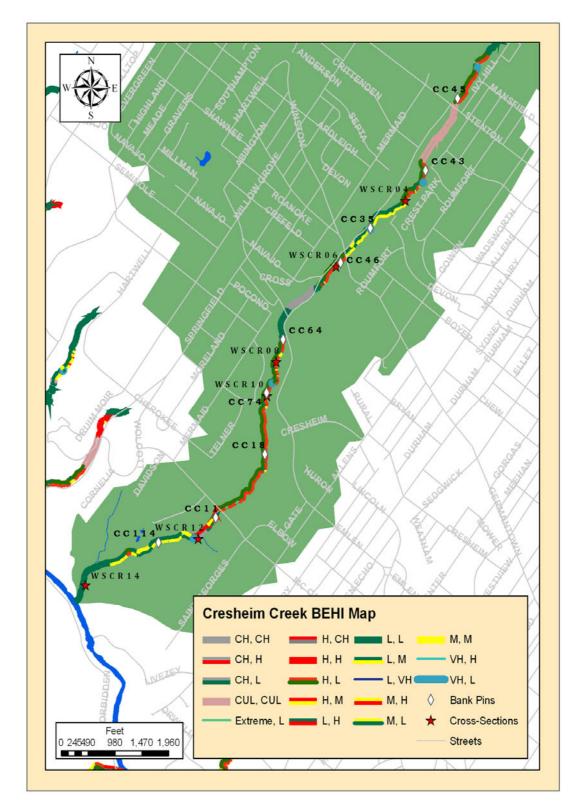
Figure 3-73: Cresheim Creek Watershed BEHI Ratings and Bank Pin Locations

There were nine bank pin locations along Cresheim Creek (Figure 3-73). The calculated erosion rates are included in Table 3-74. The spatial distribution of BEHI assessment results were represented graphically (Figure 3-73) for each of the segments assessed on Cresheim Creek. Each bank within a respective segment was assessed and rated separately; however, channelized and culverted segments were not assessed as they confer a high degree of protection from bank erosion.

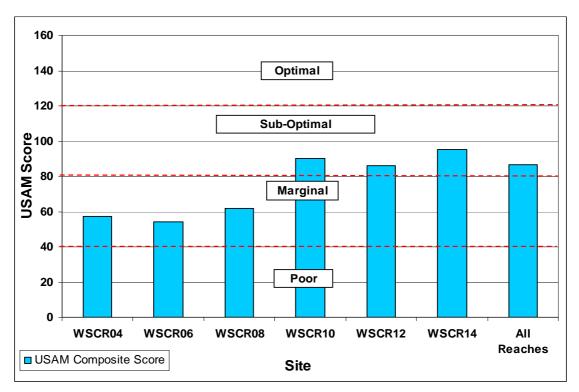
Figure 3-77: Cresheim Creek USAM Results

Reach WSCR04 formed the headwaters to Cresheim Creek and was the only reach with segments of stream channel in Montgomery County. The reach began as two small outfall-fed channels that drained to a shallow pond located 350 feet east of the intersection of Mermaid Lane and Flourtown Avenue. The larger of the two channels (DSR) received flow from WSout734 and WSout735. The DSL channel received flow from WScul532 which drained a large industrial park. Cross section WSCR04, used to characterize the reach, was located about 4,000 feet downstream within the Philadelphia portion of Cresheim Creek. The gravel-dominated (64%) reach was characterized by a very high width to depth ratio (41.7), a deeply entrenched channel (ER=1.2) and an extremely shallow gradient (0.9%). Overall, the reach was classified as an F4 stream type and had a composite USAM score (Figure 3-77) of (57/160).

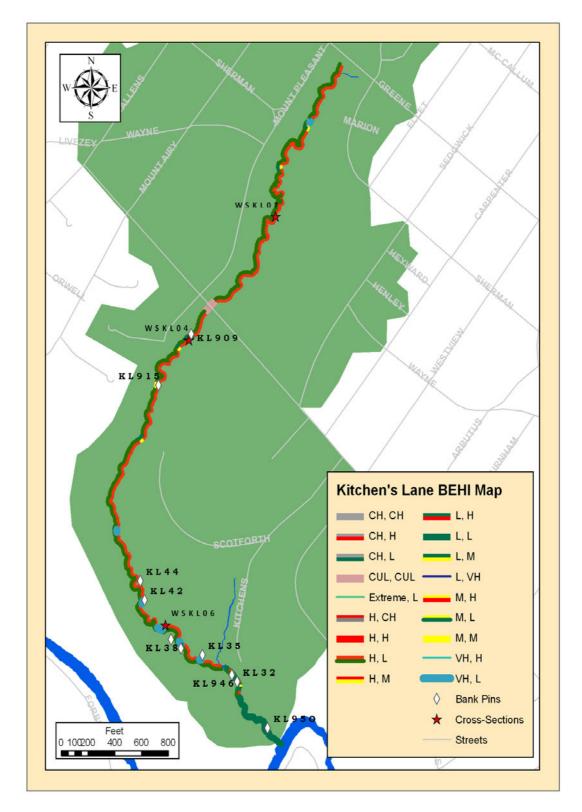
Figure 3-81: Kitchen's Lane BEHI Ratings and Bank Pin Locations

There were ten bank pin locations along Kitchen's Lane Run (Figure 3-81). The calculated erosion rates are included in Table 3-82. The spatial distribution of BEHI assessment results were represented graphically (Figure 3-81) for each of the segments assessed on Kitchen's Lane Run. Each bank within a respective segment was assessed and rated separately; however, channelized and culverted segments were not assessed as they confer a high degree of protection from bank erosion.

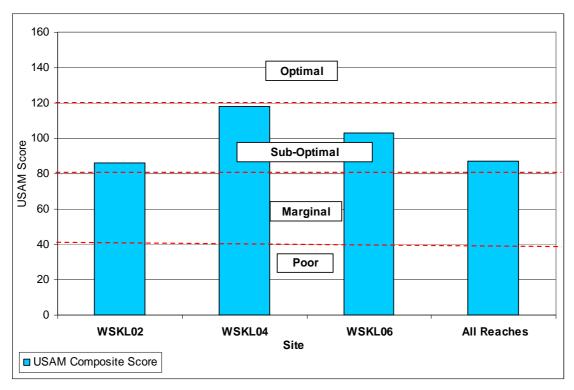
Figure 3-85: Kitchen's Lane USAM Results

The mean scores for both the individual USAM components as well as the overall USAM score were all classified as "suboptimal" (Table 3-86). Average conditions within the watershed's riparian buffers and floodplains were slightly better than conditions observed within the stream channels. The watershed averages for each component as well as the composite USAM score compared well against the respective All Reaches averages, especially for the *Overall Buffer and Floodplain* component. The ratings for individual parameters ranged from poor to optimal, displaying similar levels of variability between reaches.

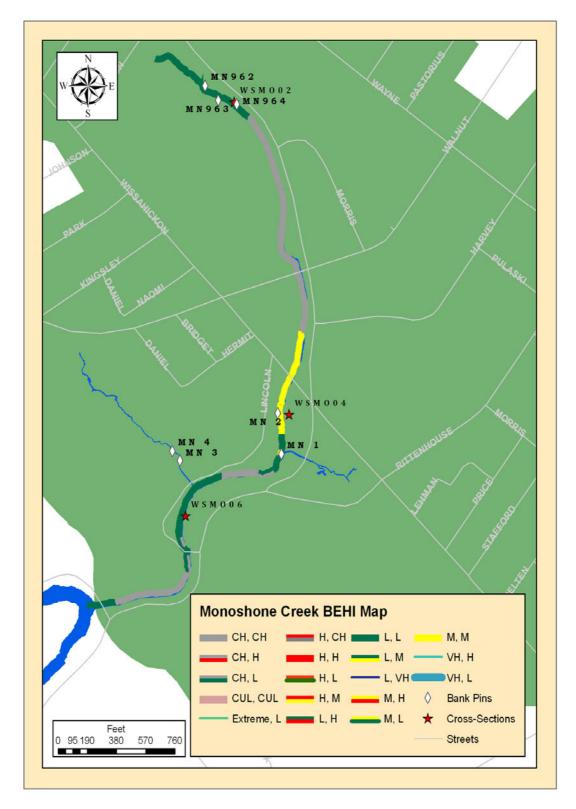
Figure 3-89: Monoshone Creek Watershed BEHI Ratings and Bank Pin Locations

There were seven bank pin locations along Monoshone Creek (Figure 3-89). The calculated erosion rates are included in Table 3-90. The spatial distribution of BEHI assessment results were represented graphically (Figure 3-89) for each of the segments assessed on Monoshone Creek. Each bank within a respective segment was assessed and rated separately; however, channelized and culverted segments were not assessed as they confer a high degree of protection from bank erosion.

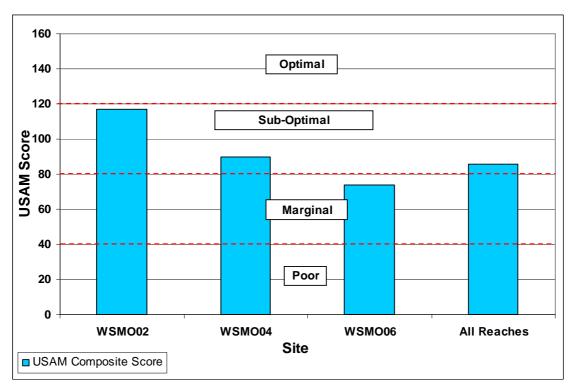
Figure 3-92: Monoshone Creek USAM Results

Reach WSMO02 contained the headwaters of Monoshone Creek which began as flow from WSout544 located 315 feet southwest of the intersection of Johnson Street and Lincoln Drive. The entire reach ran parallel to Lincoln Drive and was highly channelized (WScha203 on the DSR and WScha132 on the DSL) along the segment of the reach that was located within 40 feet of Lincoln Drive. The substrate particle size distribution was dominated by silt (67%) with sand (33%) comprising the remainder of the sediment in the reach. The channel morphology in reach WSMO02 was characterized by a moderate width to depth ratio (12), a deeply entrenched channel (ER=1.6) and a moderately shallow gradient (3.1%). The reach was classified as a type B6 stream channel and had a USAM composite score (Figure 3-92) of 117/160 which was the second highest score of all reaches assessed in the Lower Wissahickon Basin.
