APPENDIX B
INFRASTRUCTURE PHOTOS

Reach WSTM02 Infrastructure Photos

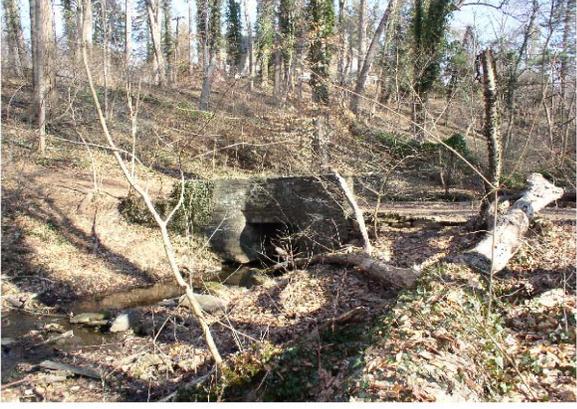
Infrastructure ID: WSbri223 Bridge

Condition	Material	Dimension (ft)	Length (ft)	Location
Good	Concrete	5.0 x 5.0	10.0	Trail near Thomas Mill Rd

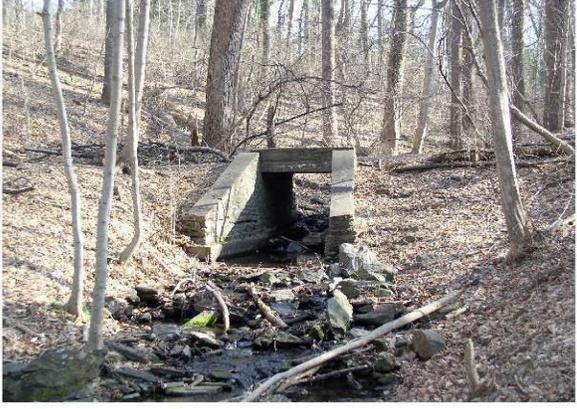
Infrastructure ID: WSbri222 Bridge

Condition	Material	Dimension (ft)	Length (ft)	Location
Good	Brick/Conc	8.0 x 5.0	20.0	Trail near Thomas Mill Rd

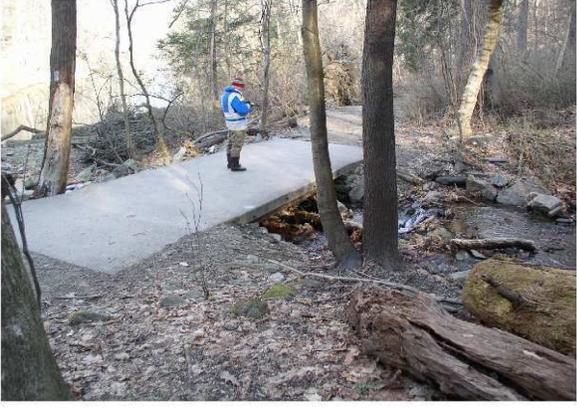
Infrastructure ID: WSbri221 Bridge

Condition	Material	Dimension (ft)	Length (ft)	Location
Good	Concrete	5.0 x 8.0	8.0	Trail near Thomas Mill Rd

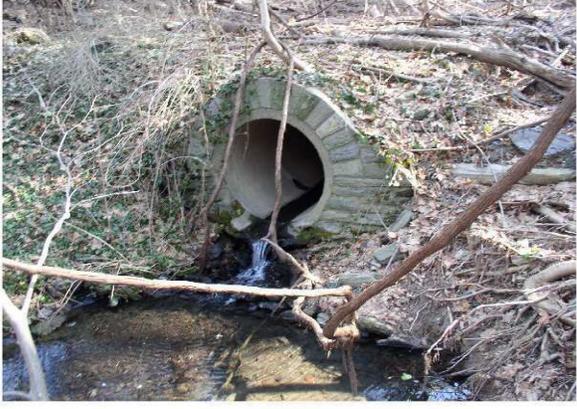
Infrastructure ID: WSout508 Outfall

Condition	Material	Location	Flow	Flow Appearance	Dimension (ft)
Good	Concrete	MID	Steady	Clear	4.0

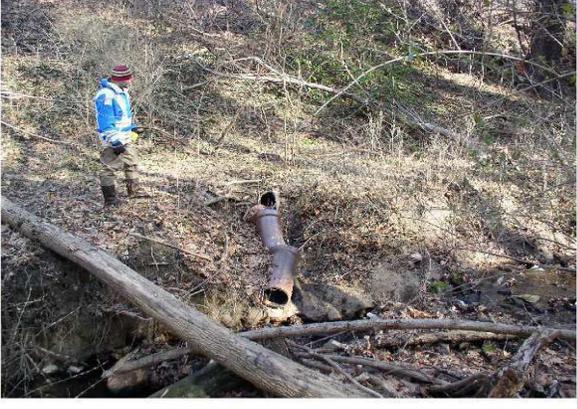
Infrastructure ID: WSout507 Outfall

Condition	Material	Location	Flow	Flow Appearance	Dimension (ft)
Poor	Clay/Terra	DSR	None		0.833

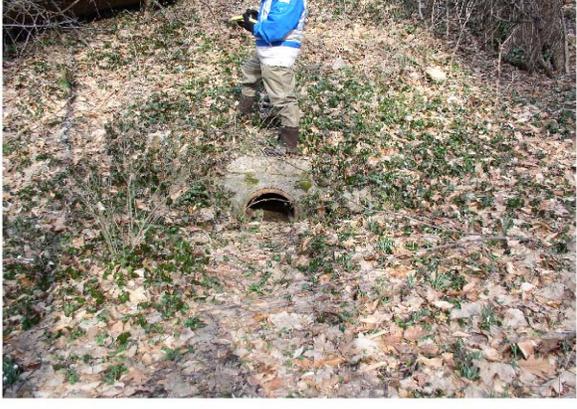
Infrastructure ID: WSout506 Outfall

Condition	Material	Location	Flow	Flow Appearance	Dimension (ft)
Good	Clay/Terra	DSR	None		1.0

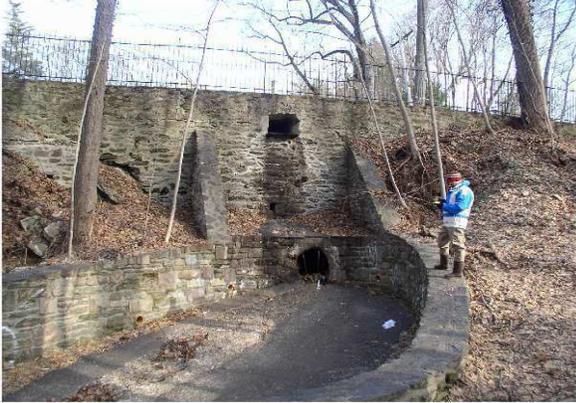
Infrastructure ID: WSout505 Outfall

Condition	Material	Location	Flow	Flow Appearance	Dimension (ft)
Good	Stone	MID	None		2.5 x 2.0

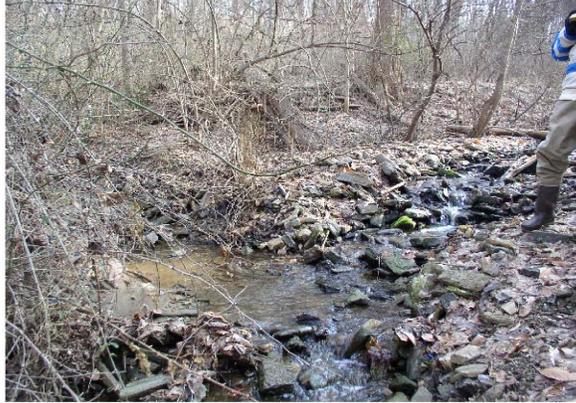
Infrastructure ID: WScon160 Confluence

Condition	Location	Width (ft)	Flow	Creeks
Good	DSR	5.0	Steady	Unnamed Trib into Thomas Mill Run

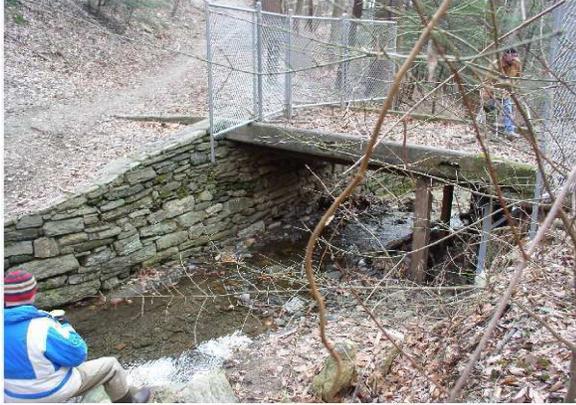
Infrastructure ID: WSbri224 Bridge

Condition	Material	Dimension (ft)	Length (ft)	Location
Good	Stone	8.0 x 8.0	15.0	Trail near Gravers Ln

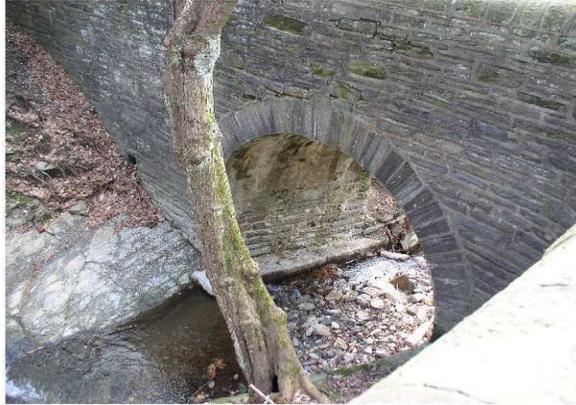
Infrastructure ID: WSbri225 Bridge

Condition	Material	Dimension (ft)	Length (ft)	Location
Good	Stone	20.0 x 20.0	15.0	Trail near Gravers Ln

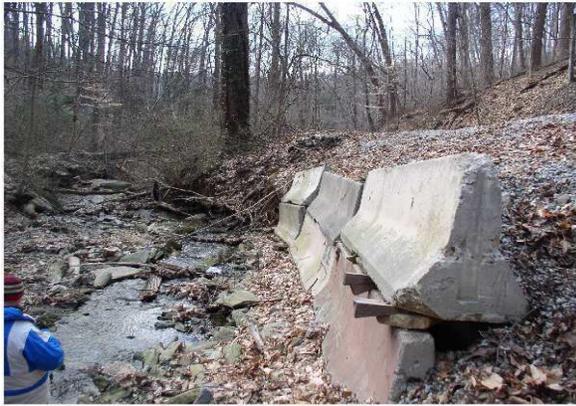
Infrastructure ID: WScha115 Channel

Condition	Material	Dimension (ft)	Length (ft)	Location
Fair	Concrete		45.0	DSR

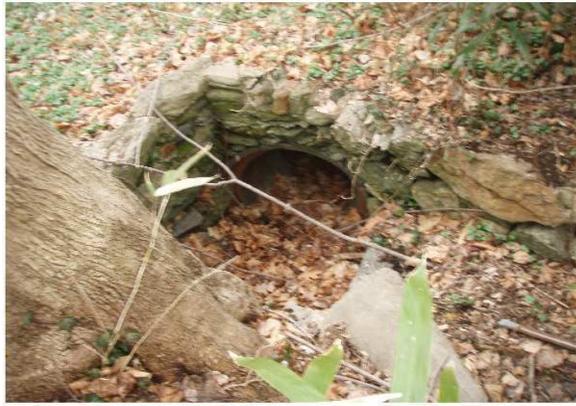
Infrastructure ID: WSout725 Outfall

Condition	Material	Location	Flow	Flow Appearance	Dimension (ft)
Fair	Iron	MID			2.0

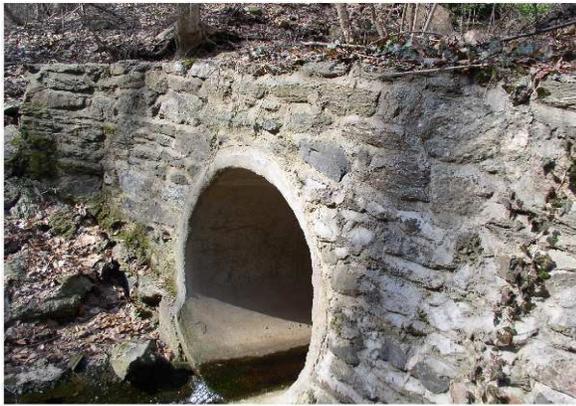
Infrastructure ID: WSout509 Outfall

Condition	Material	Location	Flow	Flow Appearance	Dimension (ft)
Good	Concrete	DSR	Steady	Clear	4.0

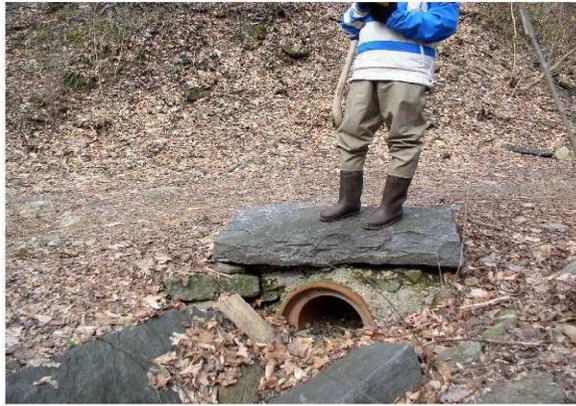
Infrastructure ID: WSout510 Outfall

Condition	Material	Location	Flow	Flow Appearance	Dimension (ft)
Good	ClayTerra	DSR	None		1.5

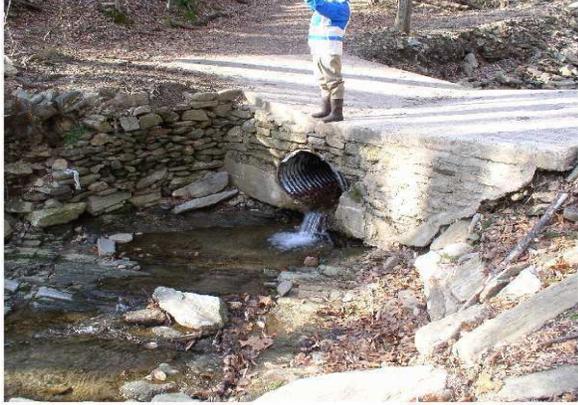
Infrastructure ID: WScul093 Culvert

Condition	Material	Dimension (ft)	Length (ft)	Location
Fair	Corr/Metal	2.0	24.0	Near Wissahickon Ave

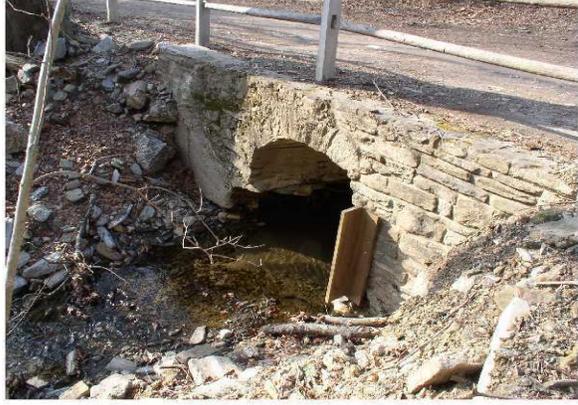
Infrastructure ID: WScul095 Culvert

Condition	Material	Dimension (ft)	Length (ft)	Location
Good	Stone	5.0	28.0	Under Wissahickon Ave

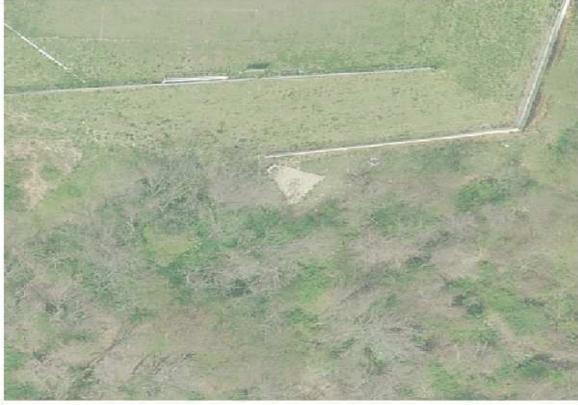
Infrastructure ID: WSout726 Outfall

Condition	Material	Location	Flow	Flow Appearance	Dimension (ft)
Good	Concrete	MID	None		3.0

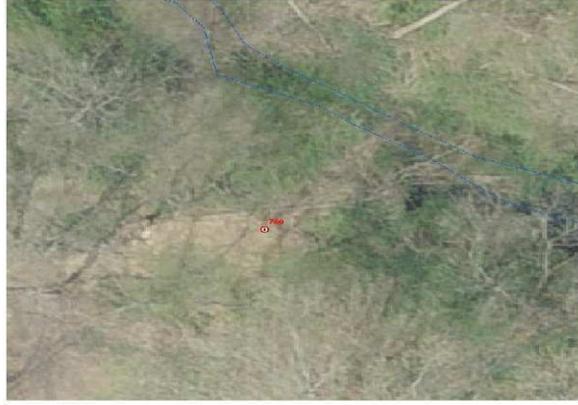
Infrastructure ID: WSout760 Outfall

Condition	Material	Location	Flow	Flow Appearance	Dimension (ft)
Fair	TerraCotta	DSR			4.0

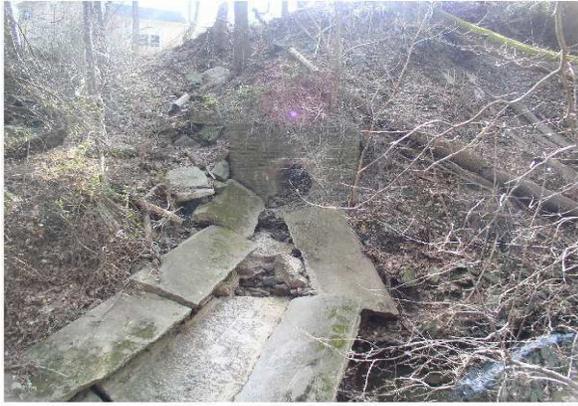
Infrastructure ID: WSout511 Outfall

Condition	Material	Location	Flow	Flow Appearance	Dimension (ft)
Fair	Stone	DSR	None		3.0

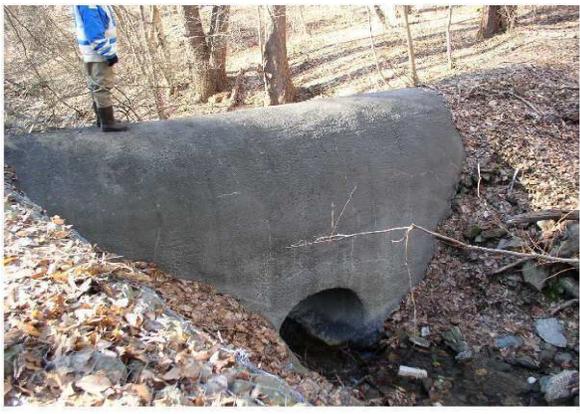
Infrastructure ID: WScul105 Culvert

Condition	Material	Dimension (ft)	Length (ft)	Location
Good	Concrete	2.0	20.0	Next to Valley Green Rd

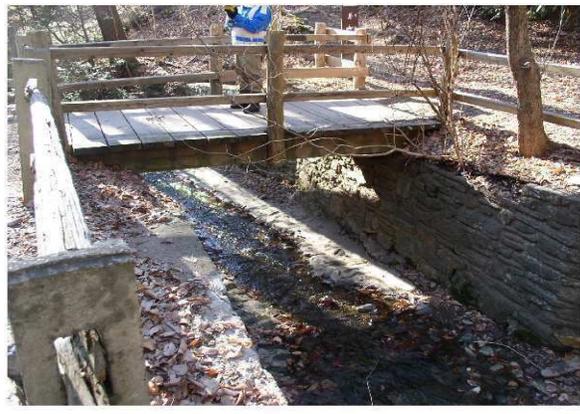
Infrastructure ID: WSbri234 Bridge

Condition	Material	Dimension (ft)	Length (ft)	Location
Good	Wood	10.0 x 15.0	10.0	Path near Valley Green Rd

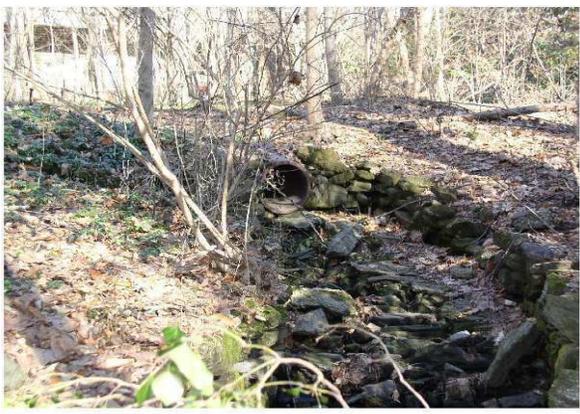
Infrastructure ID: WSout522 Outfall

Condition	Material	Location	Flow	Flow Appearance	Dimension (ft)
Good	Clay/Terra	MID	None		1.5

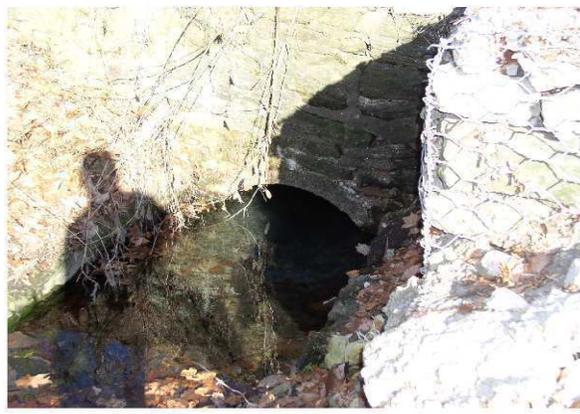
Infrastructure ID: WSout523 Outfall

Condition	Material	Location	Flow	Flow Appearance	Dimension (ft)
Good	Concrete	DSL	Trickle		2.5

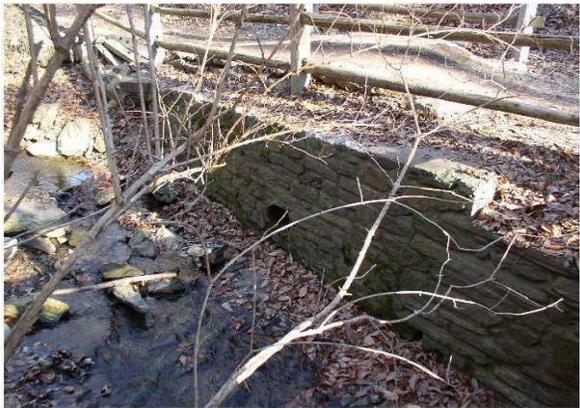
Infrastructure ID: WSout524 Outfall

Condition	Material	Location	Flow	Flow Appearance	Dimension (ft)
Good	Clay/Terra	DSL	None		1.333

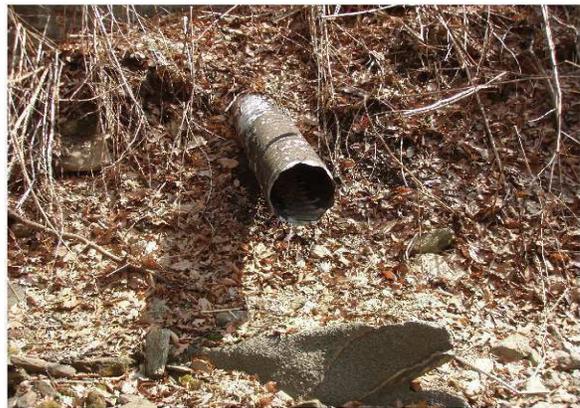
Infrastructure ID: WSout525 Outfall

Condition	Material	Location	Flow	Flow Appearance	Dimension (ft)
Good	CorrMetal	DSL	None		2.0

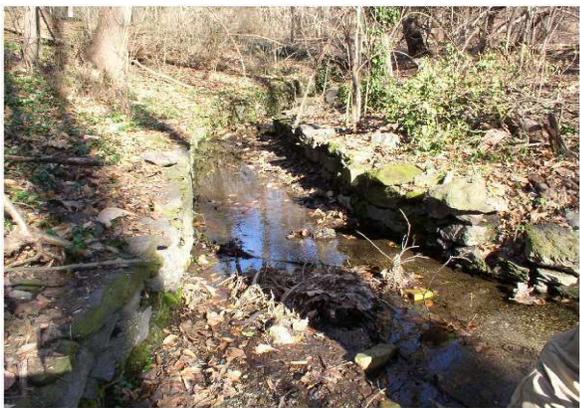
Infrastructure ID: WScon166 Confluence

Condition	Location	Width (ft)	Flow	Creeks
Good	DSR	5.0	Intermittent

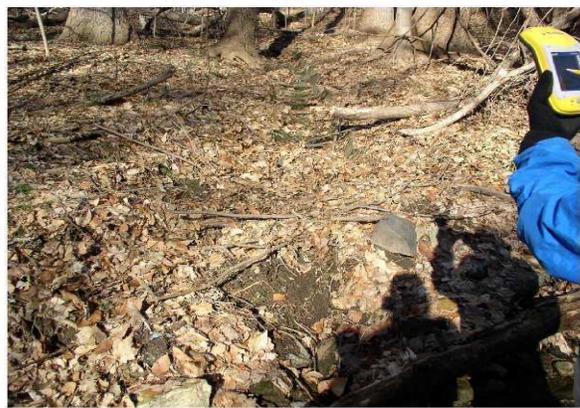
Infrastructure ID: WScon167 Confluence

Condition	Location	Width (ft)	Flow	Creeks
Good	DSR	5.0	None

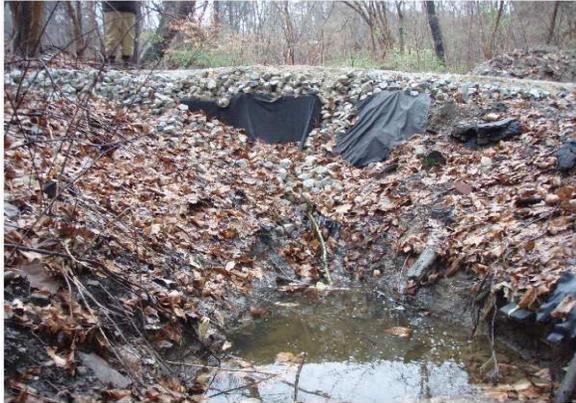
Infrastructure ID: WScul600

Condition Good **Material** **Dimension (ft)** 3.0 **Length (ft)** 8.0 **Location** Runoff under trail, sediment blanket, under Henry Ave

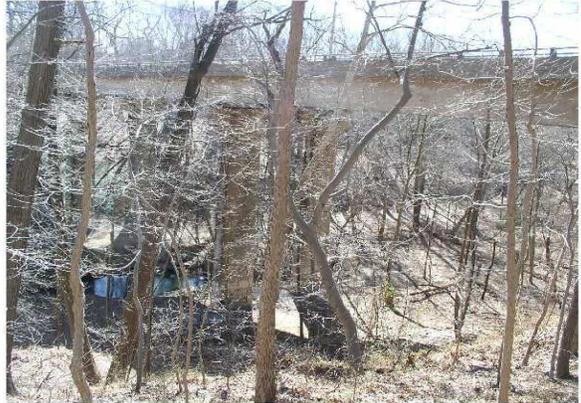
Infrastructure ID: WSbri246

Condition Good **Material** Concrete **Dimension (ft)** 100.0 x 150.0 **Length (ft)** 75.0 **Location** Henry Ave, Philadelphia

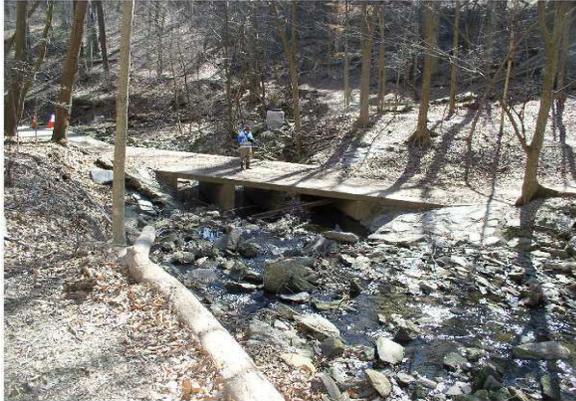
Infrastructure ID: WSbri247

Condition Good **Material** Concrete **Dimension (ft)** 5.0 x 20.0 **Length (ft)** 20.0 **Location** Off Henry Ave

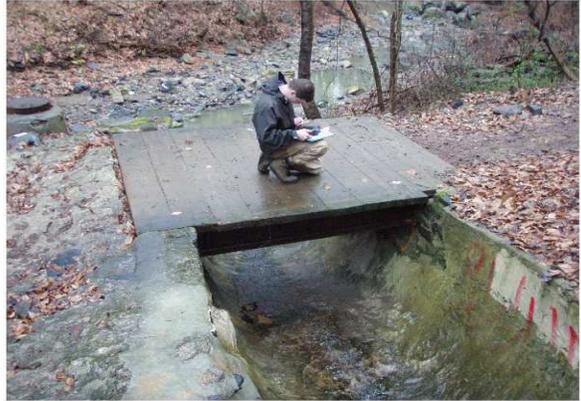
Infrastructure ID: WSbri544

Condition Good **Material** Wood **Dimension (ft)** 5.0 x 8.0 **Length (ft)** 7.0 **Location** East of Henry Ave, over unnamed tributary concrete channel

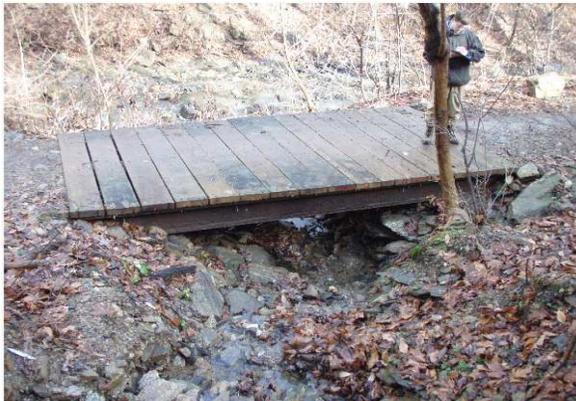
Infrastructure ID: WSbri545

Condition Good **Material** Wood **Dimension (ft)** 5.0 x 10.0 **Length (ft)** 6.0 **Location** East of Henry Ave, over tributary from runoff at Henry Ave

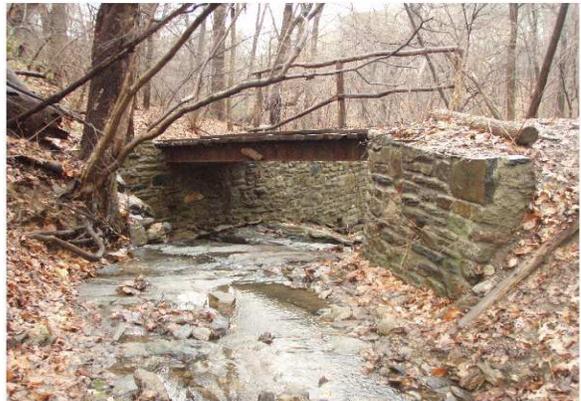
Infrastructure ID: WSbri543

Condition Good **Material** Stone+Wood **Dimension (ft)** 6.0 x 6.0 **Length (ft)** 6.0 **Location** Over unnamed tributary, east of Henry Ave

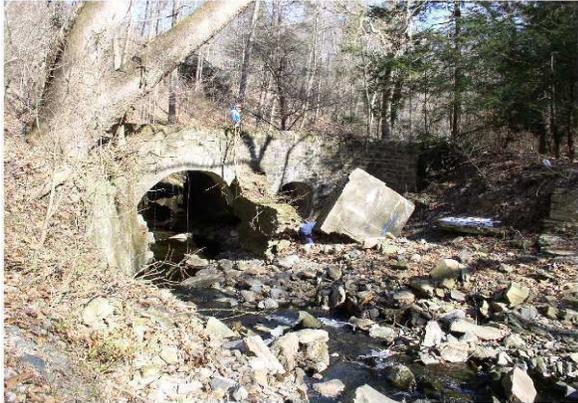
Infrastructure ID: WSbri248 Bridge

Condition	Material	Dimension (ft)	Length (ft)	Location
Good	Stone	8.0 x 15.0	50.0	Between Henry Ave and Wissahickon Dr

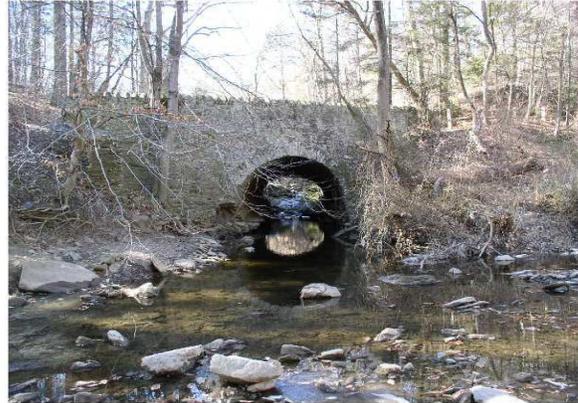
Infrastructure ID: WSbri249 Bridge

Condition	Material	Dimension (ft)	Length (ft)	Location
Good	Stone	8.0 x 20.0	50.0	Wissahickon Dr

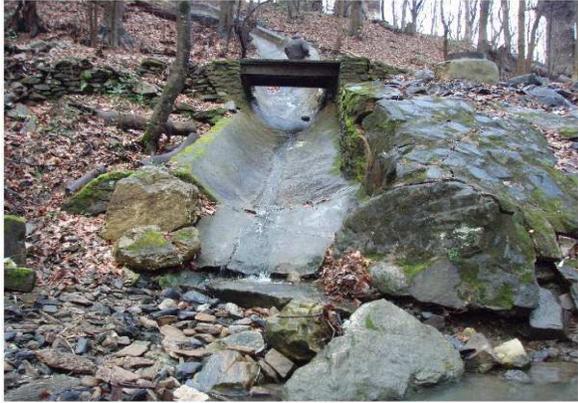
Infrastructure ID: WScha282 Channel

Condition	Material	Dimension (ft)	Length (ft)	Location
Good	Concrete	3.0 x 6.0	180.0	MID

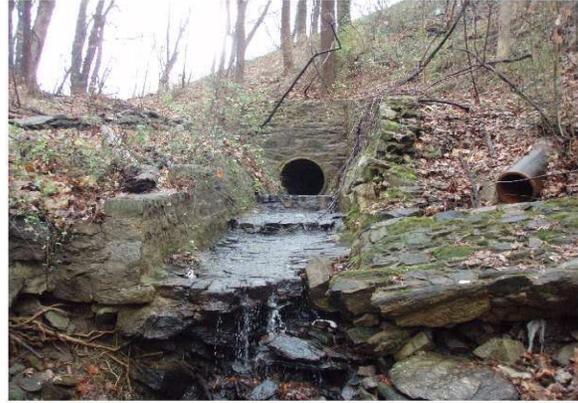
Infrastructure ID: WScha280 Channel

Condition	Material	Dimension (ft)	Length (ft)	Location
Poor	Stone	0.0 x 4.0	35.0	MID

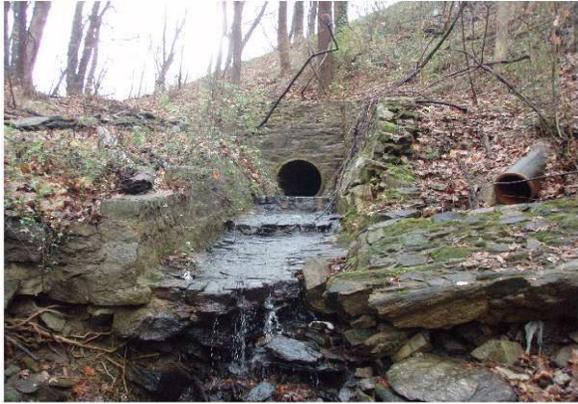
Infrastructure ID: WScha285 Channel

Condition	Material	Dimension (ft)	Length (ft)	Location
Poor	Stone	8.0 x 2.0	35.0	DSL

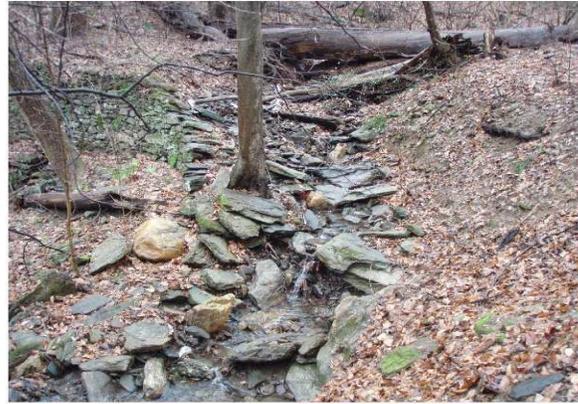
Infrastructure ID: WScha281 Channel

Condition	Material	Dimension (ft)	Length (ft)	Location
Fair	Stone	4.0 x 2.0	10.0	DSR

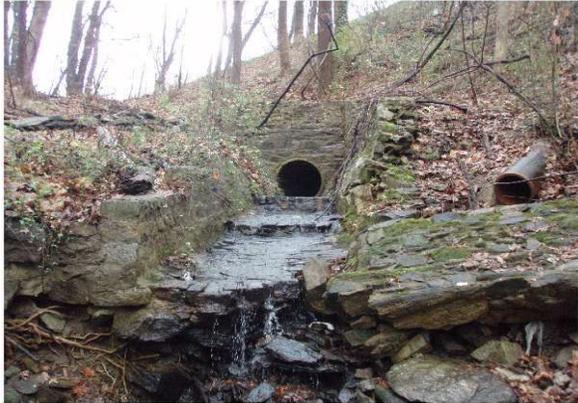
Infrastructure ID: WScha284 Channel

Condition	Material	Dimension (ft)	Length (ft)	Location
Fair	Stone	4.0 x 2.0	35.0	DSR

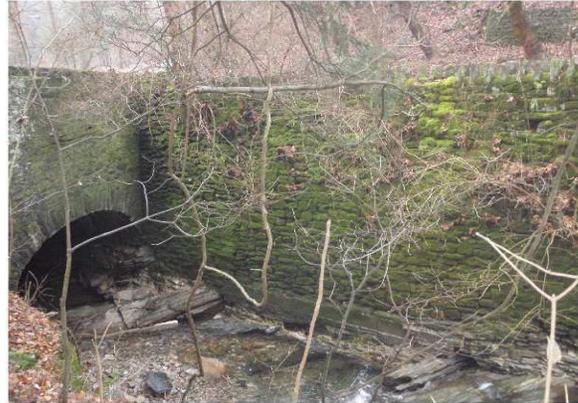
Infrastructure ID: WScha142 Channel

Condition	Material	Dimension (ft)	Length (ft)	Location
Poor	Stone	20.0 x 3.0	208.0	DSR

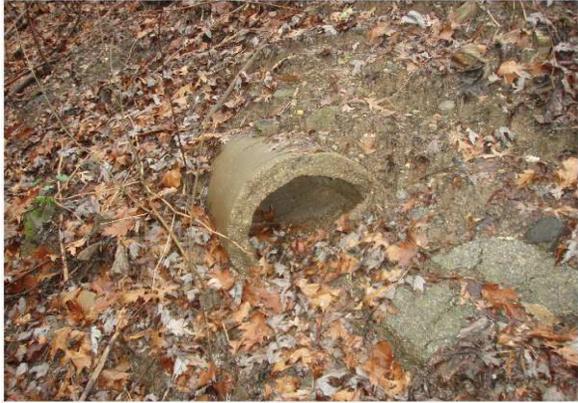
Infrastructure ID: WSout761 Outfall

Condition	Material	Location	Flow	Flow Appearance	Dimension (ft)
Fair	Concrete	DSL	None		1.0

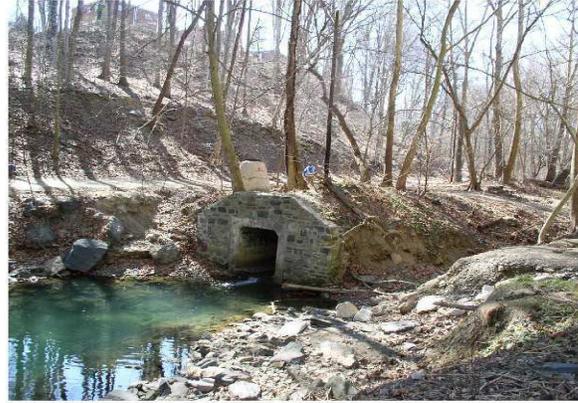
Infrastructure ID: WSout566 Outfall

Condition	Material	Location	Flow	Flow Appearance	Dimension (ft)
Good	Concrete	CROSS	Steady	Clear	6.0 x 6.0

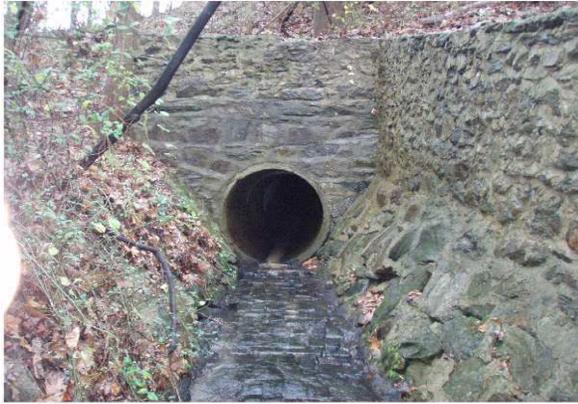
Infrastructure ID: WSout762 Outfall

Condition	Material	Location	Flow	Flow Appearance	Dimension (ft)
Good	Concrete	MID			4.0

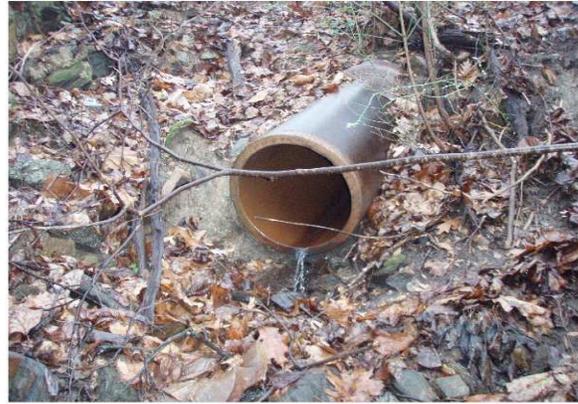
Infrastructure ID: WSout763 Outfall

Condition	Material	Location	Flow	Flow Appearance	Dimension (ft)
Fair	TerraCotta	DSL			2.0

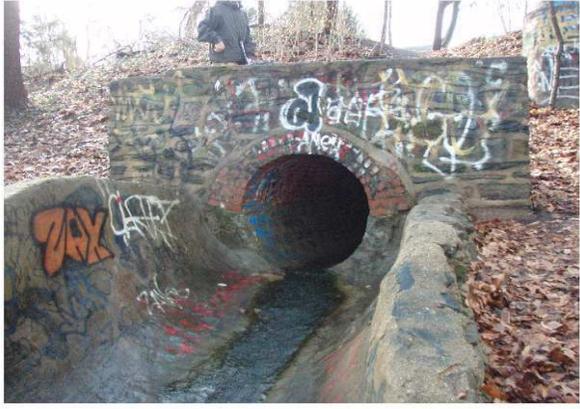
Infrastructure ID: WSout764 Outfall

Condition	Material	Location	Flow	Flow Appearance	Dimension (ft)
Good	Stone+Conc	DSR			4.0

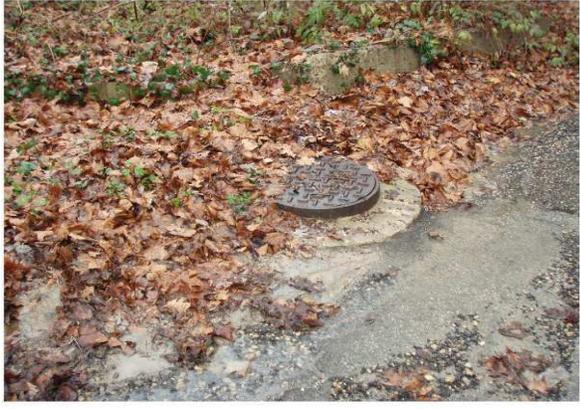
Infrastructure ID: WSman055 Manhole

Condition	Location	Height Exposed (ft)
Good	DSR	0.5

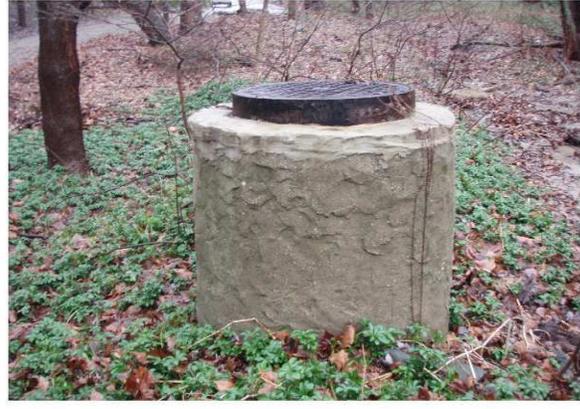
Infrastructure ID: WSman056 Manhole

Condition	Location	Height Exposed (ft)
Good	DSR	4.0

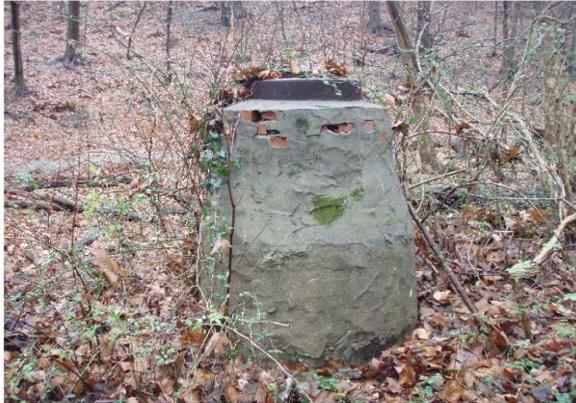
Infrastructure ID: WSman059

Condition	Location	Height Exposed (ft)
Fair	DSR	5.0

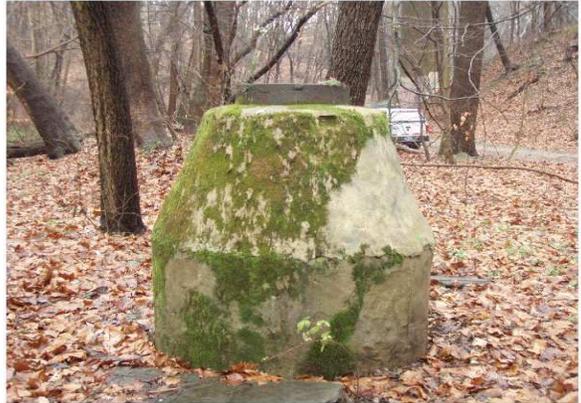
Infrastructure ID: WSman060

Condition	Location	Height Exposed (ft)
Good	DSR	5.0

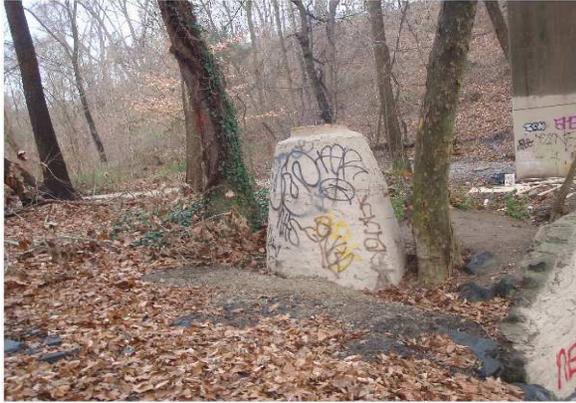
Infrastructure ID: WSman061

Condition	Location	Height Exposed (ft)
Good	DSR	5.0

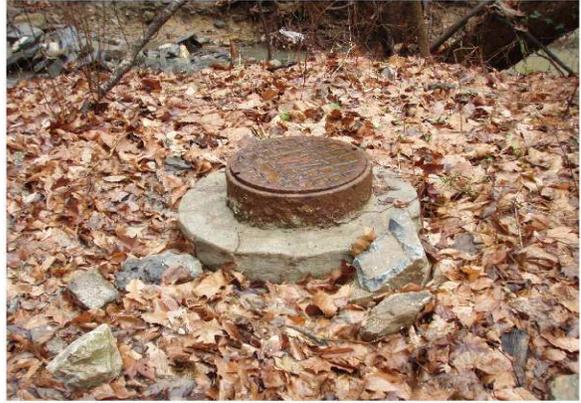
Infrastructure ID: WSman062

Condition	Location	Height Exposed (ft)
Good	DSR	2.0

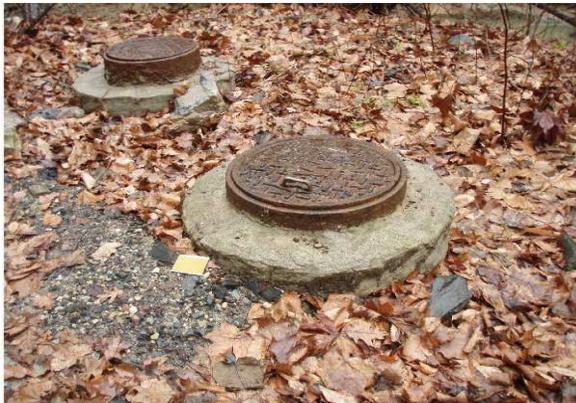
Infrastructure ID: WSman063

Condition	Location	Height Exposed (ft)
Good	DSR	2.0

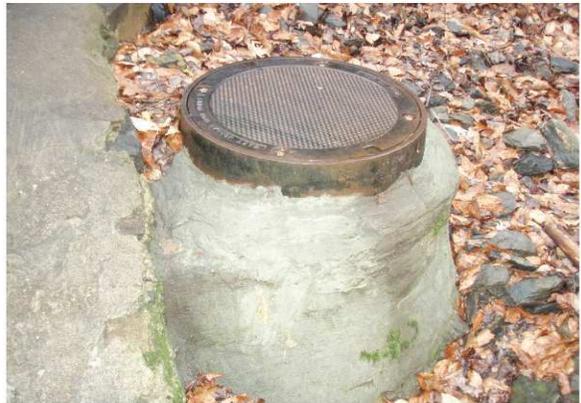
Infrastructure ID: WSman064

Condition	Location	Height Exposed (ft)
Good	DSR	3.0

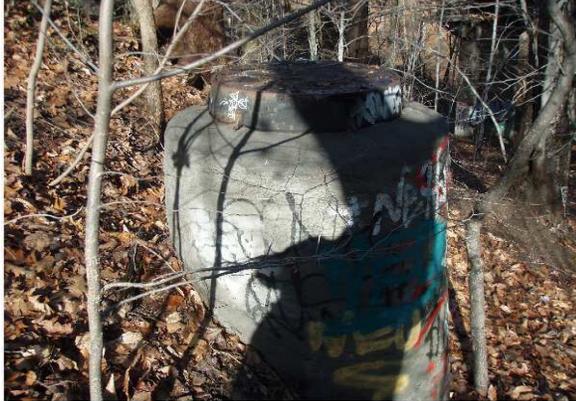
Infrastructure ID: WSman065

Condition	Location	Height Exposed (ft)
Good	DSR	5.0

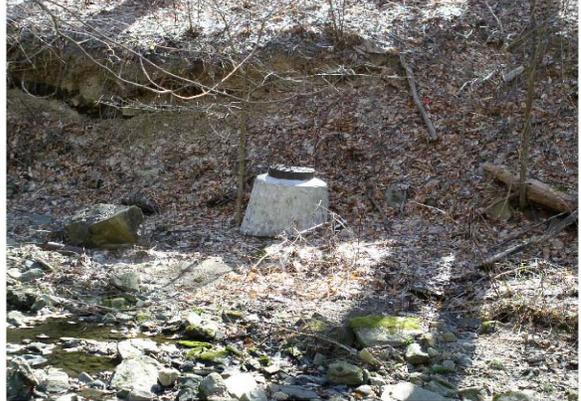
Infrastructure ID: WSman032

Condition	Location	Height Exposed (ft)
Good	DSR	3.0

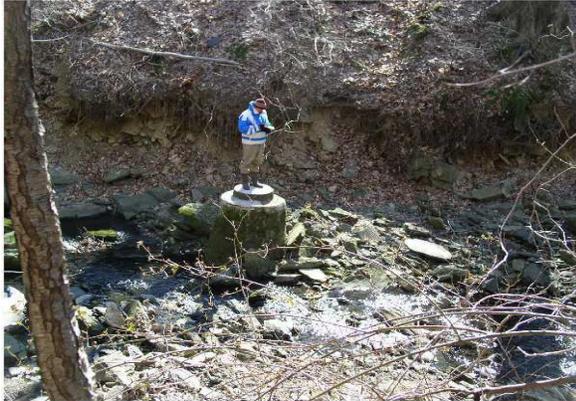
Infrastructure ID: WSman033

Condition	Location	Height Exposed (ft)
Good	MID	4.0

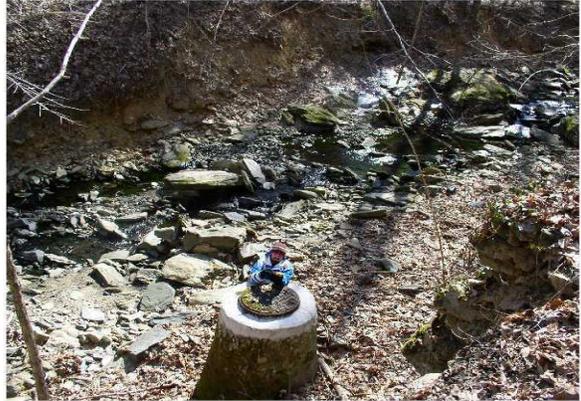
Infrastructure ID: WSman034

Condition	Location	Height Exposed (ft)
Good	DSL	4.0

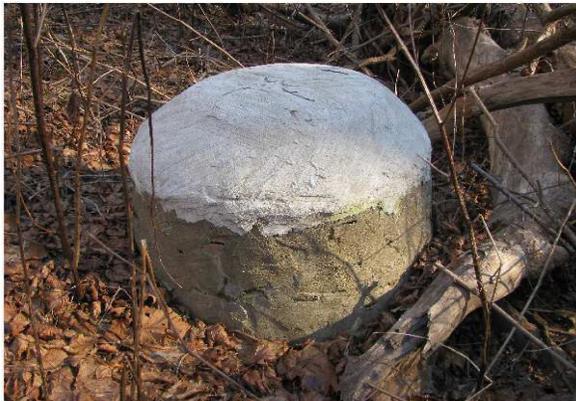
Infrastructure ID: WSman067

Condition	Location	Height Exposed (ft)
Fair	DSL	3.0

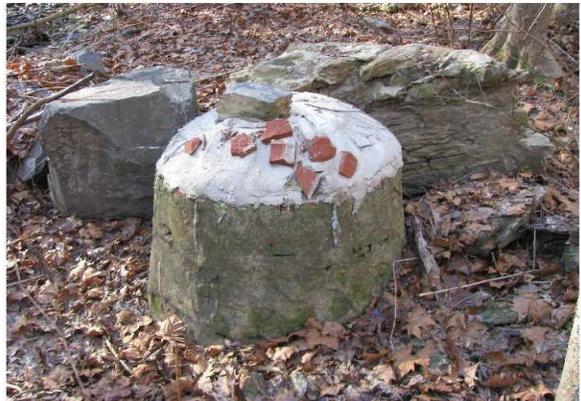
Infrastructure ID: WSman066

Condition	Location	Height Exposed (ft)
Fair	DSL	3.0

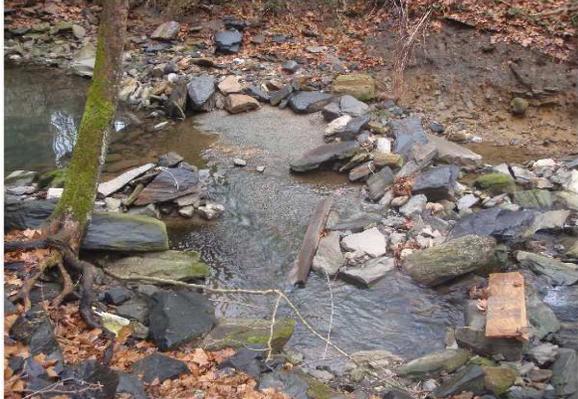
Infrastructure ID: WSpip011 PipeSewer

Condition	Material	Location	Diameter (ft)	Height Exposed (ft)	Length Exposed (ft)
Good	Steel/Conc	CROSS	3.0	2.0	8.0

Notes
Inlet to 48 inch dia stormsewer

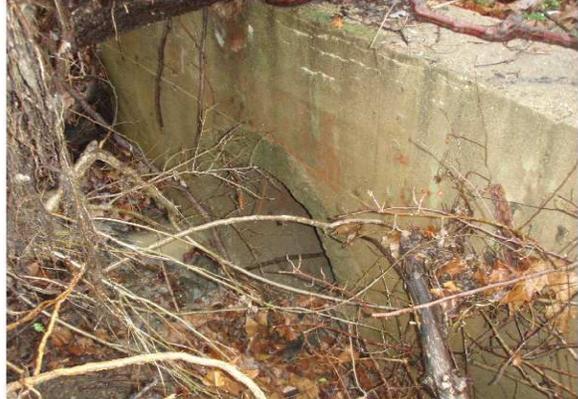
Infrastructure ID: WSmisc095 Other

Notes
Inlet to 48 inch dia stormsewer

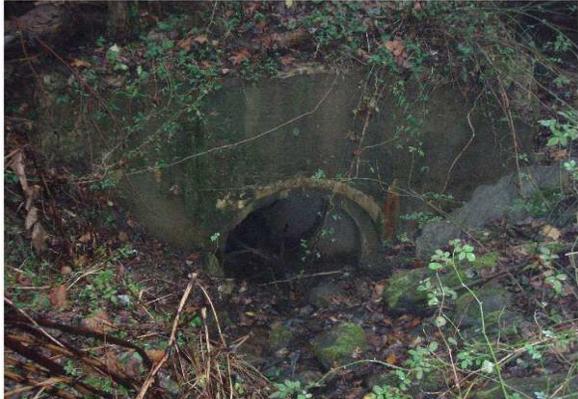
Infrastructure ID: WSmisc096 Other

Notes
Inlet to 48 inch dia stormsewer

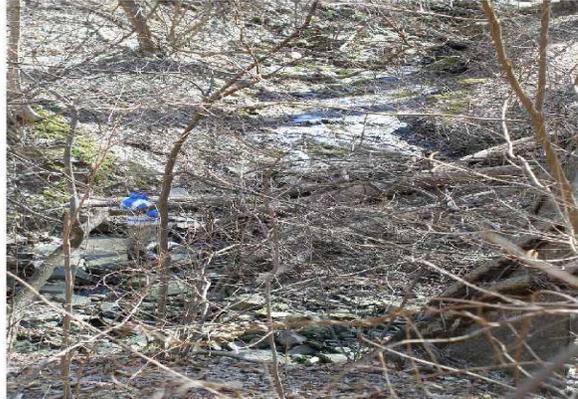
Infrastructure ID: WScon174 Confluence

Condition	Location	Width (ft)	Flow	Creeks
Good	DSR	5.0	Steady	Unnamed tributary to Gorgas Run

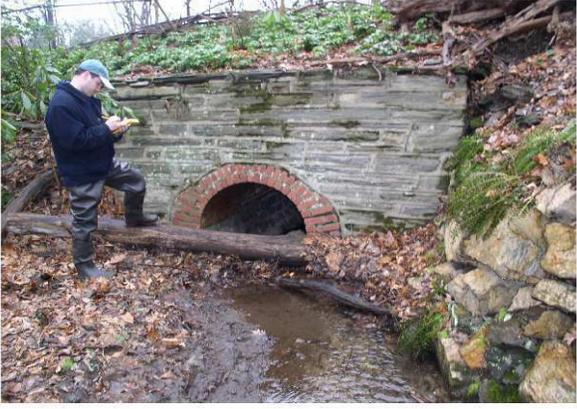
Infrastructure ID: WScul074 Culvert

Condition Material Dimension (ft) Length (ft) Location
 Good Brick 4.0 150.0 Lynnebrook Rd

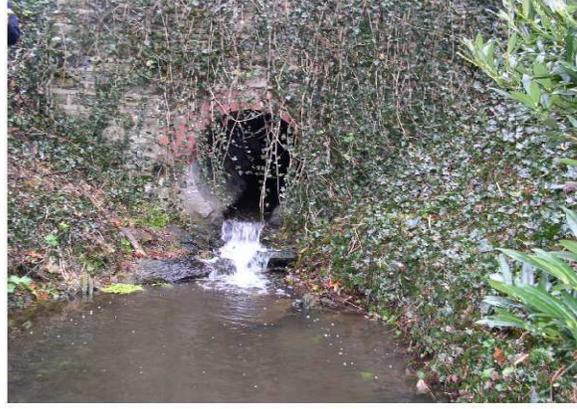
Infrastructure ID: WScul076 Culvert

Condition Material Dimension (ft) Length (ft) Location
 Good Brick 4.0 143.0 Lynnebrook Rd

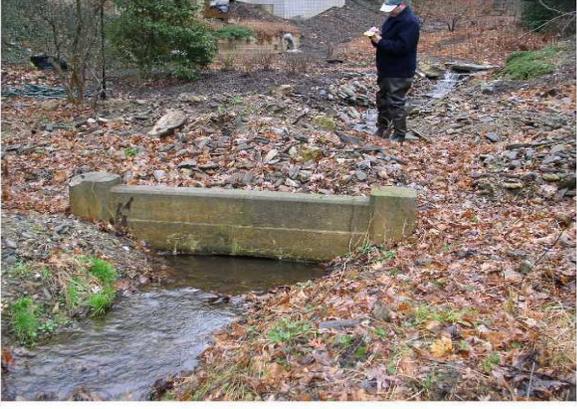
Infrastructure ID: WScul480 Culvert

Condition Material Dimension (ft) Length (ft) Location
 Poor Concrete 0.5 x 2.0 13.0 Behind homes on Lynnebrook Rd, Philadelphia

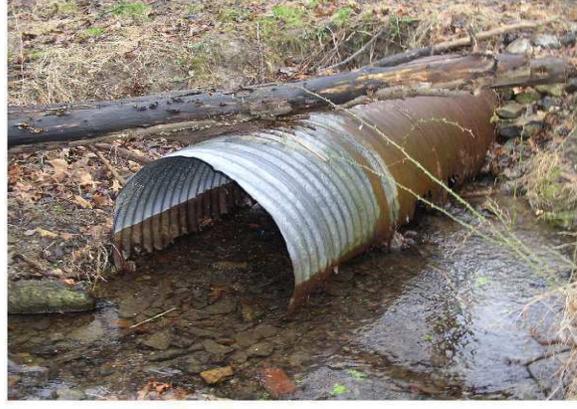
Infrastructure ID: WScul078 Culvert

Condition Material Dimension (ft) Length (ft) Location
 Poor CorrMetal 2.0 15.0 East of Bells Mill Rd

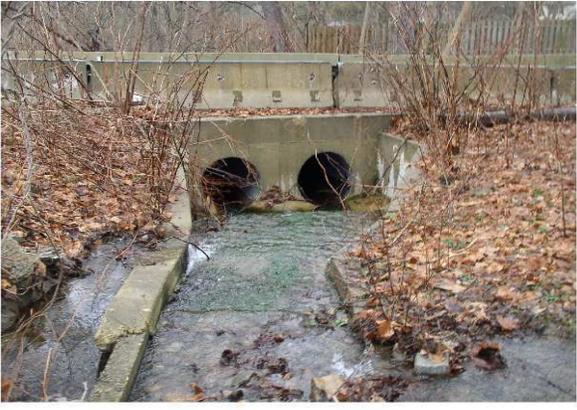
Infrastructure ID: WScul482 Culvert

Condition Material Dimension (ft) Length (ft) Location
 Fair CorrMetal 3.0 26.0 Under Bells Mill Rd, Philadelphia

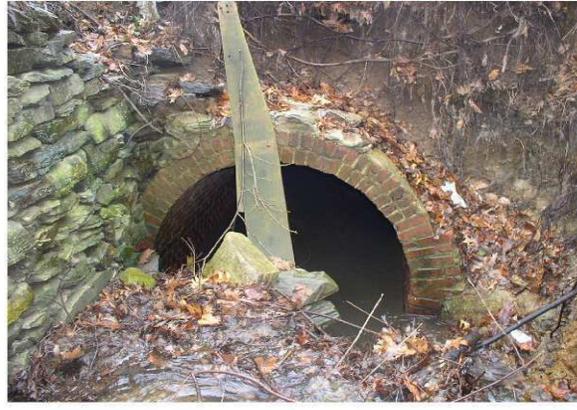
Infrastructure ID: WScul079 Culvert

Condition Material Dimension (ft) Length (ft) Location
 Fair Brick 4.0 645.0 Hillcrest Rd in Philadelphia

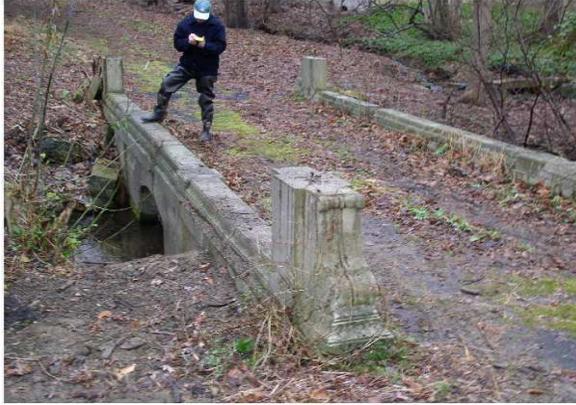
Infrastructure ID: WSbri205 Bridge

Condition	Material	Dimension (ft)	Length (ft)	Location
Good	Concrete	3.0 x 4.0	14.0	Path off of Lynnebrook Rd, Philadelphia

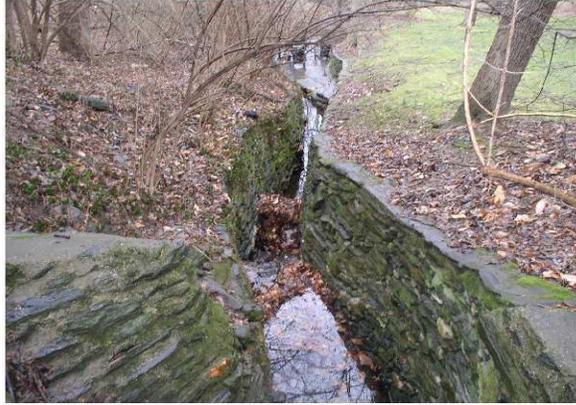
Infrastructure ID: WScha105 Channel

Condition	Material	Dimension (ft)	Length (ft)	Location
Good	Stone	8.0 x 1.0	526.0	DSR

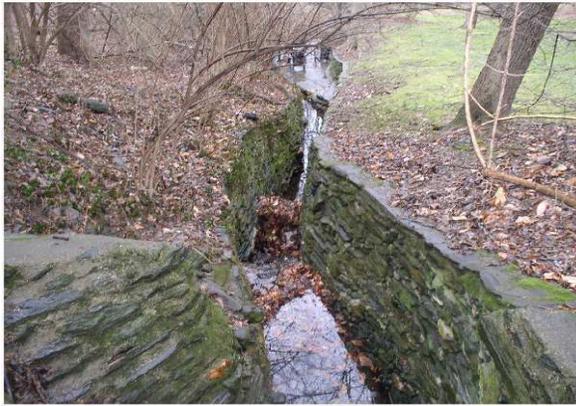
Infrastructure ID: WScha219 Channel

Condition	Material	Dimension (ft)	Length (ft)	Location
Good	Stone	8.0 x 1.0	520.0	DSL

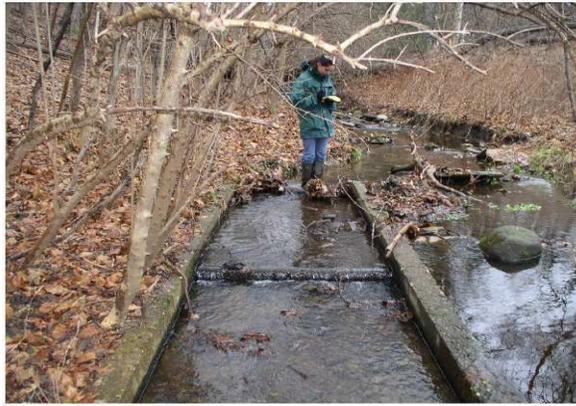
Infrastructure ID: WScha220 Channel

Condition	Material	Dimension (ft)	Length (ft)	Location
Fair	Concrete	2.0 x 1.0	91.0	DSL

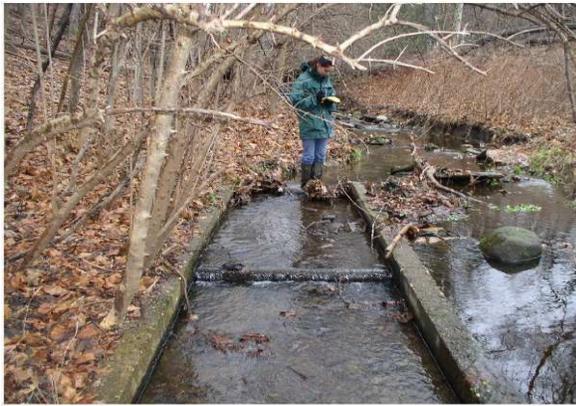
Infrastructure ID: WScha106 Channel

Condition	Material	Dimension (ft)	Length (ft)	Location
Fair	Concrete	2.0 x 1.0	91.0	DSR

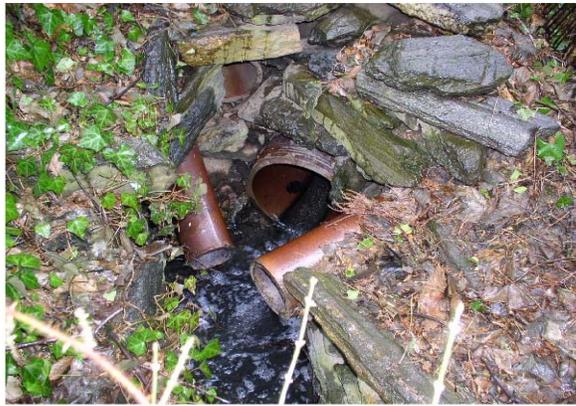
Infrastructure ID: WSout469 Outfall

Condition	Material	Location	Flow	Flow Appearance	Dimension (ft)
Good	ClayTerra	CROSS	Steady	Clear	1.5

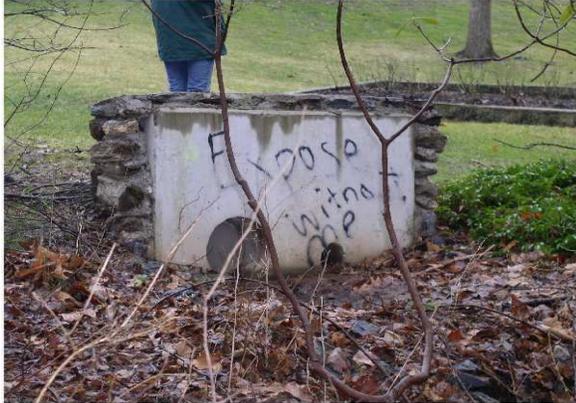
Infrastructure ID: WSout470 Outfall

Condition	Material	Location	Flow	Flow Appearance	Dimension (ft)
Good	Plastic	DSL	Trickle	Clear	1.0

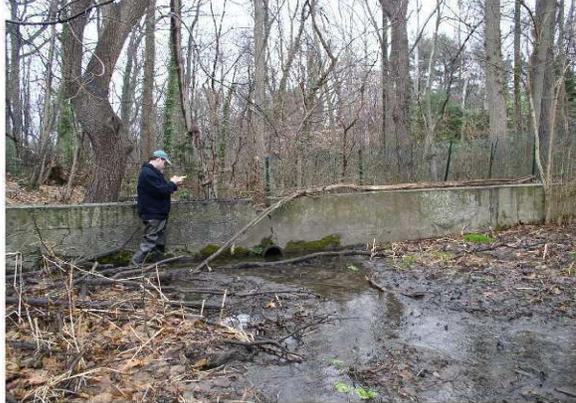
Infrastructure ID: WSDam091 Dam

Condition	Material	Width (ft)	Length (ft)	Height Exposed (ft)
Good	Concrete	1.333	50.0	0.166

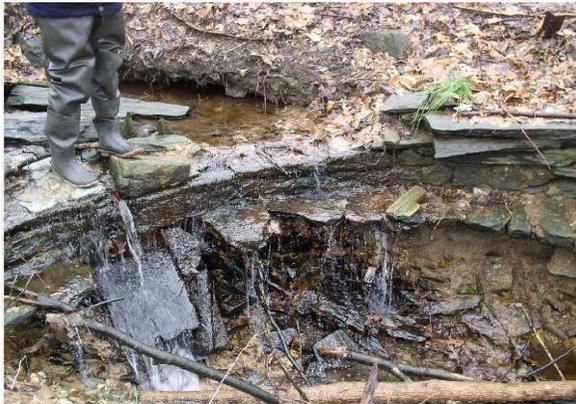
Infrastructure ID: WSDam095 Dam

Condition	Material	Width (ft)	Length (ft)	Height Exposed (ft)
Poor	Stone	4.0	10.0	4.0

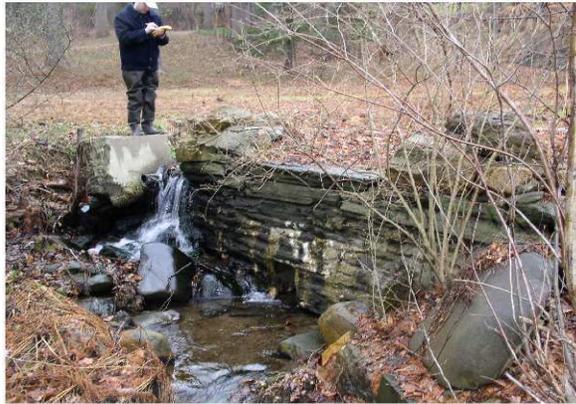
Infrastructure ID: WSDam097 Dam

Condition	Material	Width (ft)	Length (ft)	Height Exposed (ft)
Poor	Stone	1.0	12.0	3.0

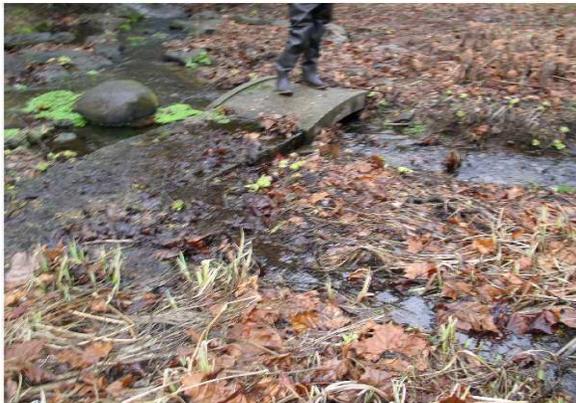
Infrastructure ID: WSDam098 Dam

Condition	Material	Width (ft)	Length (ft)	Height Exposed (ft)
Poor	Concrete	2.5	20.0	0.166

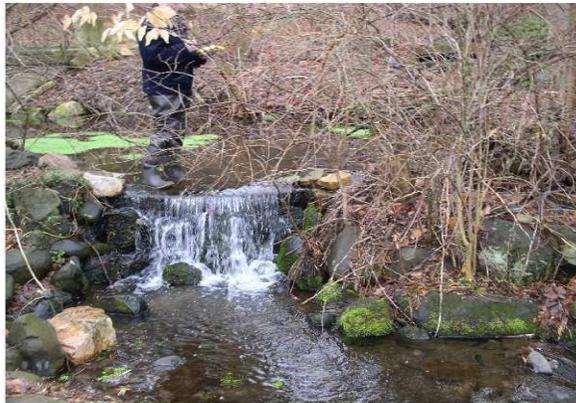
Infrastructure ID: WSDam100 Dam

Condition	Material	Width (ft)	Length (ft)	Height Exposed (ft)
Poor	Stone	0.833	15.0	2.0

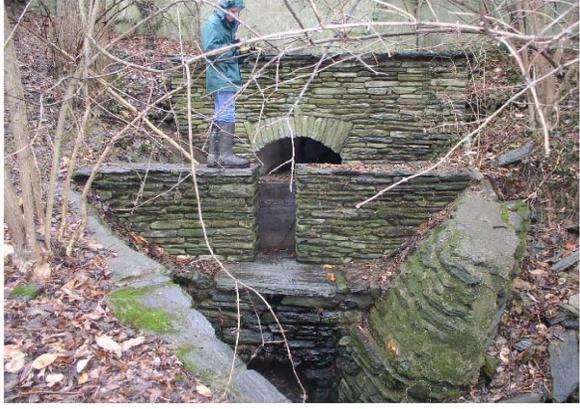
Infrastructure ID: WSDam092 Dam

Condition	Material	Width (ft)	Length (ft)	Height Exposed (ft)
Good	Stone	2.0	12.0	10.0

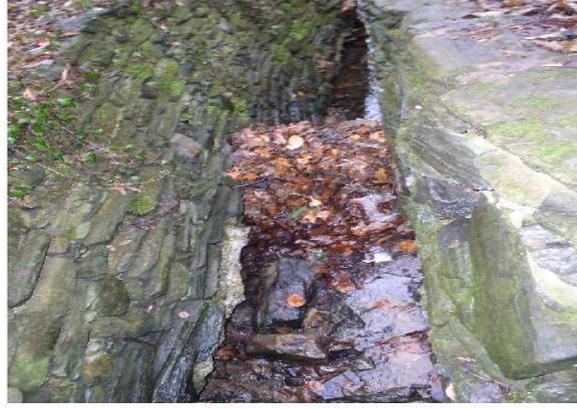
Infrastructure ID: WSDam093 Dam

Condition	Material	Width (ft)	Length (ft)	Height Exposed (ft)
Fair	Stone	1.0	5.0	3.0

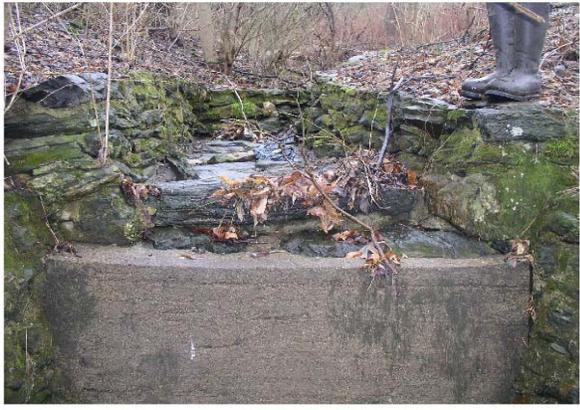
Infrastructure ID: WSDam094 Dam

Condition	Material	Width (ft)	Length (ft)	Height Exposed (ft)
Good	Concrete	0.666	5.0	3.0
