APPENDIX B
INFRASTRUCTURE PHOTOS

Reach WSTM02 Infrastructure Photos

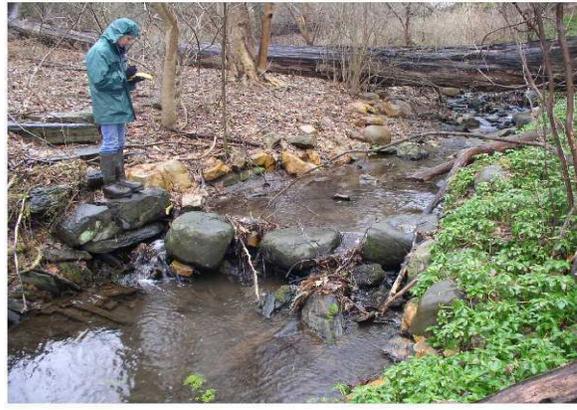
Infrastructure ID: WSDam096 Dam

Condition	Material	Width (ft)	Length (ft)	Height Exposed (ft)
Good	Stone	1.0	10.0	1.0

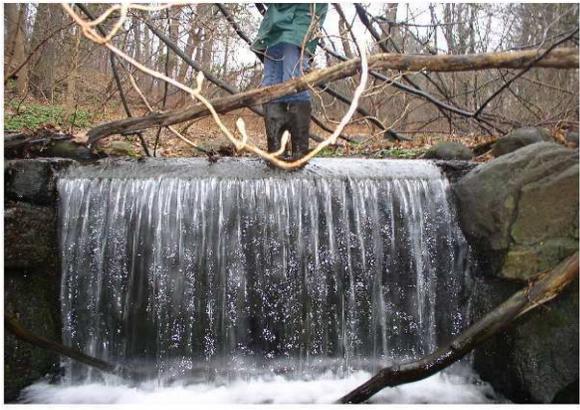
Infrastructure ID: WSDam099 Dam

Condition	Material	Width (ft)	Length (ft)	Height Exposed (ft)
Good	Concrete	1.0	25.0	4.0

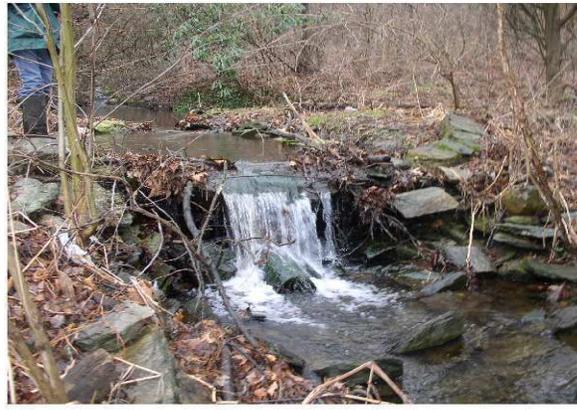
Infrastructure ID: WSDam101 Dam

Condition	Material	Width (ft)	Length (ft)	Height Exposed (ft)
Fair	Stone	1.0	8.0	3.0

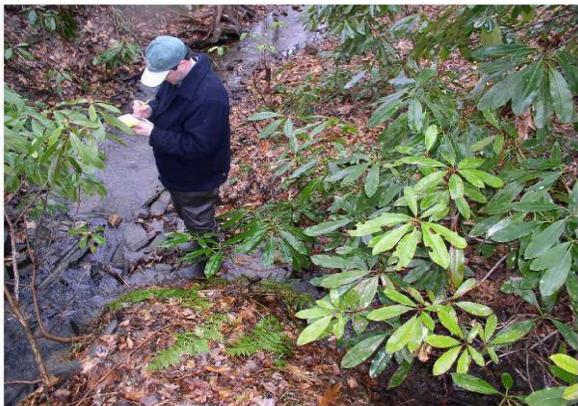
Infrastructure ID: WScon149 Confluence

Condition Location **Width (ft)** **Flow** **Creeks**
Good DSR 5.0 Steady Unnamed Trib to Hillcrest Run

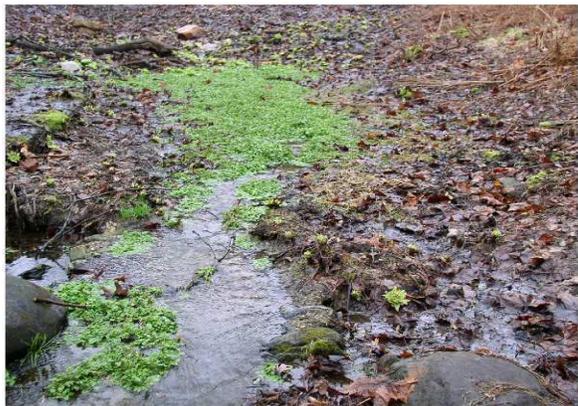
Infrastructure ID: WScon151 Confluence

Condition Location **Width (ft)** **Flow** **Creeks**
Good DSL 5.0 Steady Unnamed Trib to Hillcrest Run

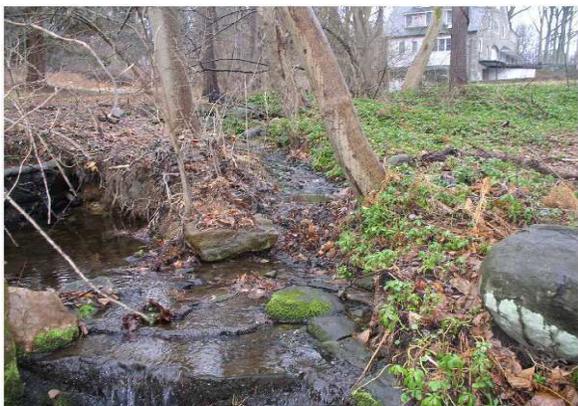
Infrastructure ID: WScon150 Confluence

Condition Location **Width (ft)** **Flow** **Creeks**
Good DSL 5.0 Steady Unnamed Trib to Hillcrest Run

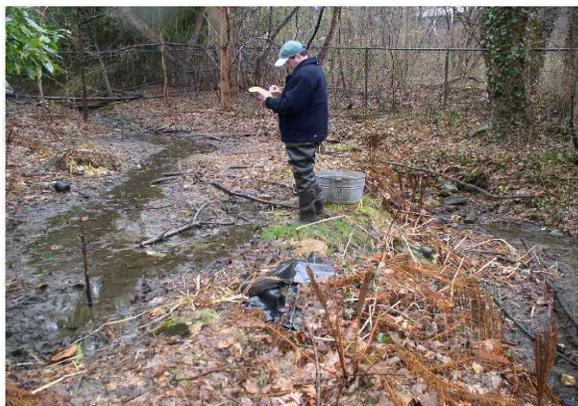
Infrastructure ID: WSmisc067 Other

Notes
Wetland area, near Bethlehem Pk and Newton St

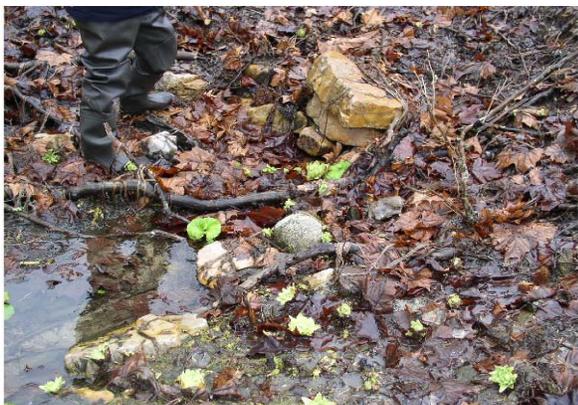
Infrastructure ID: WSmisc068 Other

Notes
Seepage source

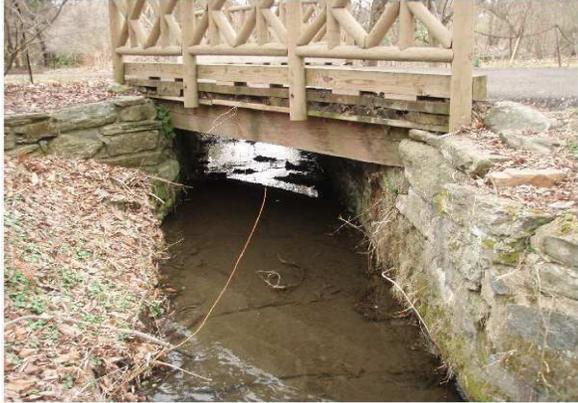
Infrastructure ID: WScul484 Culvert

Condition	Material	Dimension (ft)	Length (ft)	Location
Fair	Concrete	3.0 x 5.0	15.0	Path near Hillcrest Rd

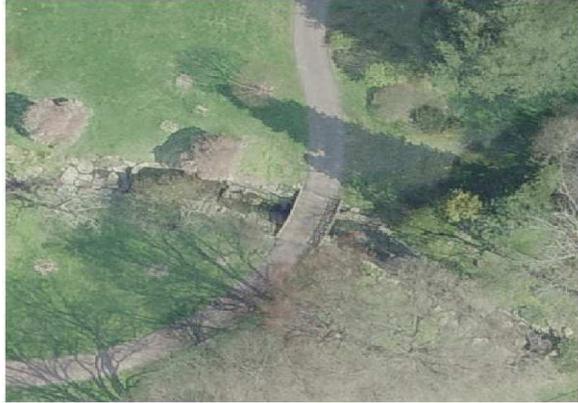
Infrastructure ID: WSbri535 Bridge

Condition	Material	Dimension (ft)	Length (ft)	Location
Fair	Concrete	4.0 x 10.0	15.0	Driveway near Hillcrest Rd

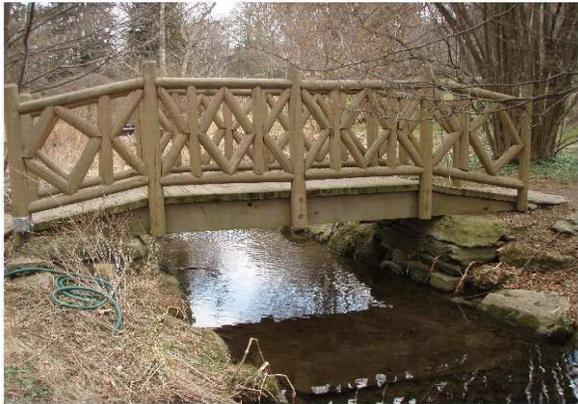
Infrastructure ID: WSbri524 Bridge

Condition	Material	Dimension (ft)	Length (ft)	Location
Fair	Concrete	4.0 x 5.0	5.0	Trail near Hillcrest Rd

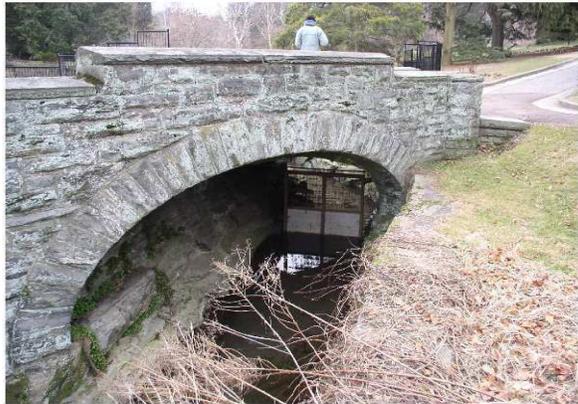
Infrastructure ID: WSbri235 Bridge

Condition	Material	Dimension (ft)	Length (ft)	Location
Good	Stone	8.0 x 15.0	20.0	Path near Hillcrest Rd

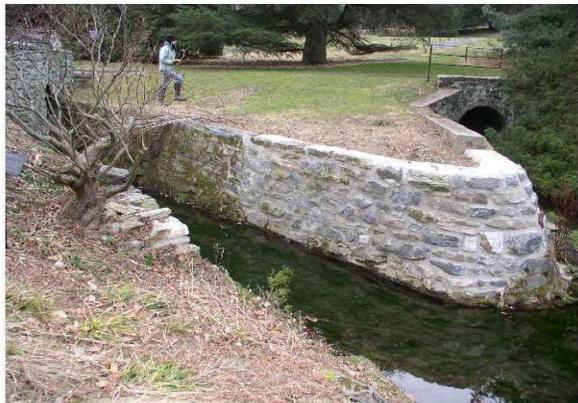
Infrastructure ID: WScha119 Channel

Condition	Material	Dimension (ft)	Length (ft)	Location
Good	Stone	6.0 x 2.0	35.0	DSL

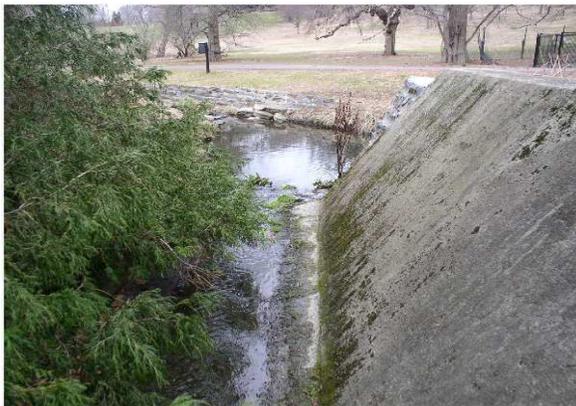
Infrastructure ID: WScha120 Channel

Condition	Material	Dimension (ft)	Length (ft)	Location
Good	Concrete	x 5.0	33.0	MID

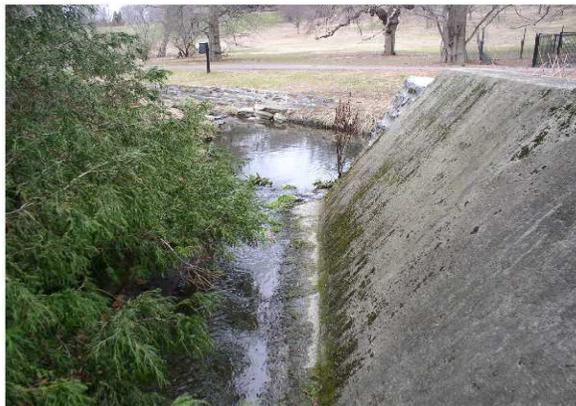
Infrastructure ID: WScha182 Channel

Condition	Material	Dimension (ft)	Length (ft)	Location
Good	Stone	8.0 x 1.5	32.0	DSR

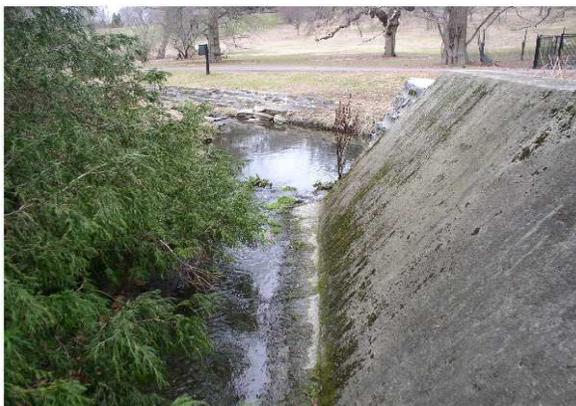
Infrastructure ID: WScha183 Channel

Condition	Material	Dimension (ft)	Length (ft)	Location
Good	Stone	8.0 x 1.5	28.0	DSL

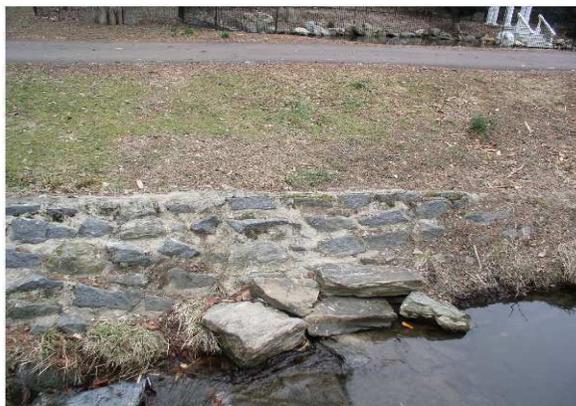
Infrastructure ID: WScha121 Channel

Condition	Material	Dimension (ft)	Length (ft)	Location
Good	Stone	4.0 x 1.0	457.0	DSR

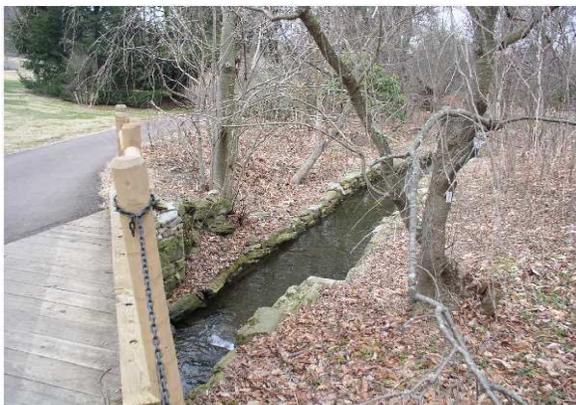
Infrastructure ID: WScha122 Channel

Condition	Material	Dimension (ft)	Length (ft)	Location
Good	Stone	2.0 x 1.0	369.0	DSL

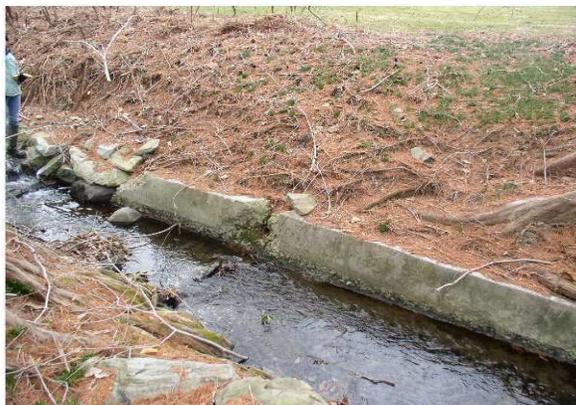
Infrastructure ID: WScha123 Channel

Condition	Material	Dimension (ft)	Length (ft)	Location
Fair	Concrete	2.0 x 0.5	31.0	DSL

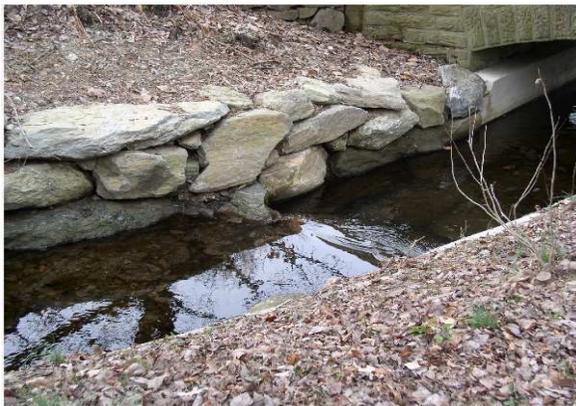
Infrastructure ID: WScha124 Channel

Condition	Material	Dimension (ft)	Length (ft)	Location
Good	Concrete	2.0 x 2.0	125.0	DSL

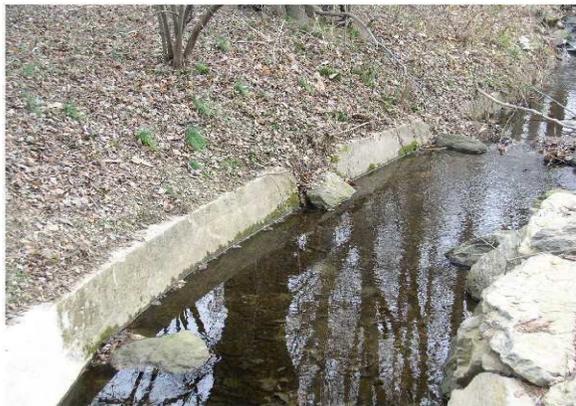
Infrastructure ID: WScha125 Channel

Condition	Material	Dimension (ft)	Length (ft)	Location
Good	Concrete	2.0 x 0.5	22.0	DSR

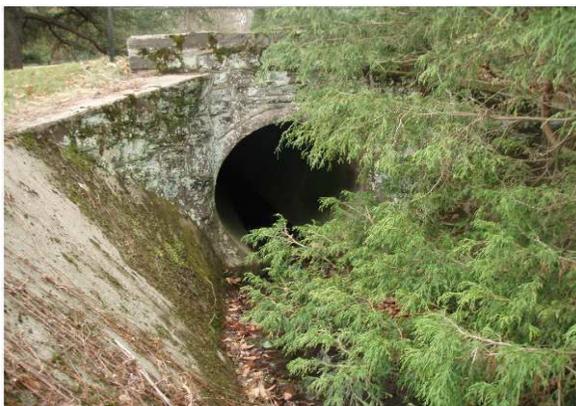
Infrastructure ID: WSout526 Outfall

Condition	Material	Location	Flow	Flow Appearance	Dimension (ft)
Good	Concrete	MID	Steady	Clear	4.0 x 4.0

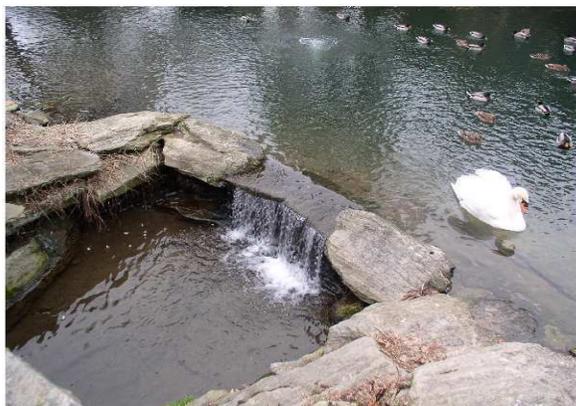
Infrastructure ID: WSDam106 Dam

Condition	Material	Width (ft)	Length (ft)	Height Exposed (ft)
Good	Stone	2.0	15.0	2.0

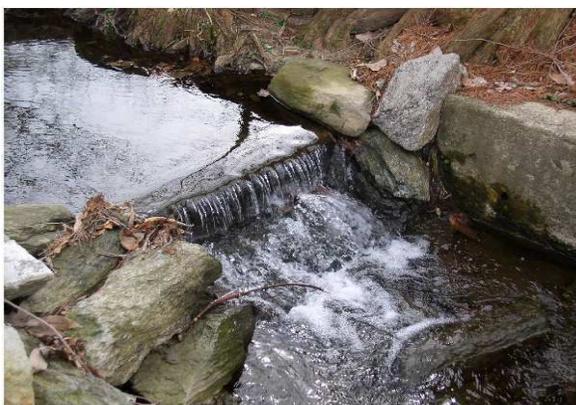
Infrastructure ID: WSDam107 Dam

Condition	Material	Width (ft)	Length (ft)	Height Exposed (ft)
Good	Stone	0.666	5.0	1.5

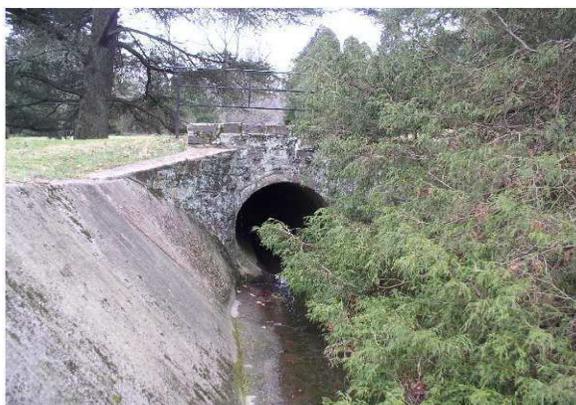
Infrastructure ID: WScon168 Confluence

Condition	Location	Width (ft)	Flow	Creeks
Fair	DSR	8.0	Steady	Unnamed Trib to Hillcrest Run

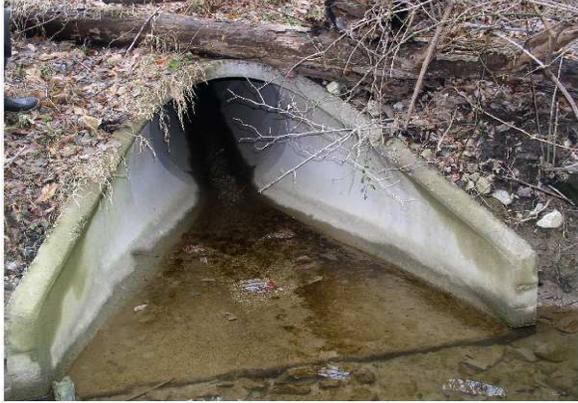
Infrastructure ID: WScul083 Culvert

Condition	Material	Dimension (ft)	Length (ft)	Location
Good	Concrete	1.5	68.0	Bells Mill Rd

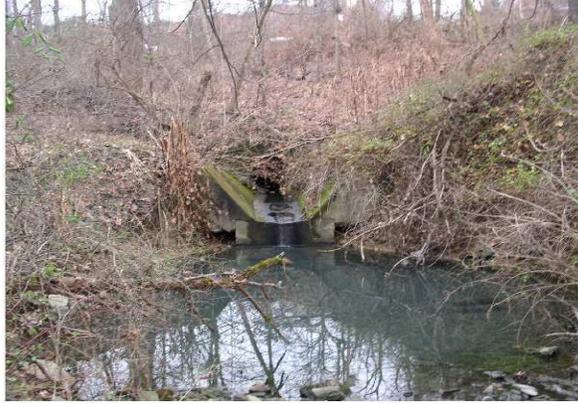
Infrastructure ID: WSout472 Outfall

Condition	Material	Location	Flow	Flow Appearance	Dimension (ft)
Good	Concrete	MID	Steady	Gray	4.0

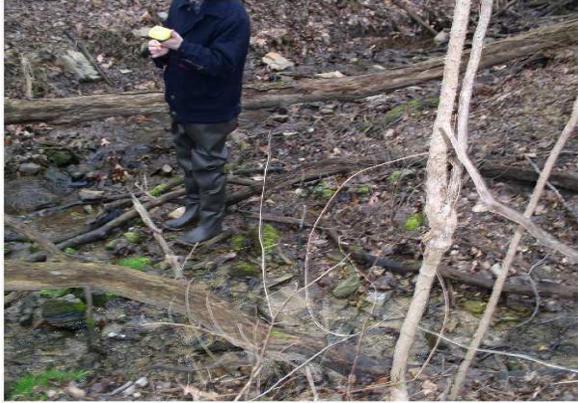
Infrastructure ID: WScon152 Confluence

Condition	Location	Width (ft)	Flow	Creeks
Good	DSL	5.0	Steady	Unnamed trib to Bells Mill Run

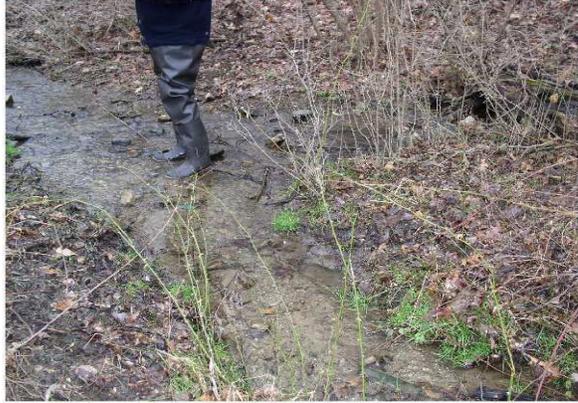
Infrastructure ID: WScon154 Confluence

Condition	Location	Width (ft)	Flow	Creeks
Good	DSL	5.0	Steady	Unnamed trib to Bells Mill Run

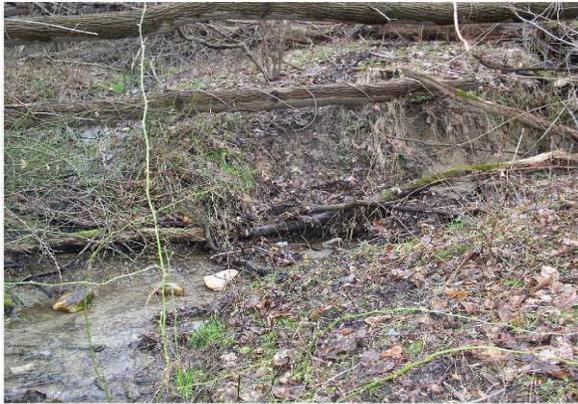
Infrastructure ID: WScon155 Confluence

Condition	Location	Width (ft)	Flow	Creeks
Good	DSL	5.0	Intermittent	Unnamed trib to Bells Mill Run

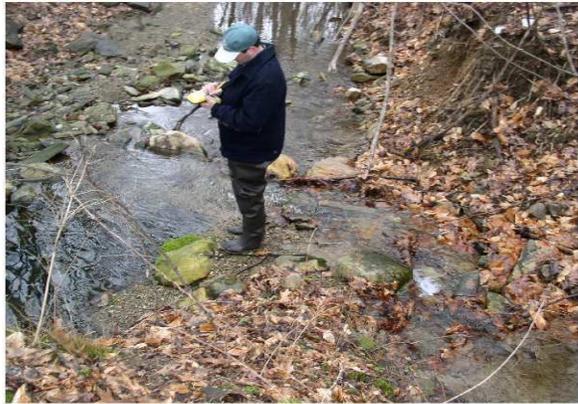
Infrastructure ID: WScon156 Confluence

Condition	Location	Width (ft)	Flow	Creeks
Good	DSL	5.0	Steady	Unnamed trib to Bells Mill Run

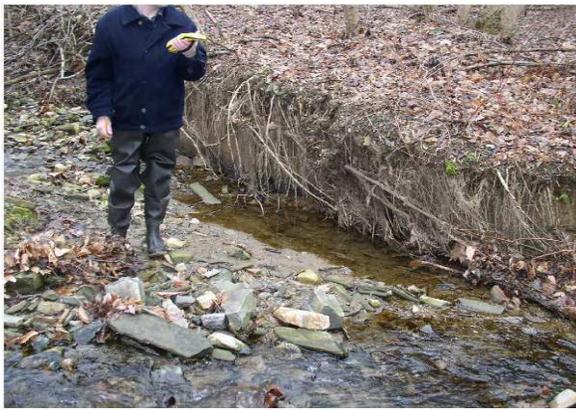
Infrastructure ID: WScon157 Confluence

Condition: Good Location: DSL Width (ft): 5.0 Flow: Steady Creeks: Unnamed trib to Bells Mill Run

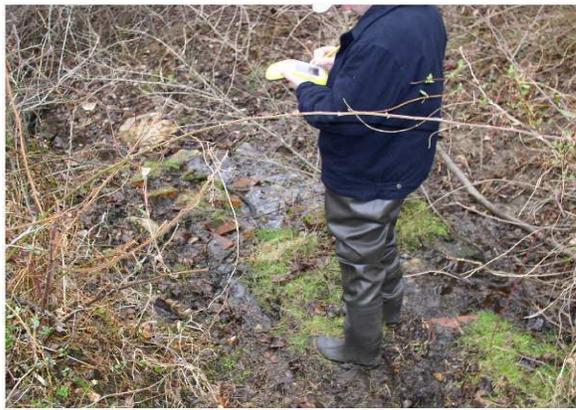
Infrastructure ID: WSmisc069 Other

Notes: Trib source from groundwater seepage/road runoff

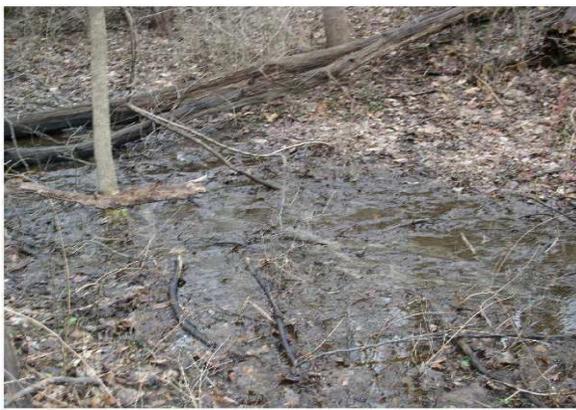
Infrastructure ID: WSmisc070 Other

Notes: Trib source from groundwater seepage

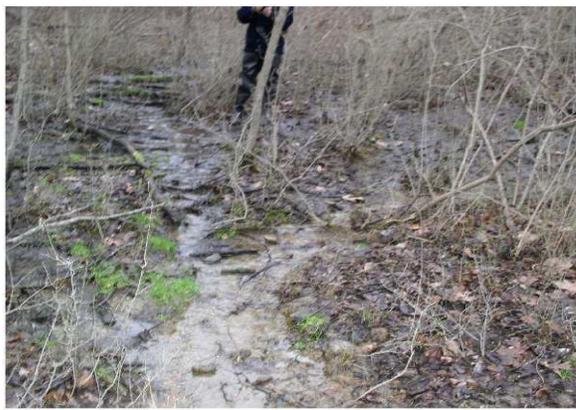
Infrastructure ID: WSmisc066 Other

Notes: Wetland runoff area

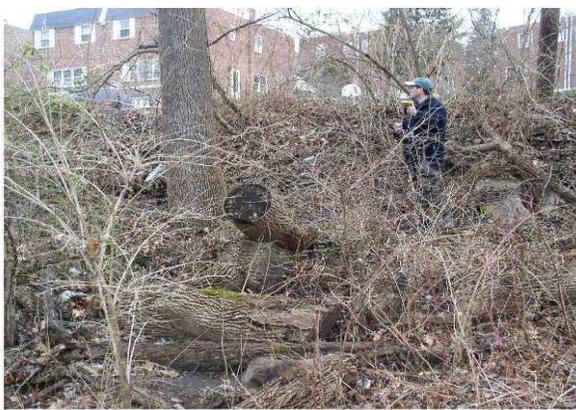
Infrastructure ID: WSmisc071 Other

Notes: Trib source, road run-off

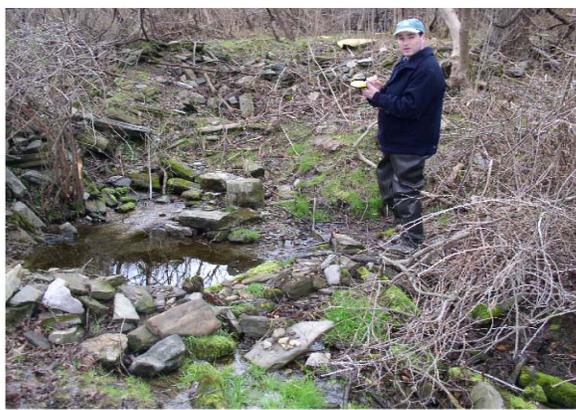
Infrastructure ID: WSmisc072 Other

Notes: Trib source from groundwater seepage

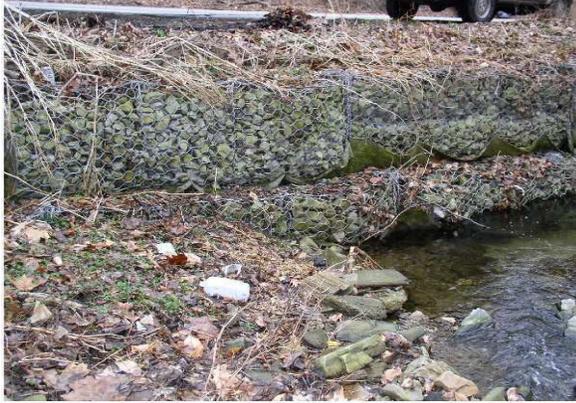
Infrastructure ID: WScha103 Channel

Condition	Material	Dimension (ft)	Length (ft)	Location
Good	Stone	4.0 x 3.0	39.0	DSL

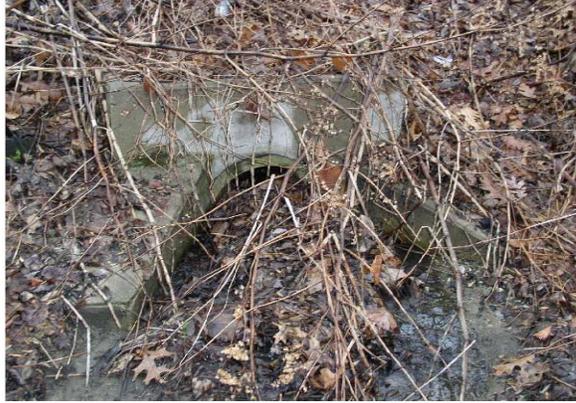
Infrastructure ID: WSout474 Outfall

Condition	Material	Location	Flow	Flow Appearance	Dimension (ft)
Fair	Concrete	DSL	Trickle	Clear	1.5

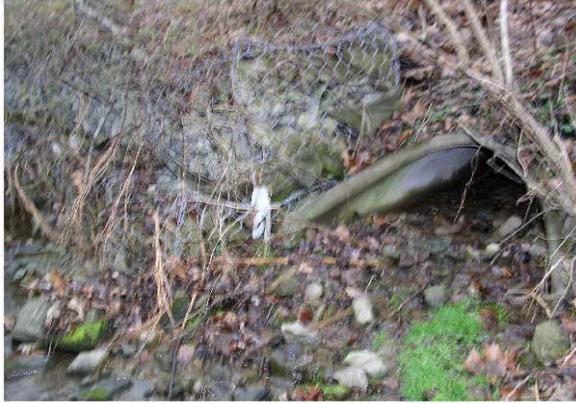
Infrastructure ID: WSout477 Outfall

Condition	Material	Location	Flow	Flow Appearance	Dimension (ft)
Good	Concrete	DSL	Steady	Clear	2.0

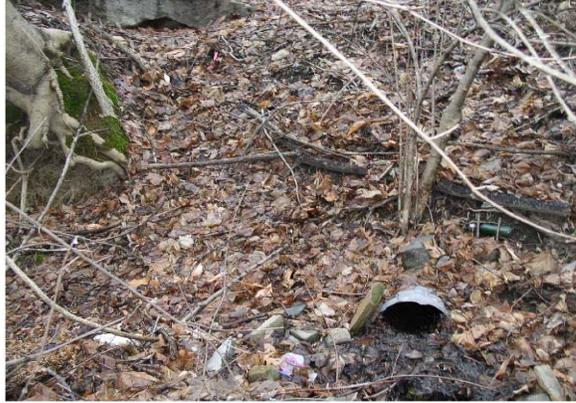
Infrastructure ID: WSout476 Outfall

Condition	Material	Location	Flow	Flow Appearance	Dimension (ft)
Poor	CorrMetal	DSL	Trickle	Clear	0.666

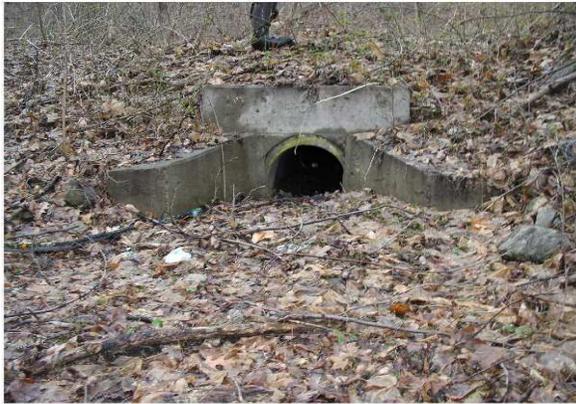
Infrastructure ID: WSout475 Outfall

Condition	Material	Location	Flow	Flow Appearance	Dimension (ft)
Fair	Clay/Terra	DSL	None		1.0

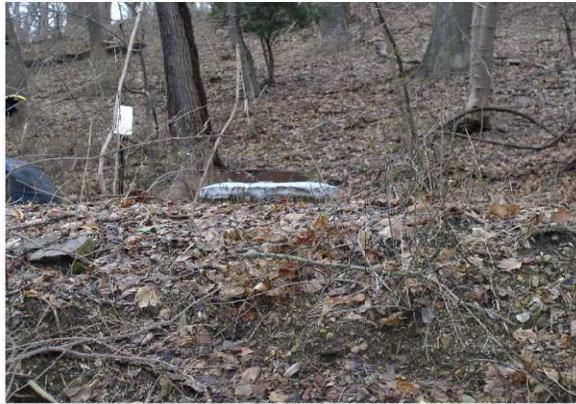
Infrastructure ID: WSman031 Manhole

Condition	Location	Height Exposed (ft)
Fair	DSL	0.5

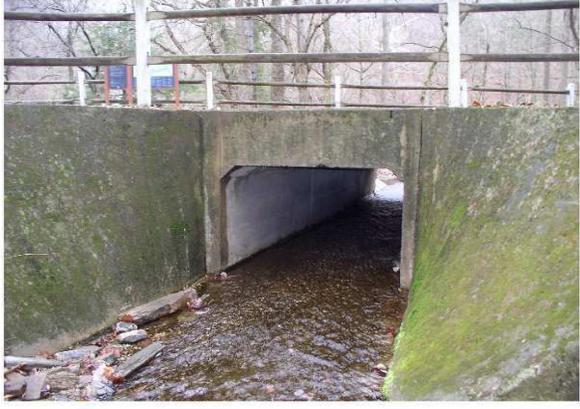
Infrastructure ID: WScul081 Culvert

Condition: Good Material: Concrete Dimension (ft): 4.0 x 6.0 Length (ft): 61.0 Location: Wissahickon Ave at Bells Mill Rd

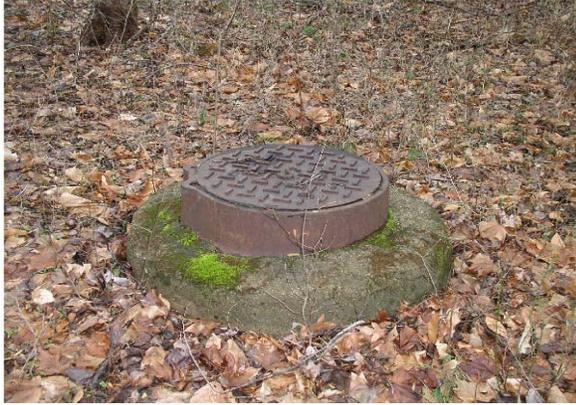
Infrastructure ID: WSman028

Condition	Location	Height Exposed (ft)
Fair	DSL	0.5

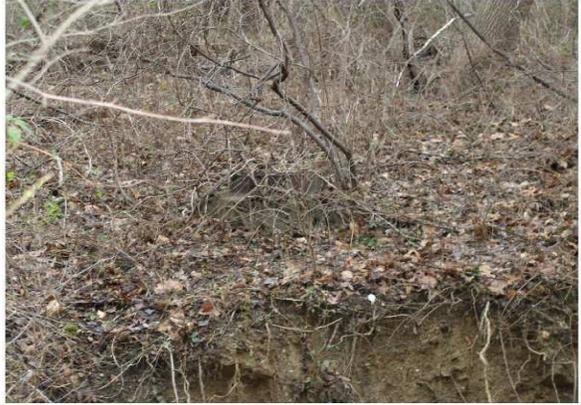
Infrastructure ID: WSman027

Condition	Location	Height Exposed (ft)
Fair	DSL	0.5

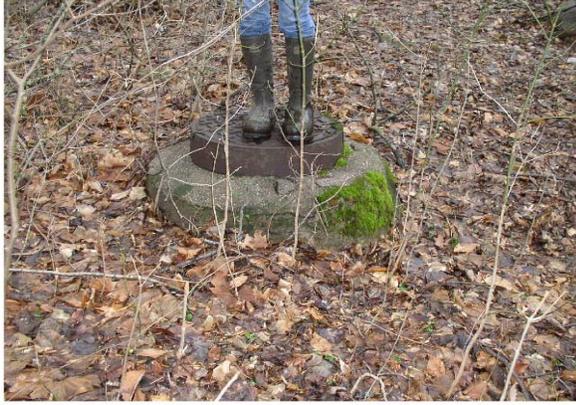
Infrastructure ID: WSman026

Condition	Location	Height Exposed (ft)
Fair	DSL	0.666

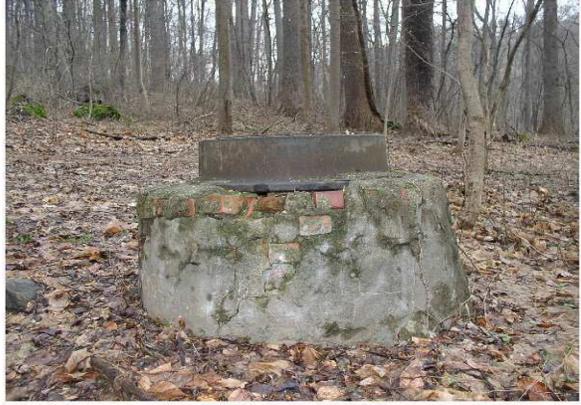
Infrastructure ID: WSman025

Condition	Location	Height Exposed (ft)
Fair	DSL	1.0

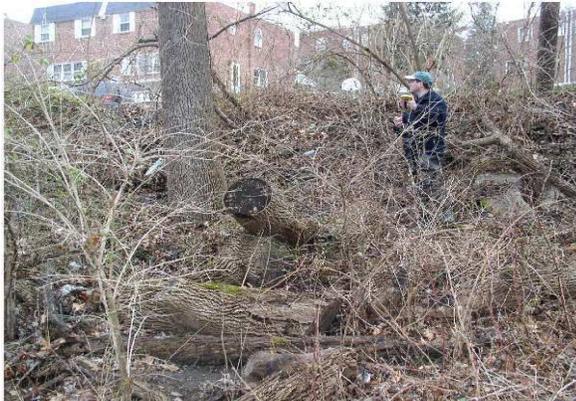
Infrastructure ID: WSmisc071

Notes
Trib source, road run-off.

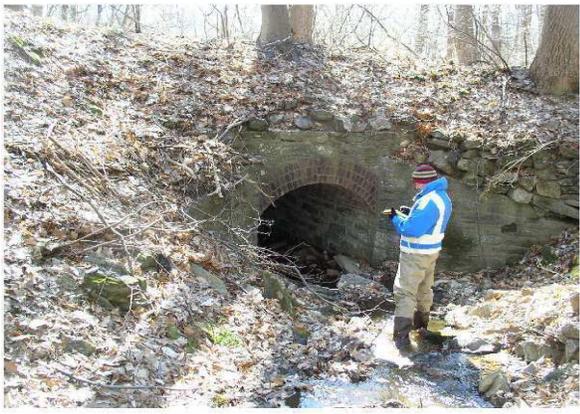
Infrastructure ID: WScul113 Culvert

Condition	Material	Dimension (ft)	Length (ft)	Location
Good	Stone	4.0 x 6.0	71.0	East of St Andrew St, near Glengarry Rd

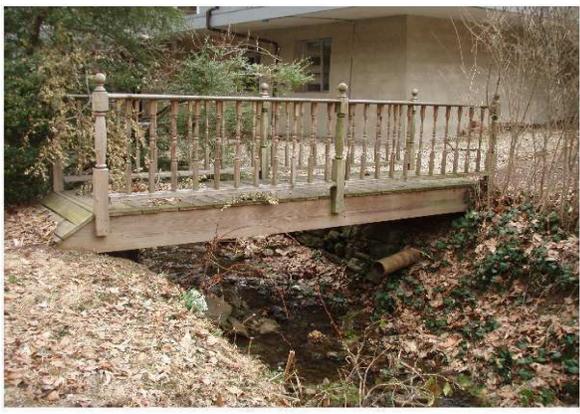
Infrastructure ID: WSbri533 Bridge

Condition	Material	Dimension (ft)	Length (ft)	Location
Good	Wood	4.0 x 8.0	4.0	Southwest corner of the home on Hartwell Ln

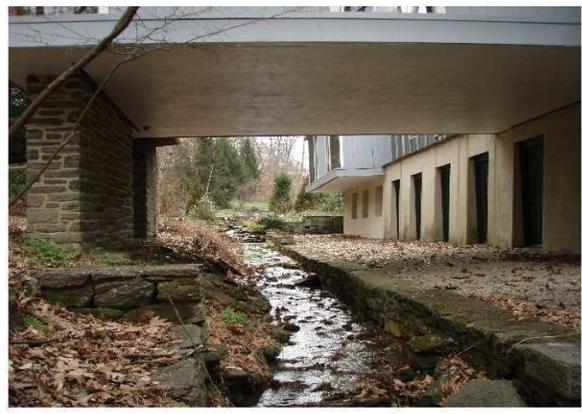
Infrastructure ID: WScha279 Channel

Condition	Material	Dimension (ft)	Length (ft)	Location
Good	Stone	2.0 x 1.0	141.0	DSL

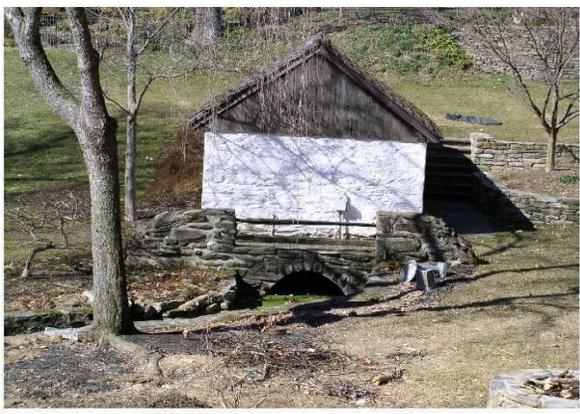
Infrastructure ID: WSout577 Outfall

Condition	Material	Location	Flow	Flow Appearance	Dimension (ft)
Good	Stone	CROSS	None		3.0

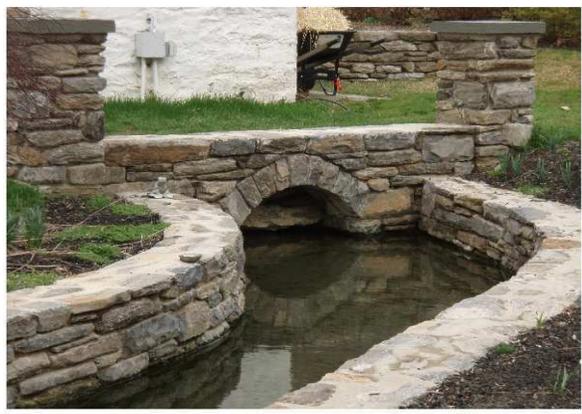
Infrastructure ID: WSout729 Outfall

Condition	Material	Location	Flow	Flow Appearance	Dimension (ft)
Good	Stone	MID			3.0

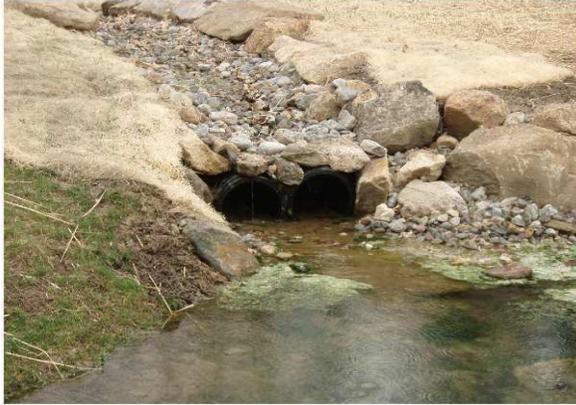
Infrastructure ID: WSout756 Outfall

Condition	Material	Location	Flow	Flow Appearance	Dimension (ft)
Good	Plastic	DSR			2.0

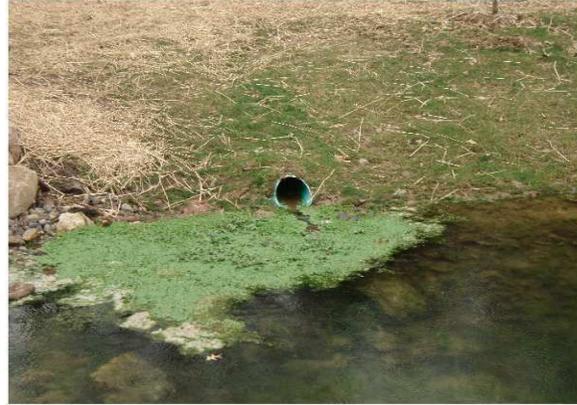
Infrastructure ID: WSout755 Outfall

Condition	Material	Location	Flow	Flow Appearance	Dimension (ft)
Fair	Plastic	DSL	Steady	Clear	1.0

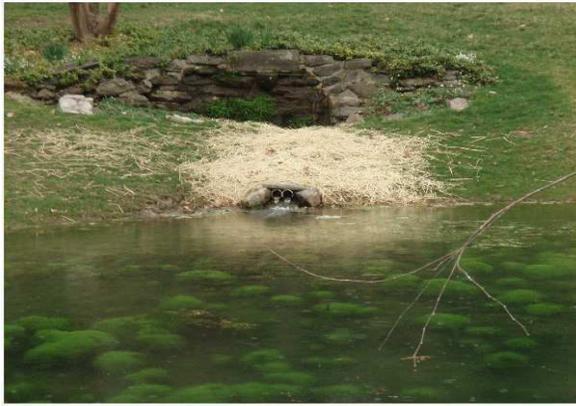
Infrastructure ID: WSout754 Outfall

Condition	Material	Location	Flow	Flow Appearance	Dimension (ft)
Good	Plastic	DSR	Steady	Clear	1.0

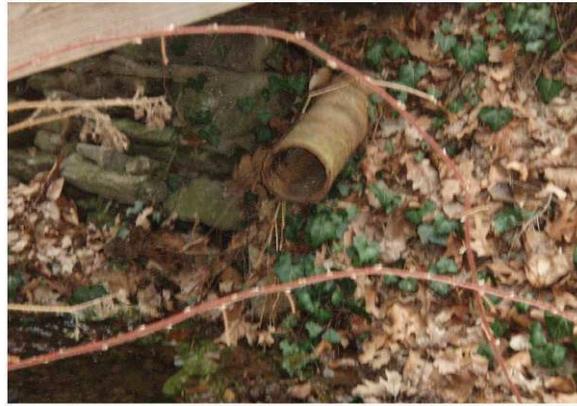
Infrastructure ID: WSout757 Outfall

Condition	Material	Location	Flow	Flow Appearance	Dimension (ft)
Fair	Iron	DSL			0.5

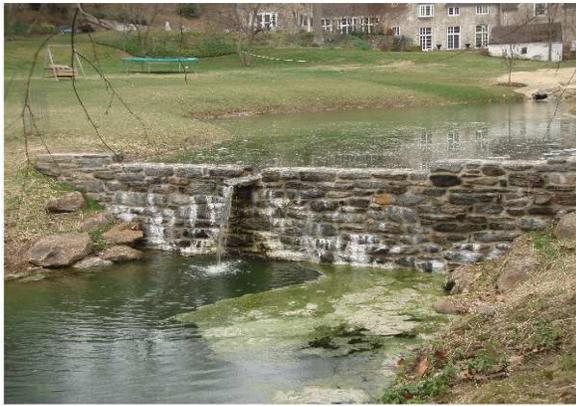
Infrastructure ID: WSDam113 Dam

Condition	Material	Width (ft)	Length (ft)	Height Exposed (ft)
Good	Stone	2.0	8.0	4.0

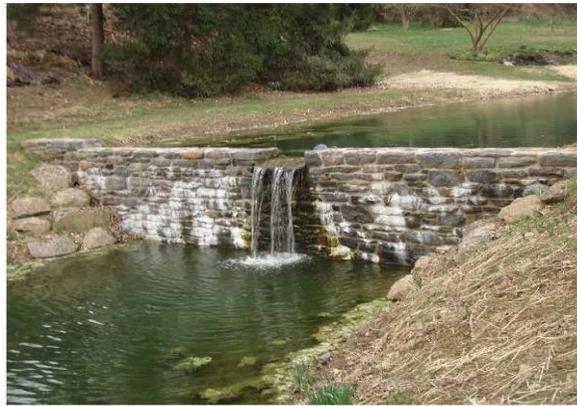
Infrastructure ID: WSDam114 Dam

Condition	Material	Width (ft)	Length (ft)	Height Exposed (ft)
Good	Stone	2.5	12.0	4.0

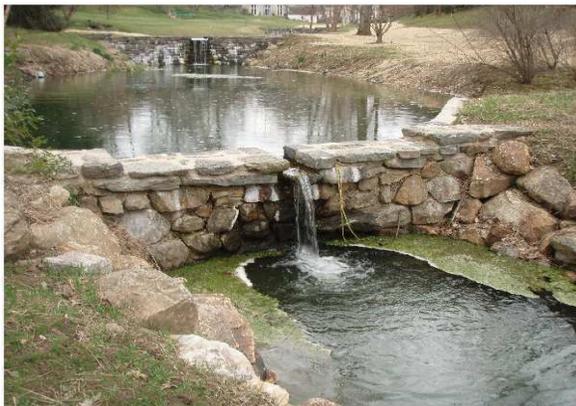
Infrastructure ID: WSDam115 Dam

Condition	Material	Width (ft)	Length (ft)	Height Exposed (ft)
Good	Stone	2.0	10.0	4.0

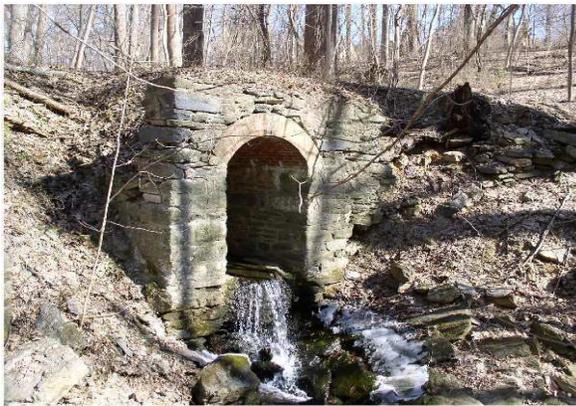
Infrastructure ID: WScul114 Culvert

Condition	Material	Dimension (ft)	Length (ft)	Location
Poor	Stone	5.0 x 3.0	76.0	Southeast of intersection of Saint Andrew St and Glengarry Rd

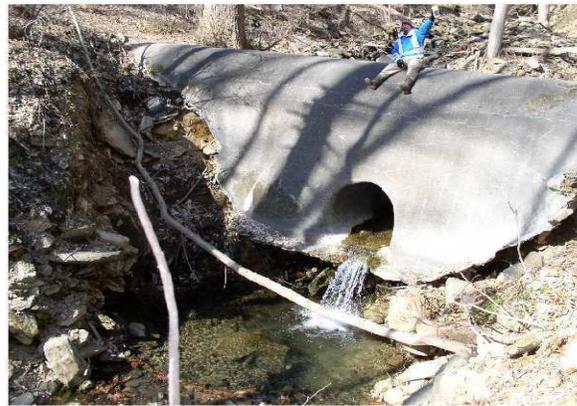
Infrastructure ID: WScul116 Culvert

Condition	Material	Dimension (ft)	Length (ft)	Location
Fair	Concrete	5.0	33.0	In Fairmount Park near Valley Green Rd, Interceptor crossing

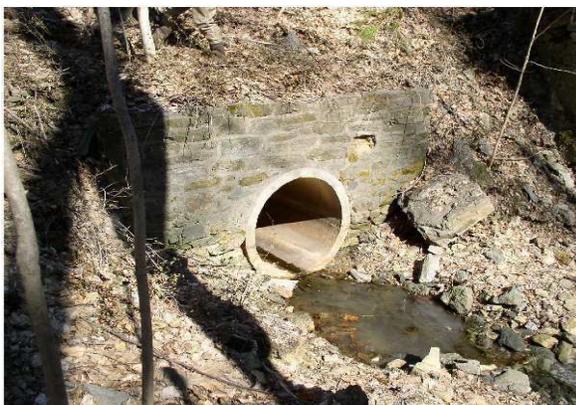
Infrastructure ID: WSout578 Outfall

Condition	Material	Location	Flow	Flow Appearance	Dimension (ft)
Good	Concrete	DSR	Trickle		3.0

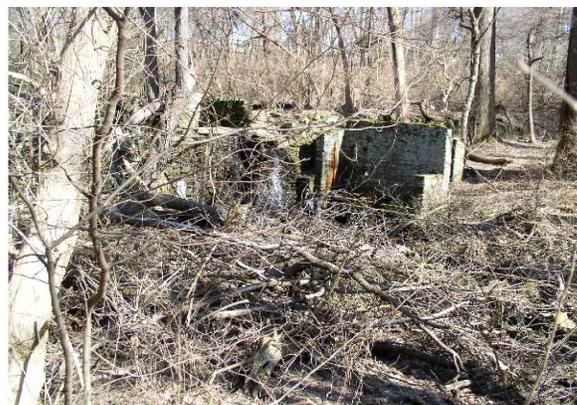
Infrastructure ID: WSDam116 Dam

Condition	Material	Width (ft)	Length (ft)	Height Exposed (ft)
Fair	Stone	2.5	8.0	16.0

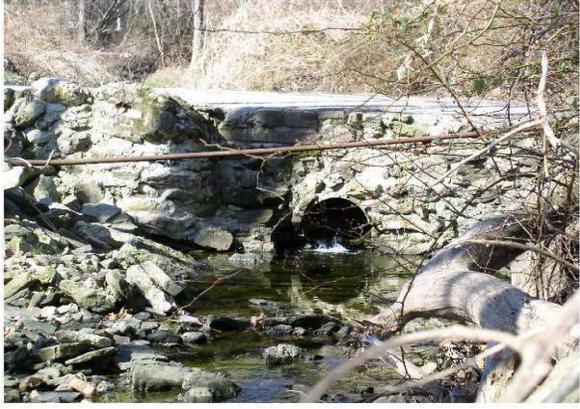
Infrastructure ID: WScul500 Culvert

Condition	Material	Dimension (ft)	Length (ft)	Location
Good	Concrete	2.0	21.0	Under driveway off Seffert St

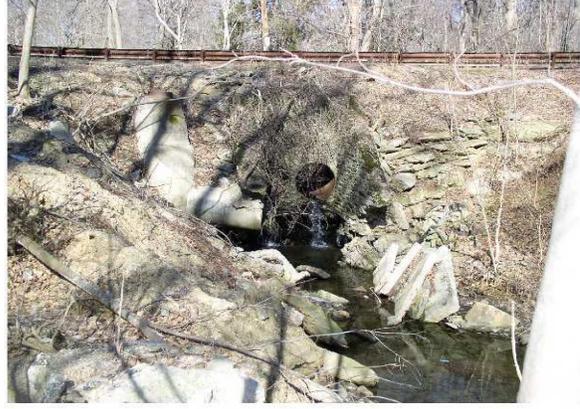
Infrastructure ID: WScul501 Culvert

Condition	Material	Dimension (ft)	Length (ft)	Location
Good	CorrMetal	3.0	71.0	Summit Ave, Fairmount Park

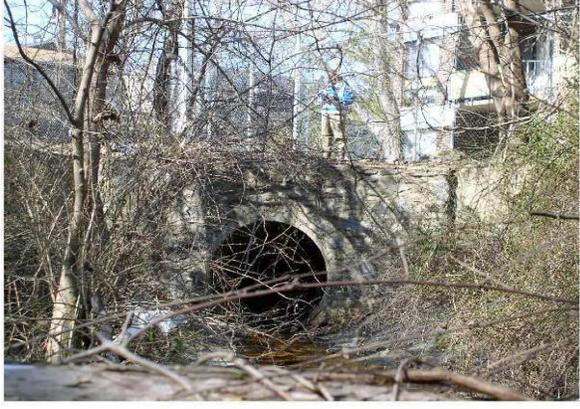
Infrastructure ID: WSout571 Outfall

Condition	Material	Location	Flow	Flow Appearance	Dimension (ft)
Good	Concrete	CROSS	Steady		5.0

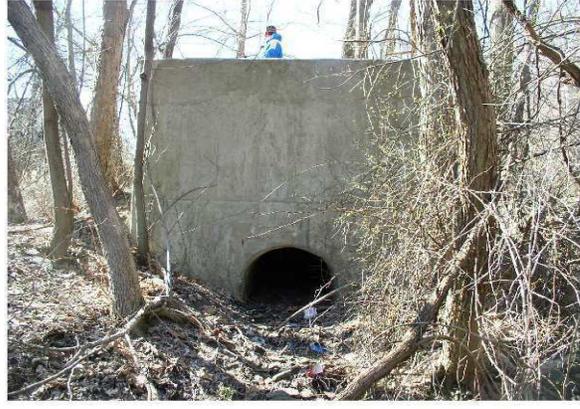
Infrastructure ID: WSout570 Outfall

Condition	Material	Location	Flow	Flow Appearance	Dimension (ft)
Good	Concrete	DSR	None		3.0

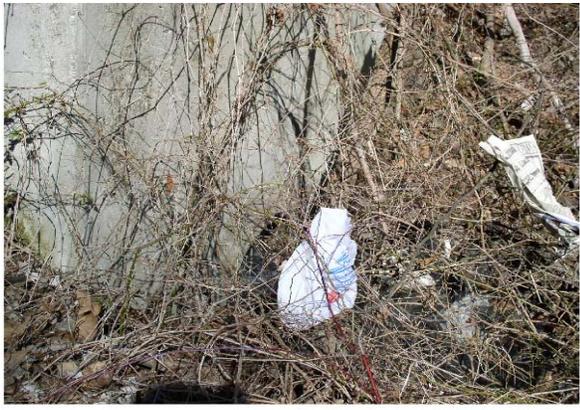
Infrastructure ID: WSout569 Outfall

Condition	Material	Location	Flow	Flow Appearance	Dimension (ft)
Good	Concrete	DSR	Steady		1.5

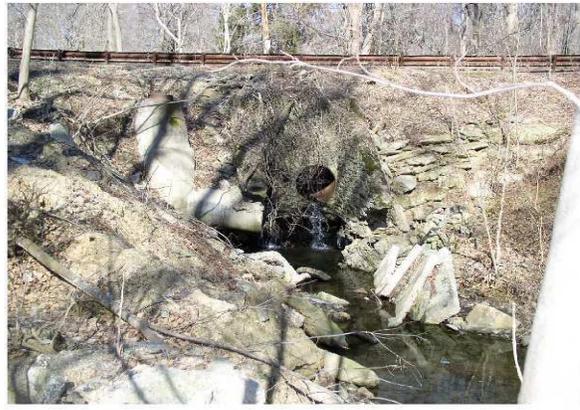
Infrastructure ID: WSman038 Manhole

Condition	Location	Height Exposed (ft)
Good	DSR	20.0

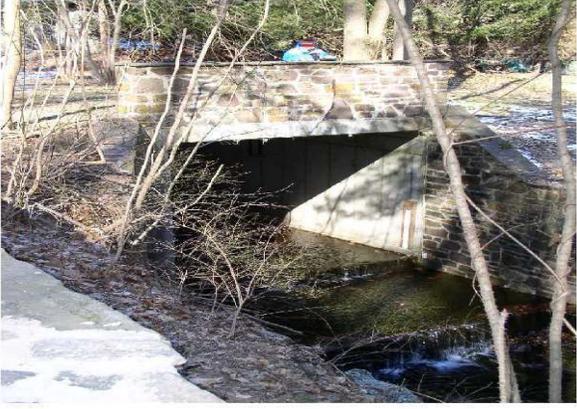
Infrastructure ID: WScul111 Culvert

Condition	Material	Dimension (ft)	Length (ft)	Location
Good	Concrete		171.0	Next to Wises Mill Rd

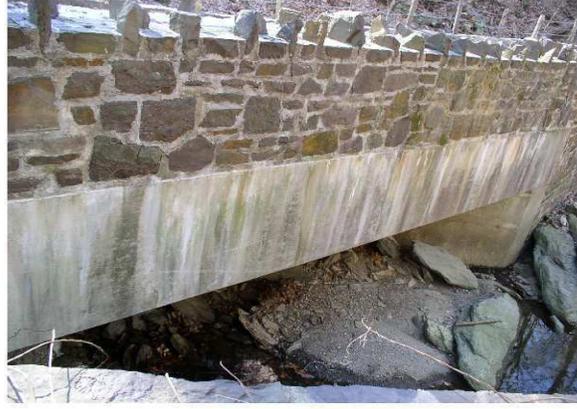
Infrastructure ID: WScul504 Culvert

Condition	Material	Dimension (ft)	Length (ft)	Location
Good	Concrete	5.0 x 30.0	70.0	Wises Mill Rd, Fairmount Park

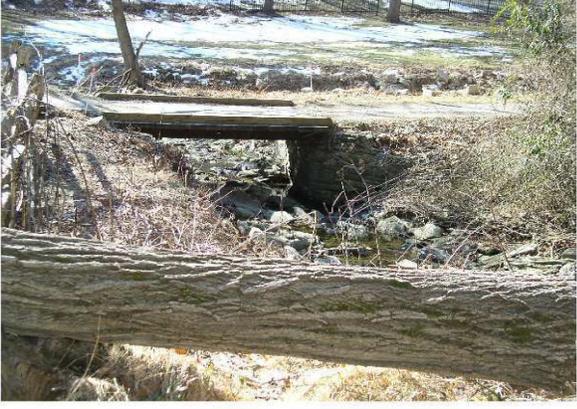
Infrastructure ID: WSbri252 Bridge

Condition	Material	Dimension (ft)	Length (ft)	Location
Good	Stone/Wood	3.0 x 10.0	15.0	Trail off Wises Mill Rd

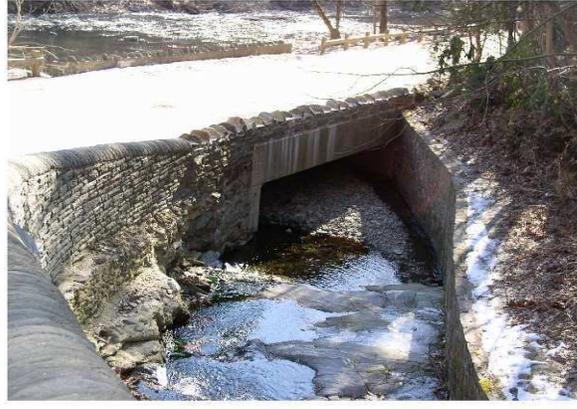
Infrastructure ID: WSbri250 Bridge

Condition	Material	Dimension (ft)	Length (ft)	Location
Good	Stone/Conc	5.0 x 30.0	40.0	Wissahickon Dr at Wises Mill Rd

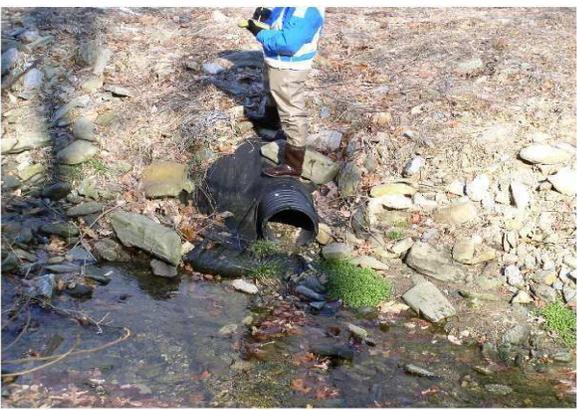
Infrastructure ID: WSout568 Outfall

Condition	Material	Location	Flow	Flow Appearance	Dimension (ft)
Good	Plastic	DSL	Trickle	Clear	1.0

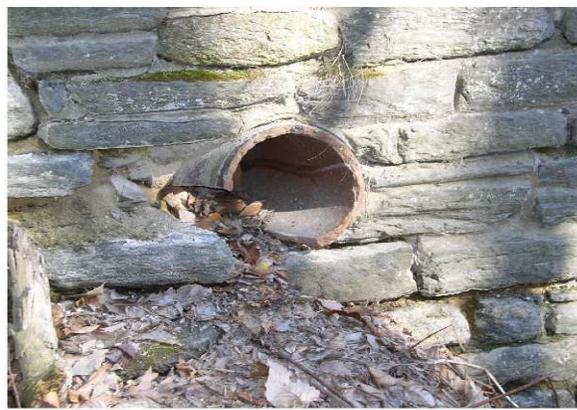
Infrastructure ID: WSout567 Outfall

Condition	Material	Location	Flow	Flow Appearance	Dimension (ft)
Fair	ClayTerra	DSL	None		1.0

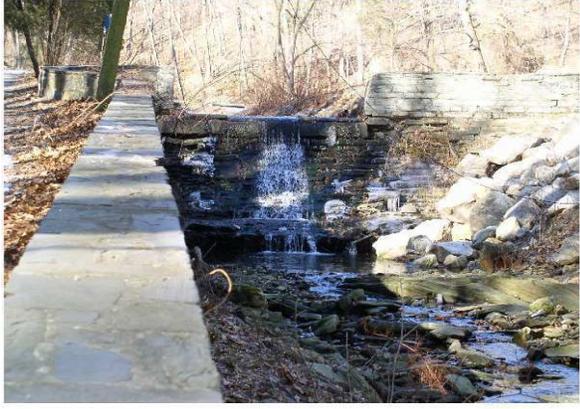
Infrastructure ID: WSDam112 Dam

Condition	Material	Width (ft)	Length (ft)	Height Exposed (ft)
Good	Stone	1.5	12.0	16.0

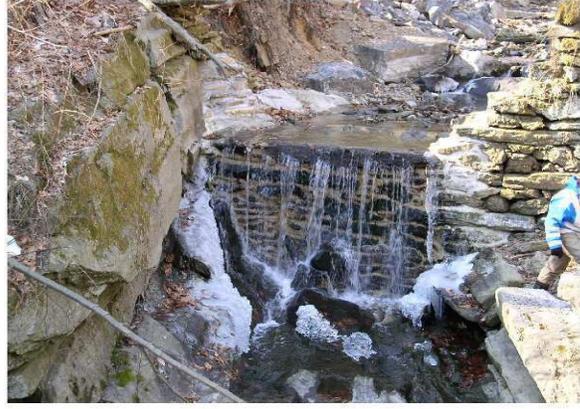
Infrastructure ID: WSDam111 Dam

Condition	Material	Width (ft)	Length (ft)	Height Exposed (ft)
Good	Stone	3.0	10.0	6.0

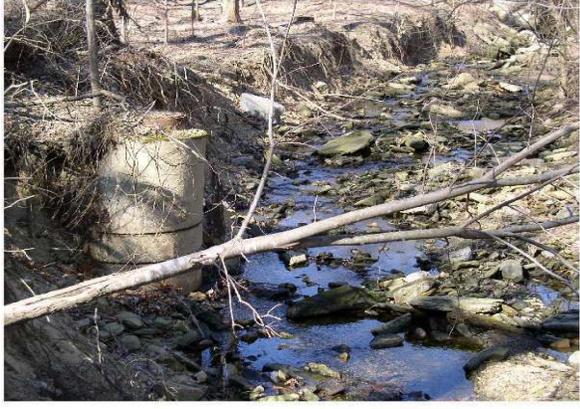
Infrastructure ID: WSman037 Manhole

Condition	Location	Height Exposed (ft)
Good	DSR	10.0

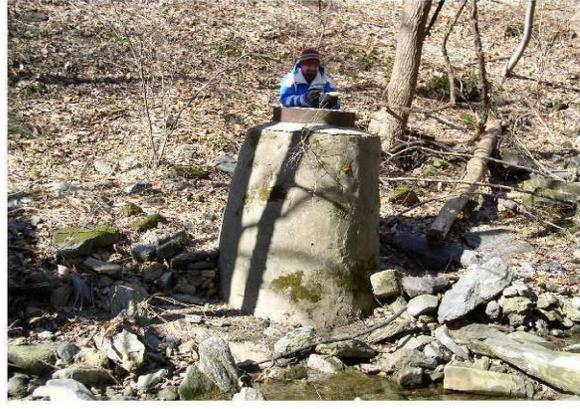
Infrastructure ID: WSman036 Manhole

Condition	Location	Height Exposed (ft)
Good	DSR	6.0

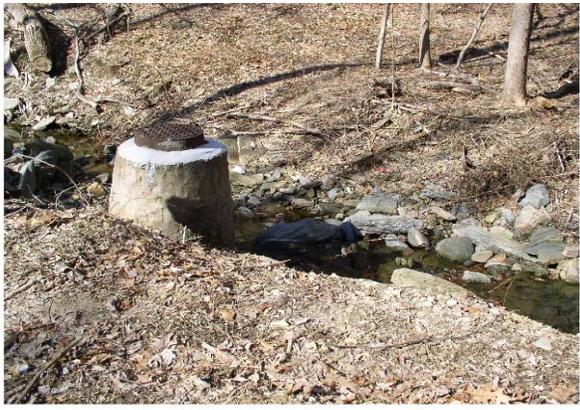
Infrastructure ID: WSman035 Manhole

Condition	Location	Height Exposed (ft)
Good	DSL	0.5

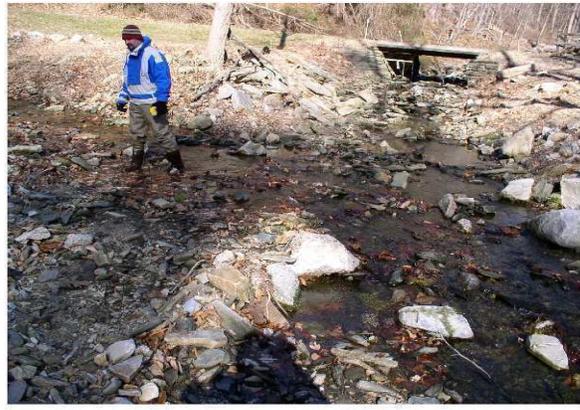
Infrastructure ID: WScon177 Confluence

Condition	Location	Width (ft)	Flow	Creeks
Good	DSR	15.0	Steady	Tributary into Wises Mill Run

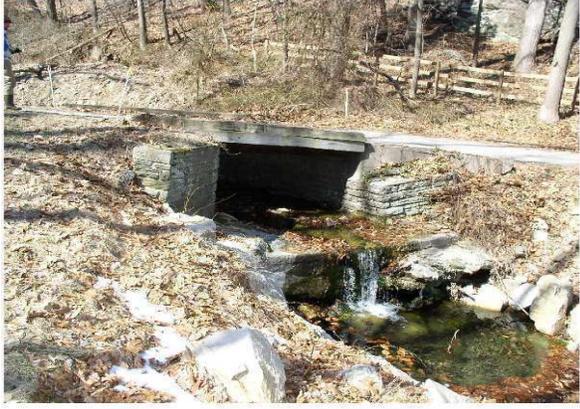
Infrastructure ID: WSbri255 Bridge

Condition	Material	Dimension (ft)	Length (ft)	Location
Good	Stone/Wood	5.0 x 10.0	15.0	Trail off Wises Mill Rd

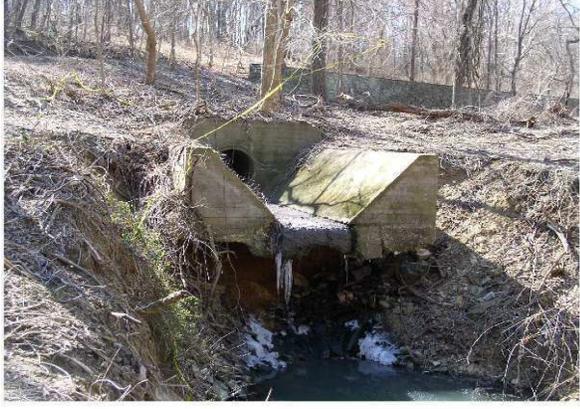
Infrastructure ID: WSout572 Outfall

Condition	Material	Location	Flow	Flow Appearance	Dimension (ft)
Good	Concrete	CROSS	Steady	Clear	4.0
