APPENDIX B
INFRASTRUCTURE PHOTOS

Reach WSTM02 Infrastructure Photos

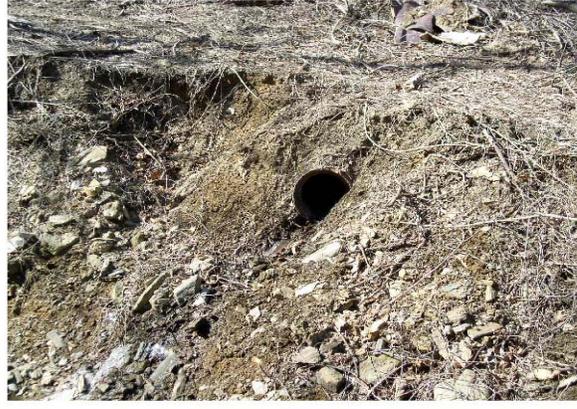
Infrastructure ID: WSout573 Outfall

Condition	Material	Location	Flow	Flow Appearance	Dimension (ft)
Good	Clay/Terra	DSL	Steady	Clear	2.5

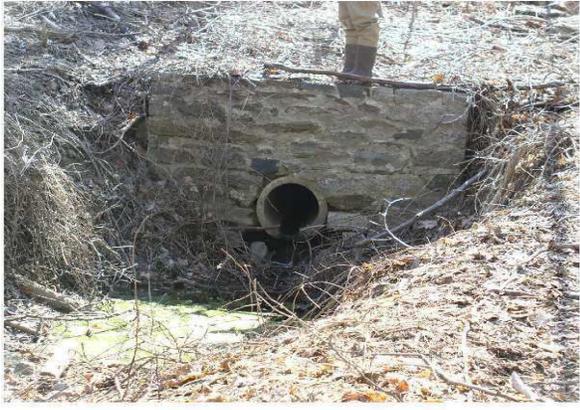
Infrastructure ID: WSout574 Outfall

Condition	Material	Location	Flow	Flow Appearance	Dimension (ft)
Good	Concrete	DSR	Steady	Clear	1.0

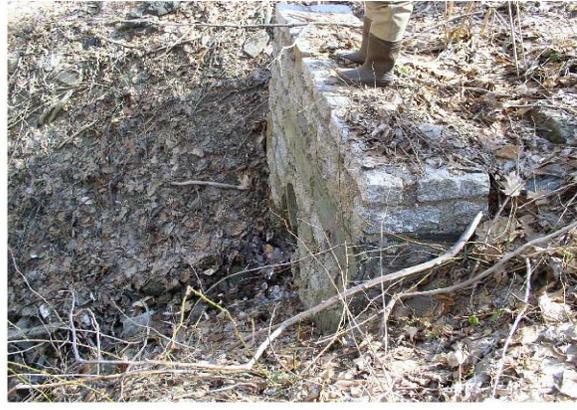
Infrastructure ID: WSout575 Outfall

Condition	Material	Location	Flow	Flow Appearance	Dimension (ft)
Good	Concrete	DSR	Trickle	Clear	1.0

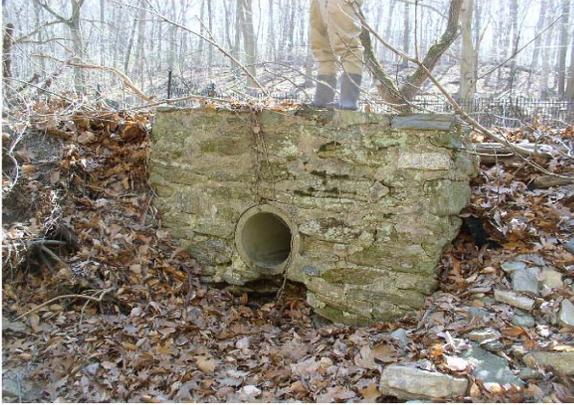
Infrastructure ID: WSout576

Condition	Material	Location	Flow	Flow Appearance	Dimension (ft)
Good	Concrete	DSR	None		1.333

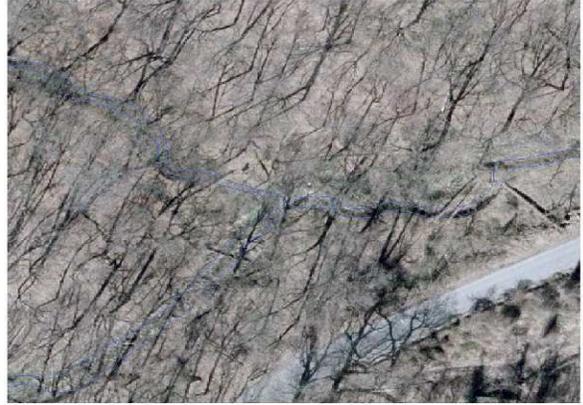
Infrastructure ID: WScon216

Condition	Location	Width (ft)	Flow	Creeks
Good	DSL	6.0		Two tribs meet before reaching Wises Mill Run

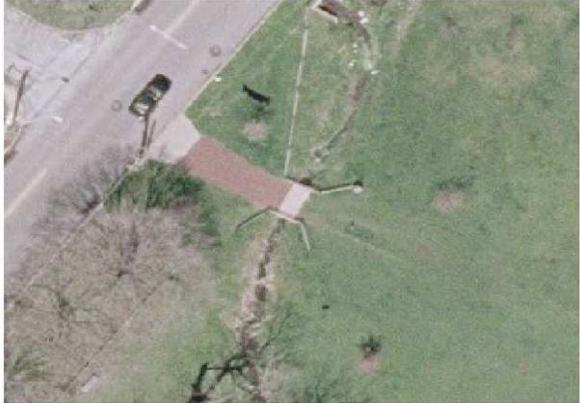
Infrastructure ID: WScul531 Culvert

Condition: Good
Material: Concrete
Dimension (ft): 14.0
Length (ft): 14.0
Location: Mermaid Ln at Elm Ave

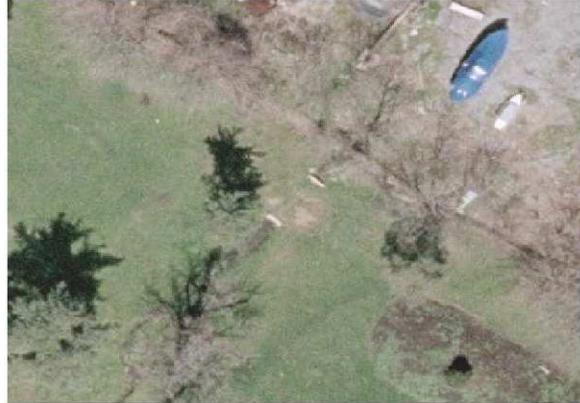
Infrastructure ID: WScul532 Culvert

Condition: Good
Material: Concrete
Dimension (ft): 3.0
Length (ft): 20.0
Location: Over stream that feeds pond at Mermaid Ln and Elm Ave

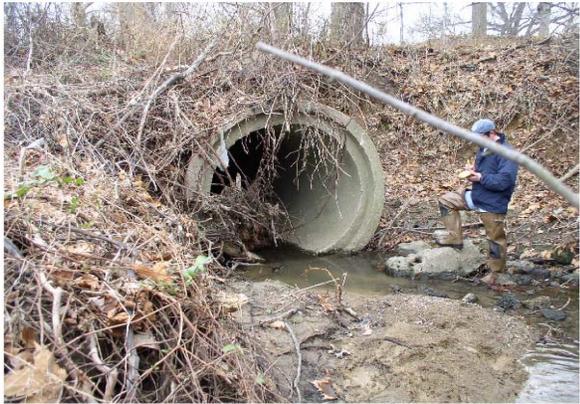
Infrastructure ID: WScul087 Culvert

Condition: Fair
Material: Concrete
Dimension (ft): 6.0
Length (ft): 87.0
Location: Parallel to Ivy Hill Rd, in Springfield

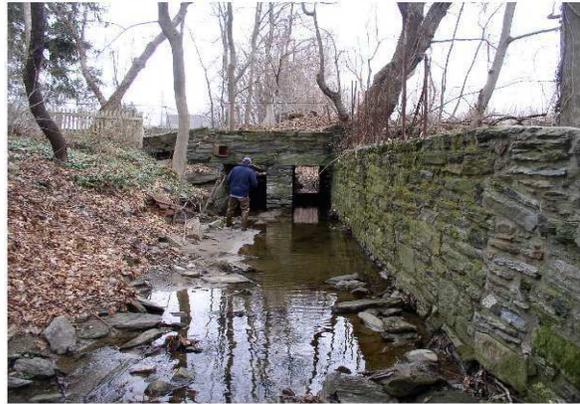
Infrastructure ID: WScul157 Culvert

Condition: Fair
Material: Stone
Dimension (ft): 5.0 x 10.0
Length (ft): 20.0
Location: At the end of East Ln

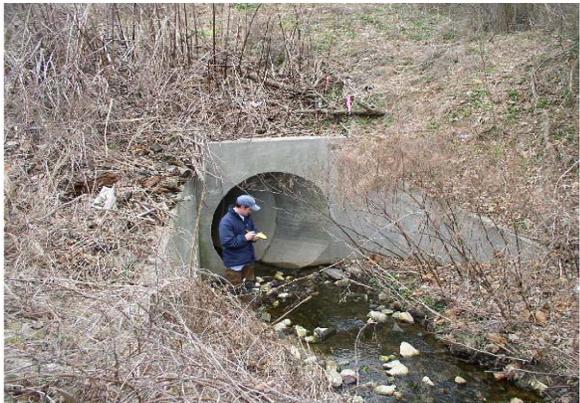
Infrastructure ID: WScul085 Culvert

Condition: Good
Material: Concrete
Dimension (ft): 8.0
Length (ft): 200.0
Location: Stenton Ave at Ivy Hill Rd

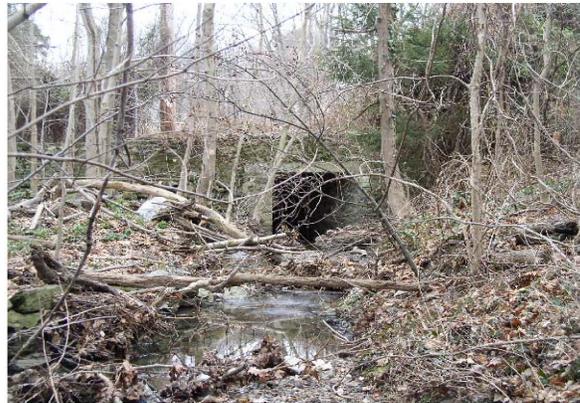
Infrastructure ID: WScul088 Culvert

Condition: Fair
Material: Stone
Dimension (ft): 4.0 x 6.0
Length (ft): 36.0
Location: Between Woodbrook Rd and Cresheim Valley Rd

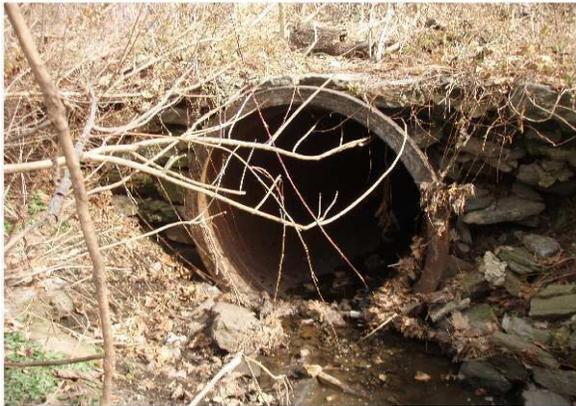
Infrastructure ID: WScul089

Condition	Material	Dimension (ft)	Length (ft)	Location
Fair	Iron	4.0		Parallel to Cresheim Valley Rd

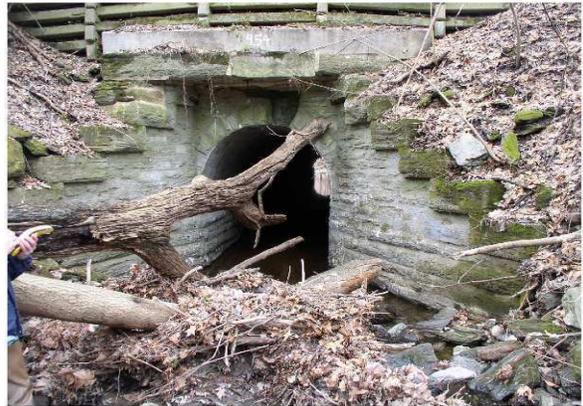
Infrastructure ID: WScul194

Condition	Material	Dimension (ft)	Length (ft)	Location
Fair	Stone	8.0 x 5.0	165.0	Under railroad near parking lot at the end of Devon St

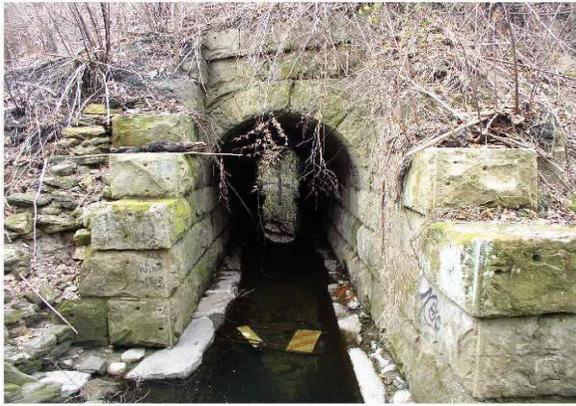
Infrastructure ID: WScul195

Condition	Material	Dimension (ft)	Length (ft)	Location
Poor	Stone	10.0 x 8.0	92.0	Next to Cresheim Valley Rd

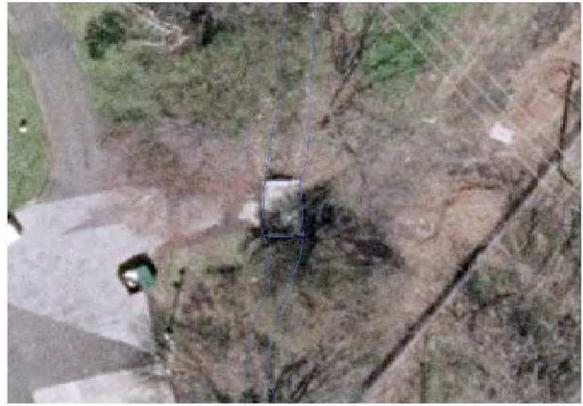
Infrastructure ID: WSbri472

Condition	Material	Dimension (ft)	Length (ft)	Location
Fair	Concrete		15.0	Pathway near Ivy Hill Rd at Rugby St

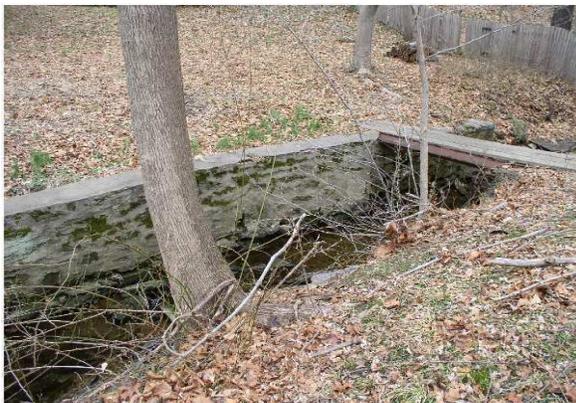
Infrastructure ID: WScha109

Condition	Material	Dimension (ft)	Length (ft)	Location
Fair	Stone		46.0	DSL

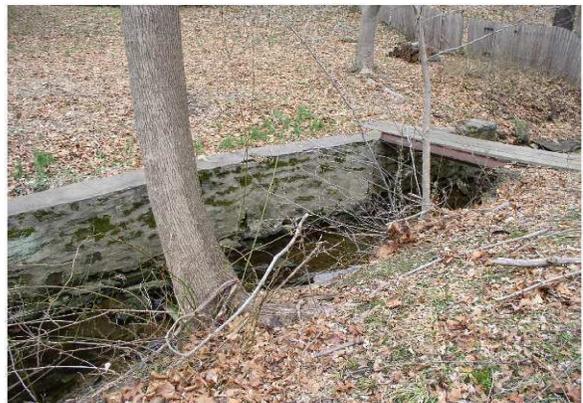
Infrastructure ID: WScha222

Condition	Material	Dimension (ft)	Length (ft)	Location
Fair	Stone		50.0	DSR

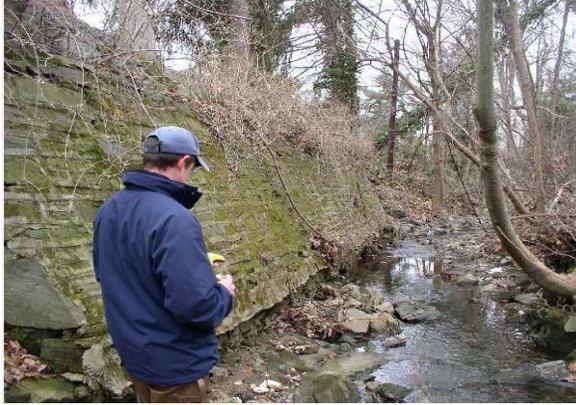
Infrastructure ID: WScha110 Channel

Condition	Material	Dimension (ft)	Length (ft)	Location
Fair	Stone		80.0	DSL

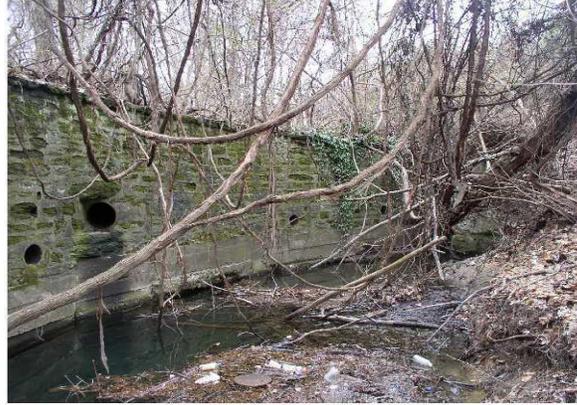
Infrastructure ID: WScha111 Channel

Condition	Material	Dimension (ft)	Length (ft)	Location
Good	Stone		108.0	DSR

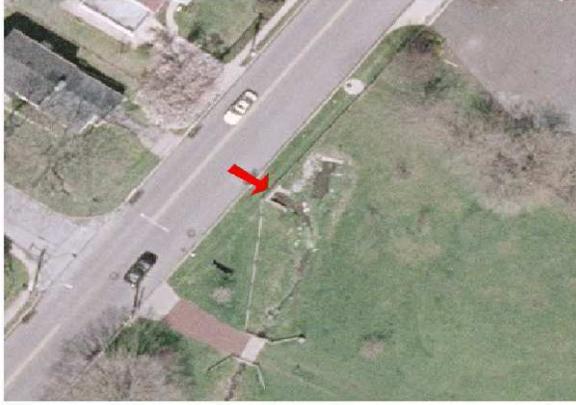
Infrastructure ID: WSout734 Outfall

Condition	Material	Location	Flow	Flow Appearance	Dimension (ft)
Good	Concrete	DSR			0.0 x 0.0

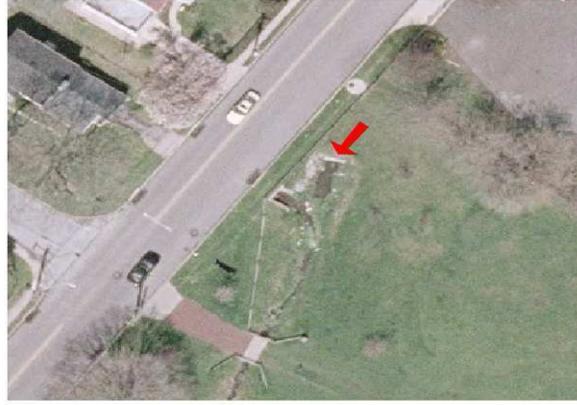
Infrastructure ID: WSout735 Outfall

Condition	Material	Location	Flow	Flow Appearance	Dimension (ft)
Good	Concrete	DSL			0.0 x 0.0

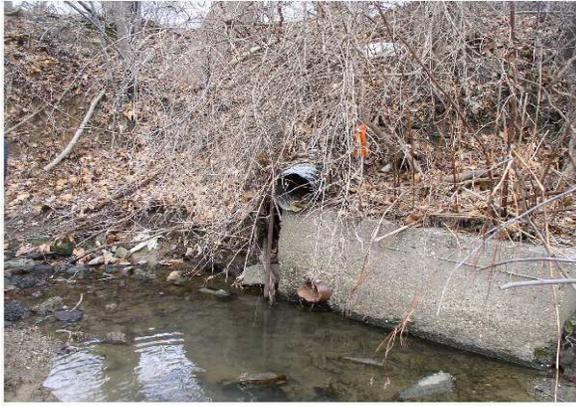
Infrastructure ID: WSout485 Outfall

Condition	Material	Location	Flow	Flow Appearance	Dimension (ft)
Fair	CorrMetal	DSR	None		1.0

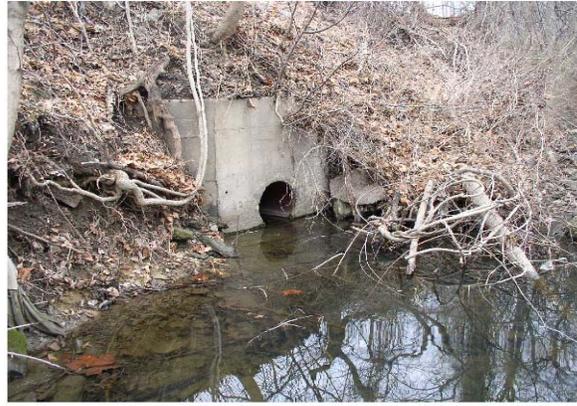
Infrastructure ID: WSout482 Outfall

Condition	Material	Location	Flow	Flow Appearance	Dimension (ft)
Good	Concrete	DSR	Steady	Clear	1.5

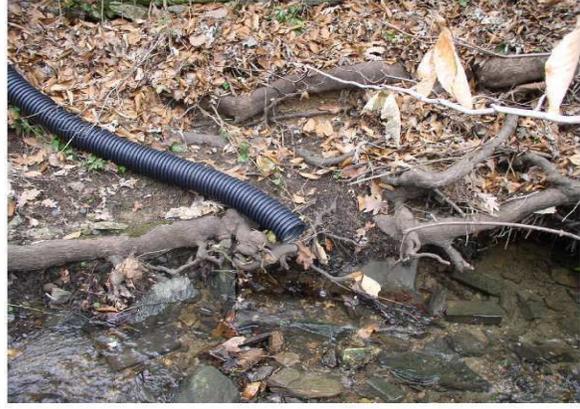
Infrastructure ID: WSout486 Outfall

Condition	Material	Location	Flow	Flow Appearance	Dimension (ft)
Good	Plastic	DSL	None		0.666

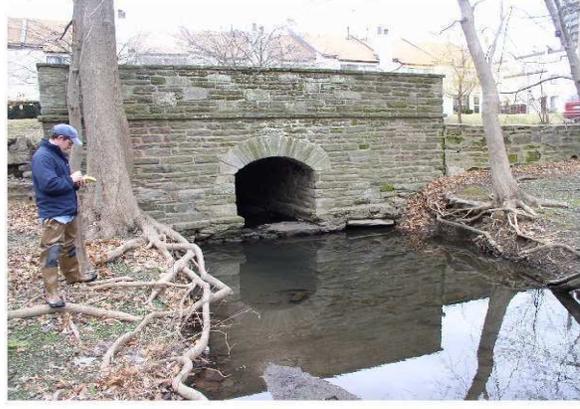
Infrastructure ID: WSout488 Outfall

Condition	Material	Location	Flow	Flow Appearance	Dimension (ft)
Good	Stone	CROSS	Steady	Gray	4.0

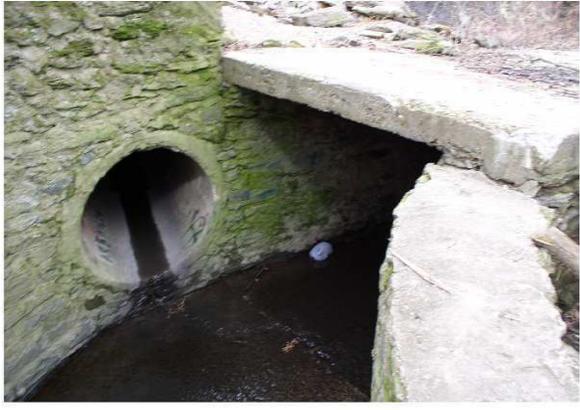
Infrastructure ID: WSout489 Outfall

Condition	Material	Location	Flow	Flow Appearance	Dimension (ft)
Good	Concrete	DSR	Trickle	Clear	4.0

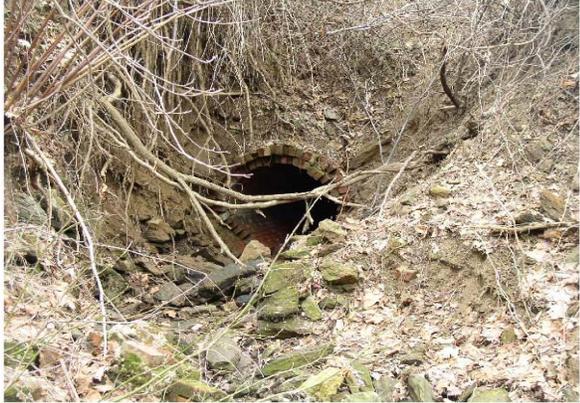
Infrastructure ID: WSout495 Outfall

Condition	Material	Location	Flow	Flow Appearance	Dimension (ft)
Good	Stone	DSL	None		4.0

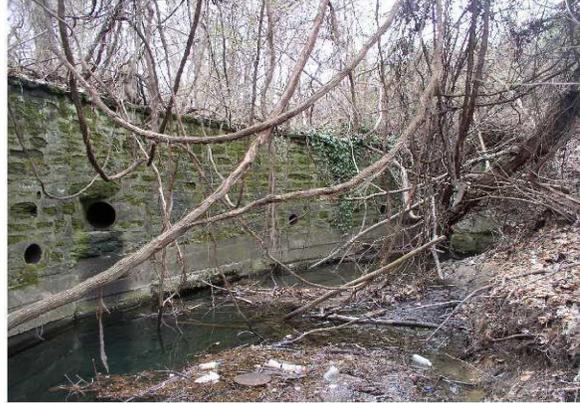
Infrastructure ID: WSout496 Outfall

Condition	Material	Location	Flow	Flow Appearance	Dimension (ft)
Good	Clay/Terra	DSR	None		1.333

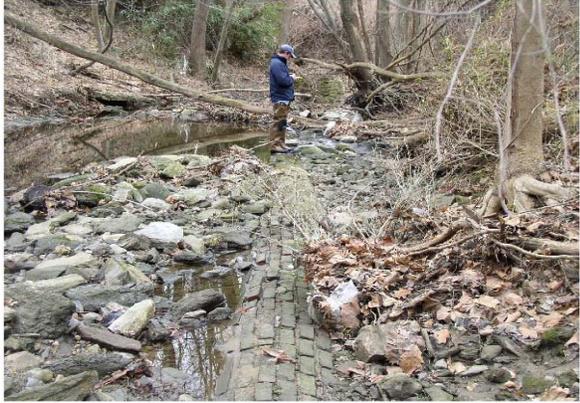
Condition	Material	Location	Diameter (ft)	Height Exposed (ft)	Length Exposed (ft)
Poor	Brick	CROSS	0.0	0.666	0.0

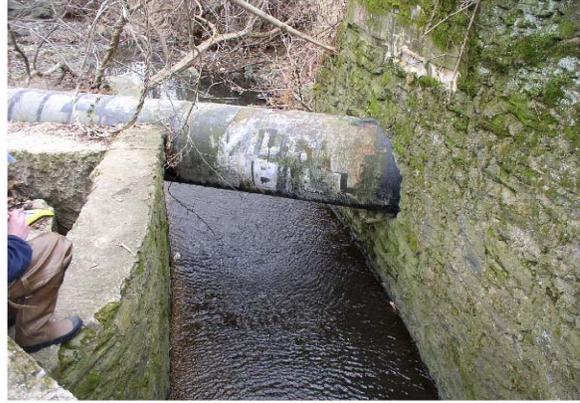
Condition	Material	Location	Diameter (ft)	Height Exposed (ft)	Length Exposed (ft)
Fair	Iron	CROSS	0.0	0.0	0.0

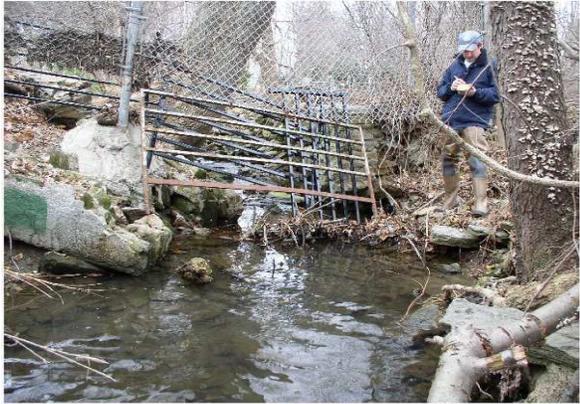
Notes
Fence. Debris trapped upstream drainage blocked.

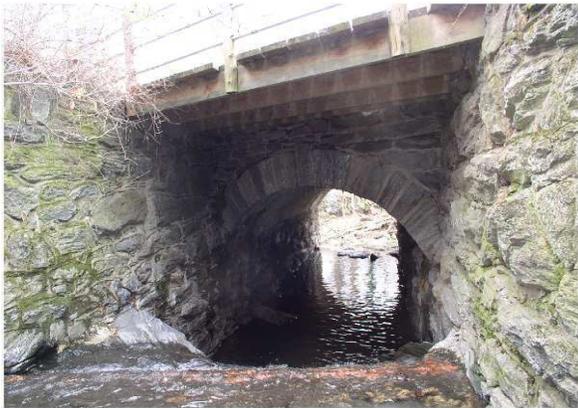
Condition	Material	Dimension (ft)	Length (ft)	Location
Fair	Stone	8.0 x 8.0	10.0	Chresheim Valley Rd

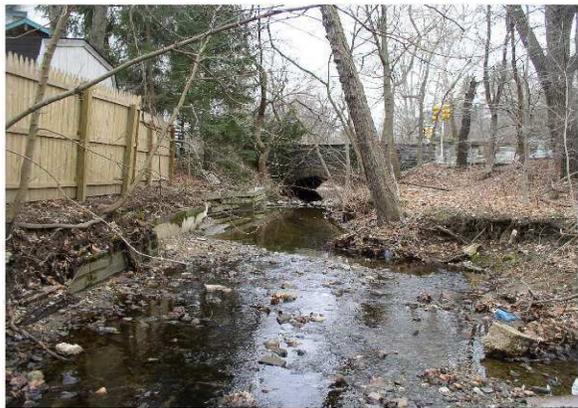
Condition	Material	Dimension (ft)	Length (ft)	Location
Fair	Stone	10.0 x 15.0	50.0	Germanstown Ave

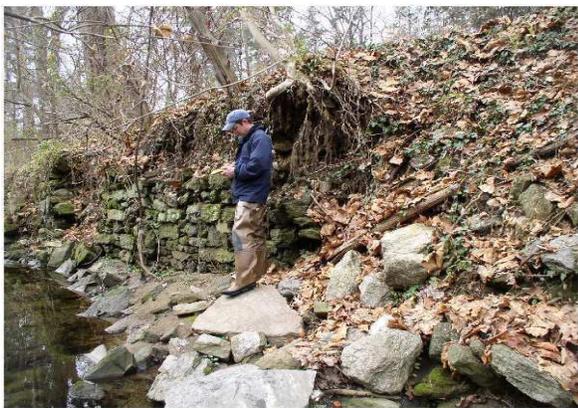
Condition	Material	Dimension (ft)	Length (ft)	Location
Poor	Stone		90.0	DSR

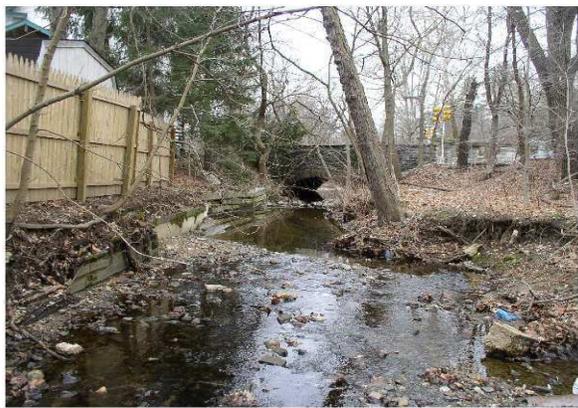
Condition	Material	Dimension (ft)	Length (ft)	Location
Poor	Wood		90.0	DSL

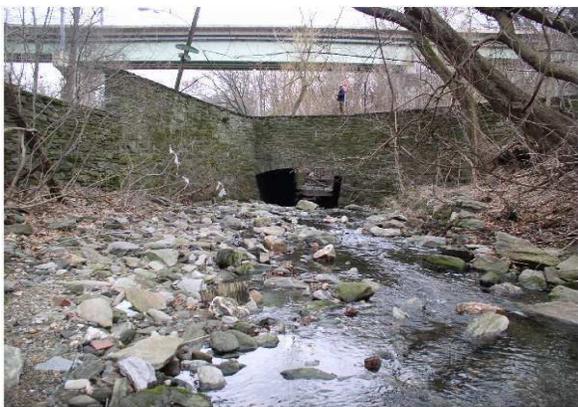
Condition	Material	Dimension (ft)	Length (ft)	Location
Fair	Stone		576.0	DSR

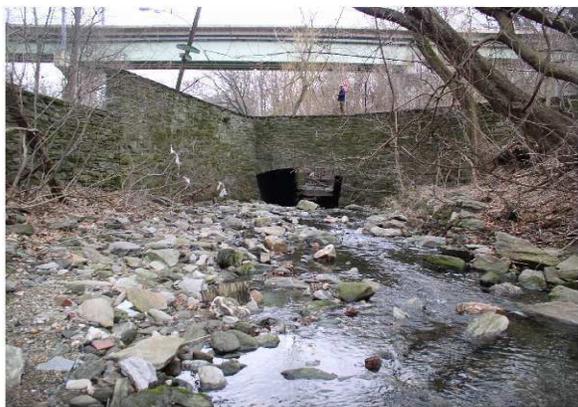
Condition	Material	Dimension (ft)	Length (ft)	Location
Fair	Stone		646.0	MID

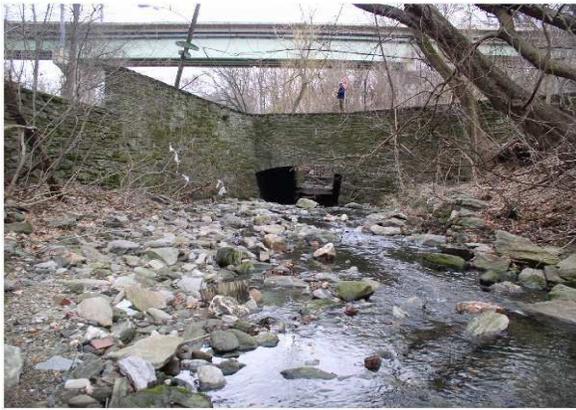
Condition: Fair | Material: Stone | Dimension (ft): 648.0 | Length (ft): DSL | Location: DSL

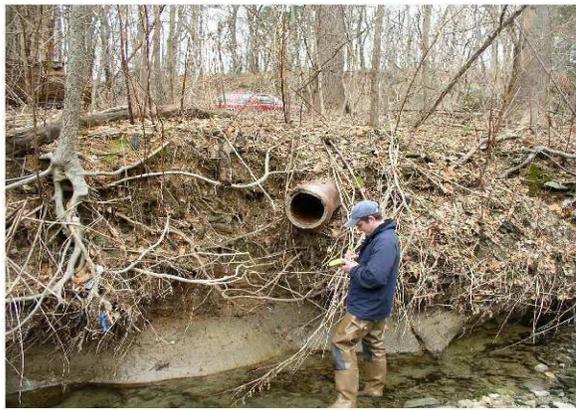
Condition: Fair | Material: ClayTerra | Location: DSR | Flow: None | Flow Appearance: None | Dimension (ft): 1.333

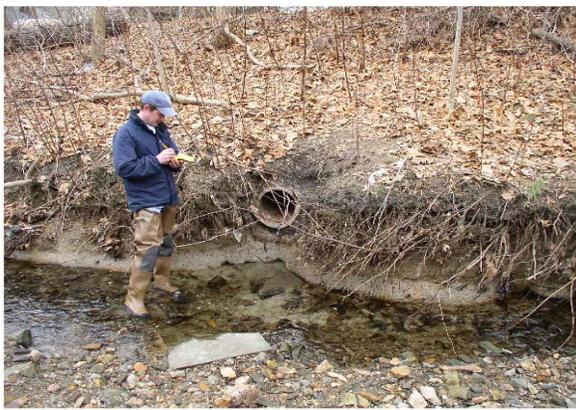
Condition: Fair | Material: ClayTerra | Location: DSR | Flow: None | Flow Appearance: None | Dimension (ft): 1.333

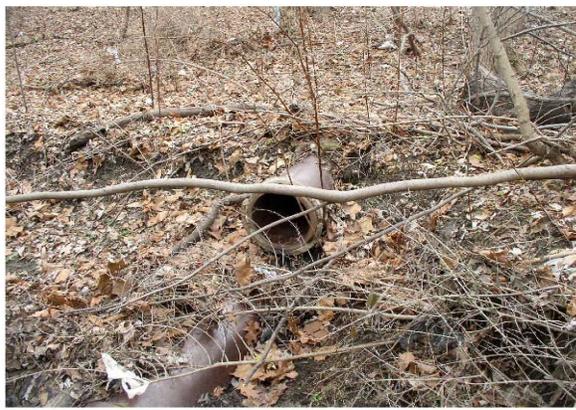
Condition: Fair | Material: ClayTerra | Location: DSR | Flow: None | Flow Appearance: None | Dimension (ft): 1.333

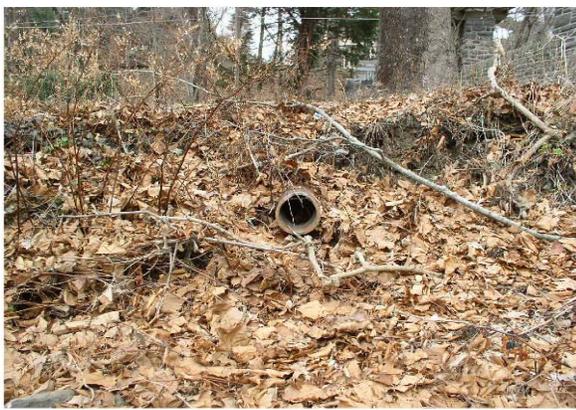
Condition: Poor | Material: ClayTerra | Location: DSR | Flow: None | Flow Appearance: None | Dimension (ft): 0.666

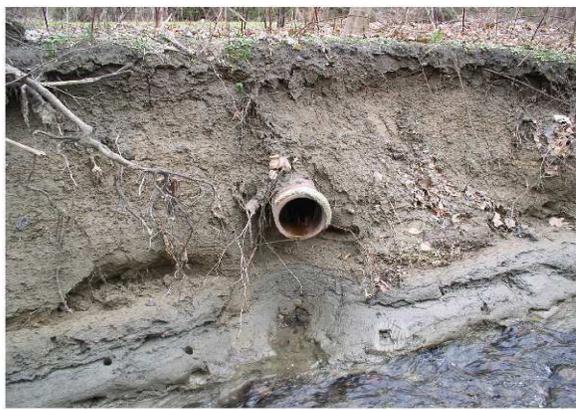
Condition: Fair | Material: ClayTerra | Location: DSR | Flow: None | Flow Appearance: None | Dimension (ft): 0.666

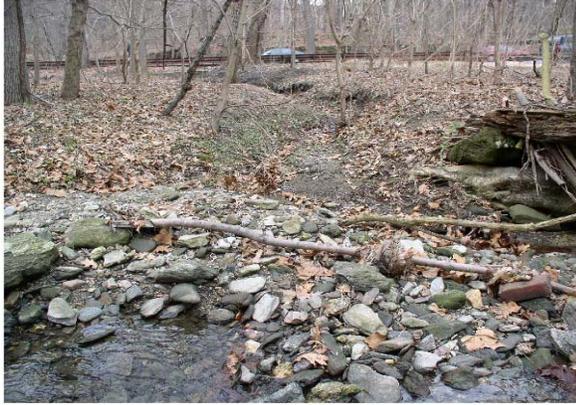
Condition	Location	Width (ft)	Flow	Creeks
Fair	DSL	5.0	None

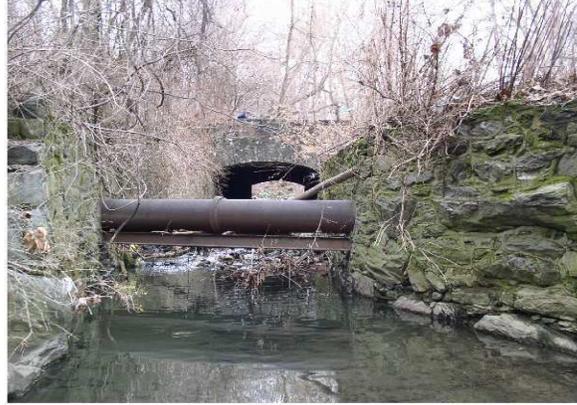
Condition	Material	Location	Diameter (ft)	Height Exposed (ft)	Length Exposed (ft)
Fair	Iron	CROSS	0.0	0.0	0.0

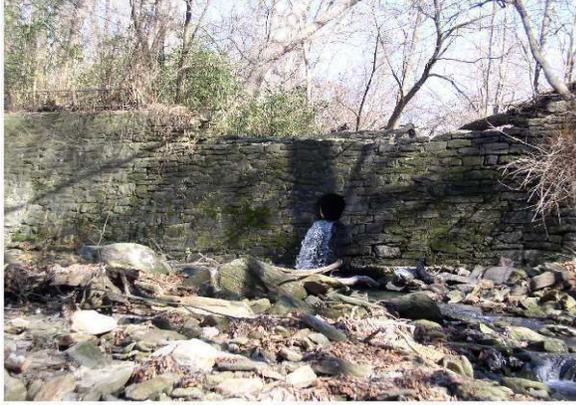
Condition	Material	Width (ft)	Length (ft)	Height Exposed (ft)
Fair	Stone	6.0	100.0	6.0

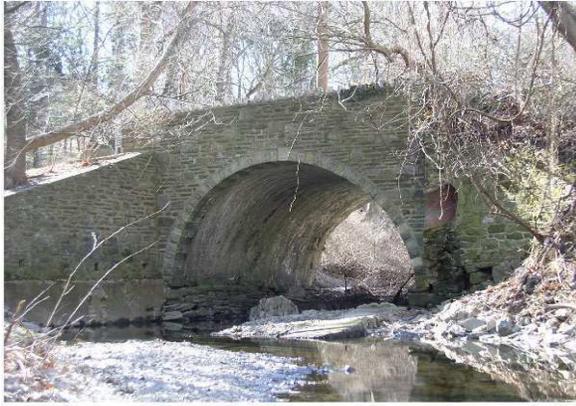
Condition	Material	Dimension (ft)	Length (ft)	Location
Poor	Stone	40.0 x 30.0	50.0	Path near McCallum St

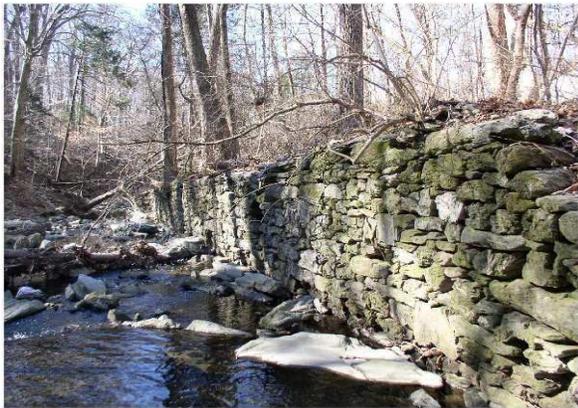
Condition	Material	Dimension (ft)	Length (ft)	Location
Fair	Stone		168.0	DSR

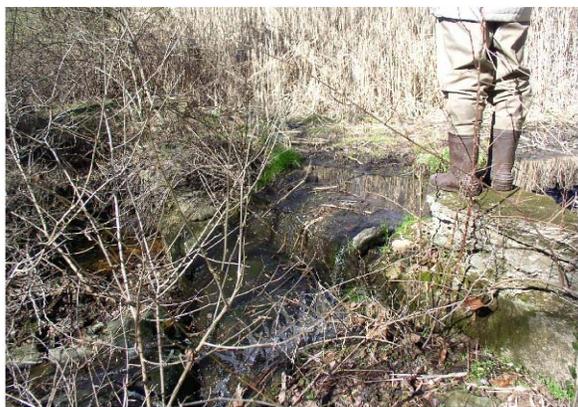
Condition	Material	Width (ft)	Length (ft)	Height Exposed (ft)
Fair	Concrete	1.5	10.0	5.0

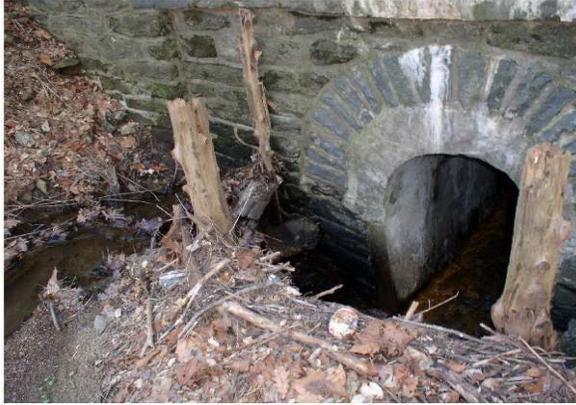
Condition	Material	Dimension (ft)	Length (ft)	Location
Fair	CorrMetal	4.0	108.0	Under Wissahickon Ave at Mount Pleasant Rd

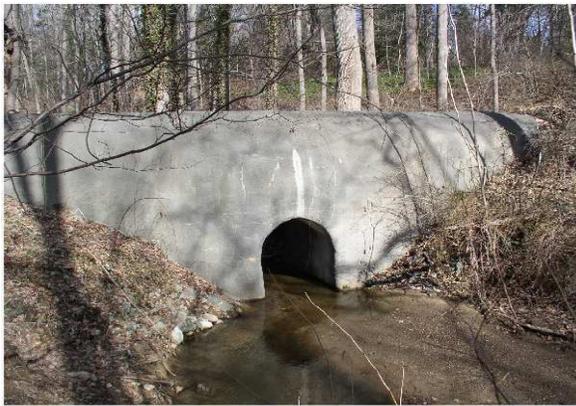
Infrastructure ID: WScul099 Culvert

Condition	Material	Dimension (ft)	Length (ft)	Location
Good	Concrete	3.0 x 2.0	21.0	In Fairmount Park off Kitchens Ln

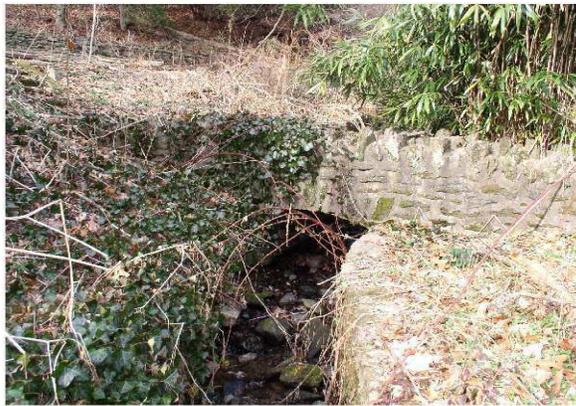
Infrastructure ID: WScul512 Culvert

Condition	Material	Dimension (ft)	Length (ft)	Location
Good	Stone	4.0 x 4.0	7.0	West of Kitchen's Ln, Fairmount Park

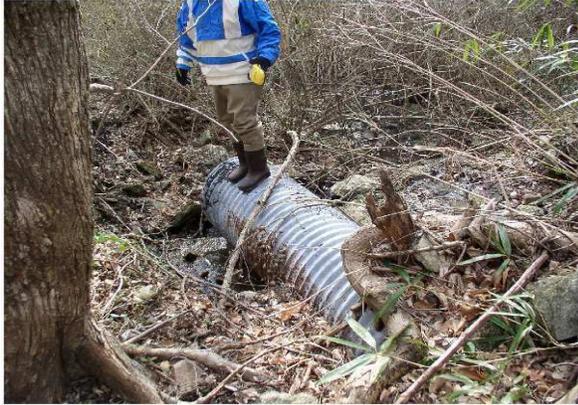
Infrastructure ID: WScul100 Culvert

Condition	Material	Dimension (ft)	Length (ft)	Location
Poor	CorrMetal	2.0	12.0	Near Kitchens Ln

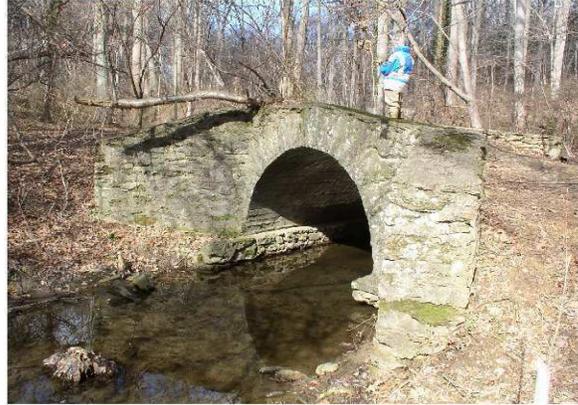
Infrastructure ID: WSbri227 Bridge

Condition	Material	Dimension (ft)	Length (ft)	Location
Good	Stone	10.0 x 12.0	25.0	Trail near Kitchens Ln

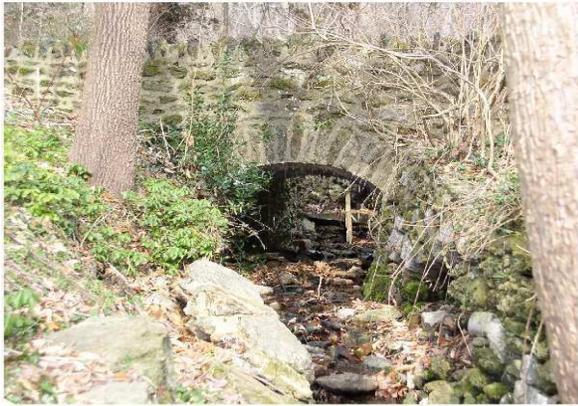
Infrastructure ID: WSbri231 Bridge

Condition	Material	Dimension (ft)	Length (ft)	Location
Good	Stone	5.0 x 5.0	15.0	Trail off Kitchens Ln

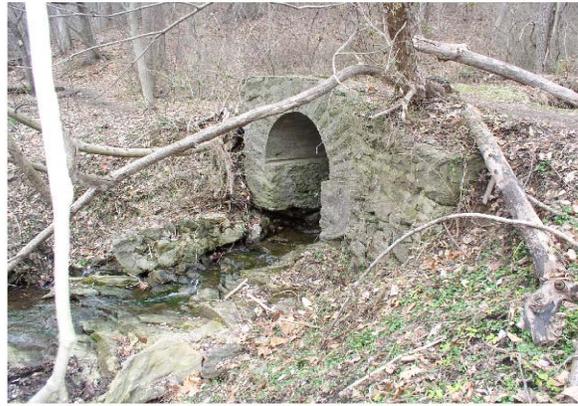
Infrastructure ID: WSbri230 Bridge

Condition	Material	Dimension (ft)	Length (ft)	Location
Good	Stone	8.0 x 5.0	20.0	Trail off Kitchens Ln

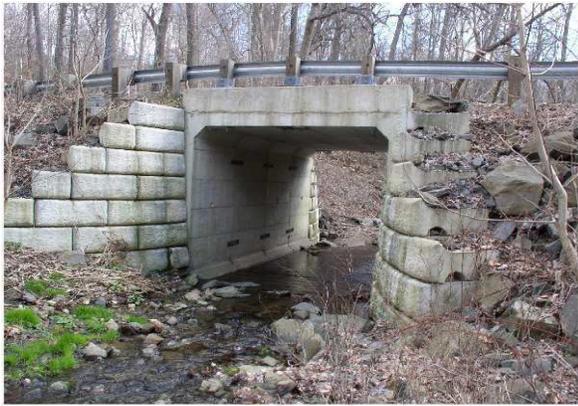
Infrastructure ID: WSbri228 Bridge

Condition	Material	Dimension (ft)	Length (ft)	Location
Good	Concrete	20.0 x 15.0	30.0	Kitchens Ln

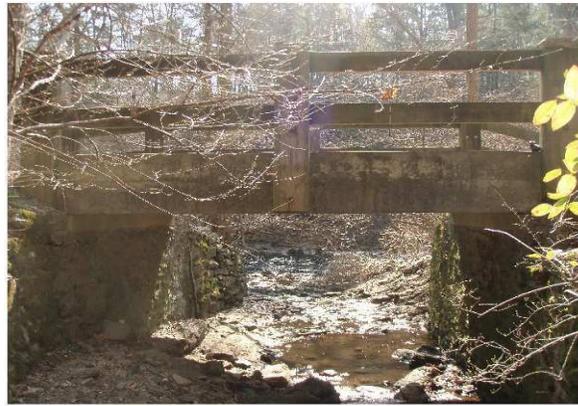
Infrastructure ID: WSbri229 Bridge

Condition	Material	Dimension (ft)	Length (ft)	Location
Good	Wood	10.0 x 20.0	15.0	Trail near Kitchens Ln

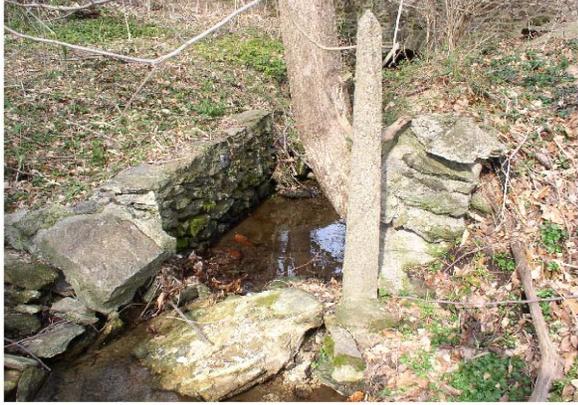
Infrastructure ID: WScha117 Channel

Condition	Material	Dimension (ft)	Length (ft)	Location
Poor	Stone	4.0 x 2.0	353.0	DSR

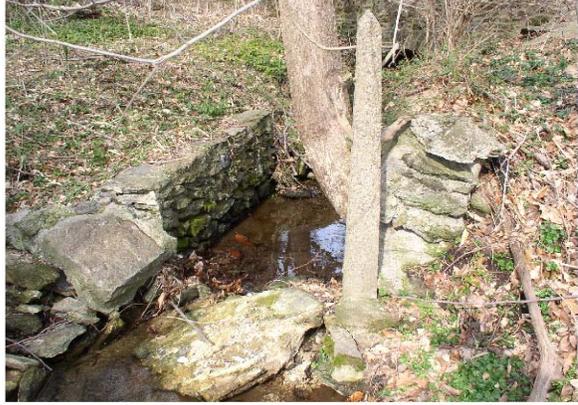
Infrastructure ID: WScha179 Channel

Condition	Material	Dimension (ft)	Length (ft)	Location
Poor	Stone	2.0 x 2.0	351.0	DSL

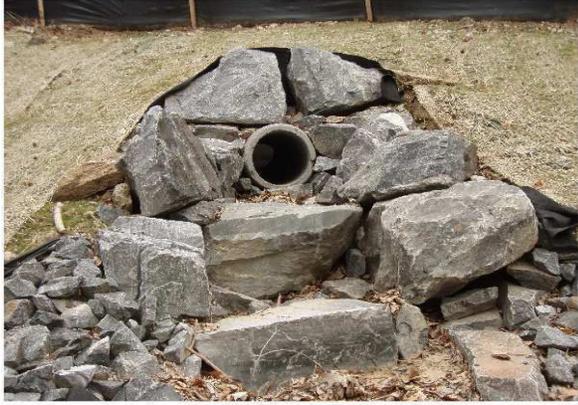
Infrastructure ID: WSout730 Outfall

Condition	Material	Location	Flow	Flow Appearance	Dimension (ft)
Good	Concrete	MID	None		1.5

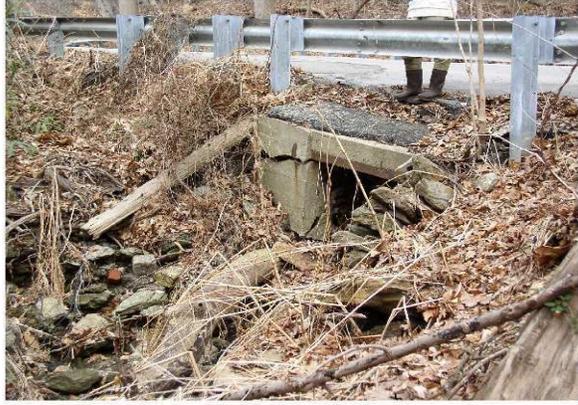
Infrastructure ID: WSout518 Outfall

Condition	Material	Location	Flow	Flow Appearance	Dimension (ft)
Fair	Concrete	MID	None		2.5 x 3.0

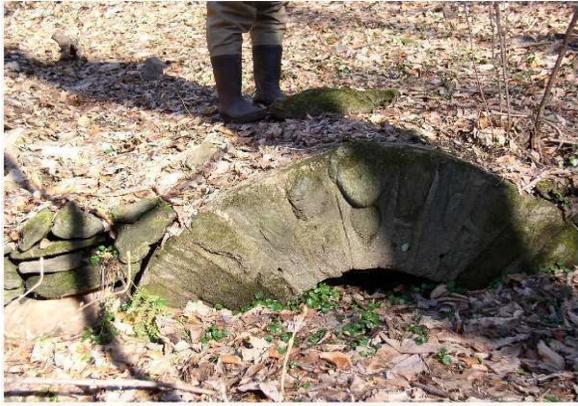
Infrastructure ID: WSout521 Outfall

Condition	Material	Location	Flow	Flow Appearance	Dimension (ft)
Fair	Concrete	MID	None		1.5

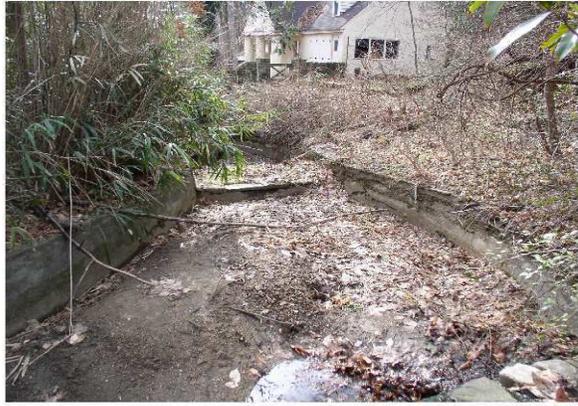
Infrastructure ID: WSDam103 Dam

Condition	Material	Width (ft)	Length (ft)	Height Exposed (ft)
Good	Concrete	1.333	20.0	3.0

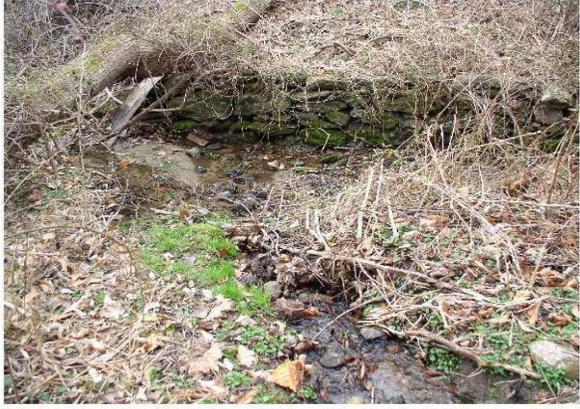
Infrastructure ID: WScn164 Confluence

Condition **Location** **Width (ft)** **Flow** **Creeks**
Good DSL 5.0 Steady Two unnamed tribs converge along Kitchens Lane

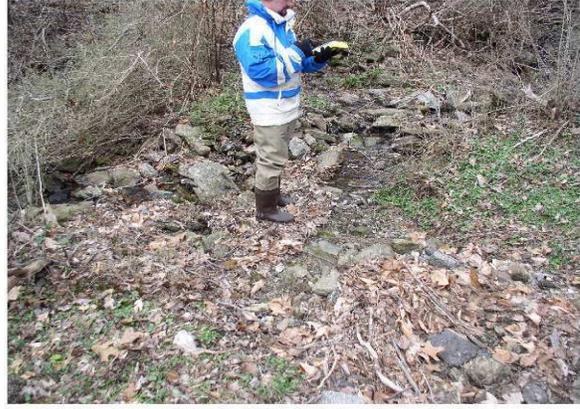
Infrastructure ID: WScn163 Confluence

Condition **Location** **Width (ft)** **Flow** **Creeks**
Good DSL 5.0 None Two unnamed tribs converge along Kitchens Lane

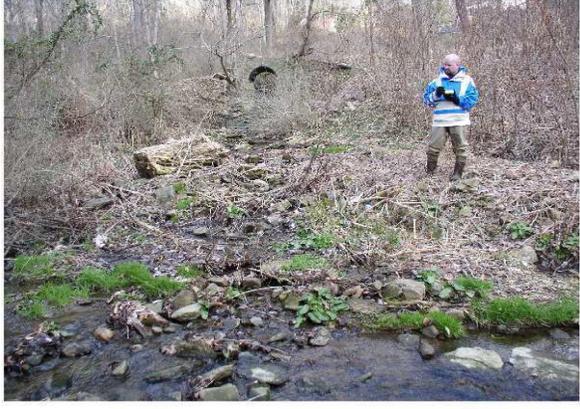
Infrastructure ID: WScn162 Confluence

Condition **Location** **Width (ft)** **Flow** **Creeks**
Good DSL 5.0 Steady Unnamed trib to Kitchens Ln Run

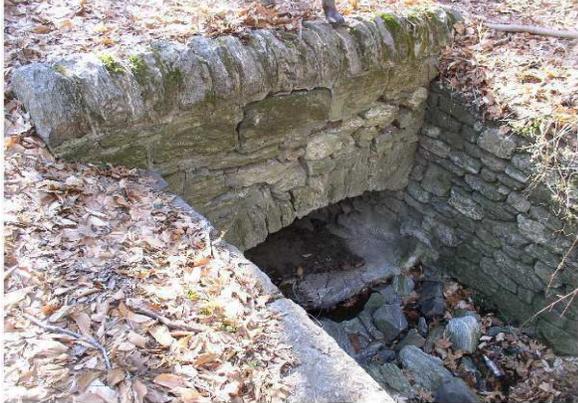
Infrastructure ID: WScul517 Culvert

Condition	Material	Dimension (ft)	Length (ft)	Location
Good	Stone	4.0 x 4.0	28.0	Next to Lincoln Dr, Philadelphia

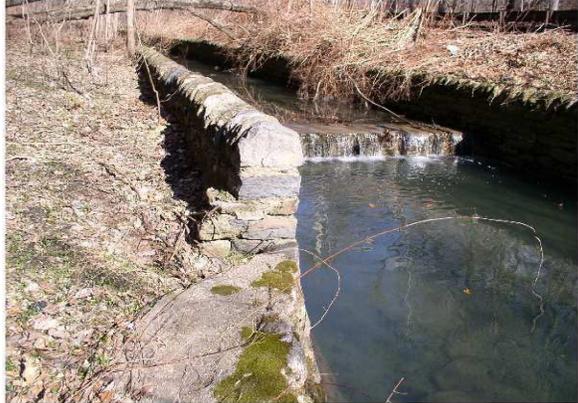
Infrastructure ID: WScha203 Channel

Condition	Material	Dimension (ft)	Length (ft)	Location
Good	Stone	6.0 x 2.0	483.0	DSR

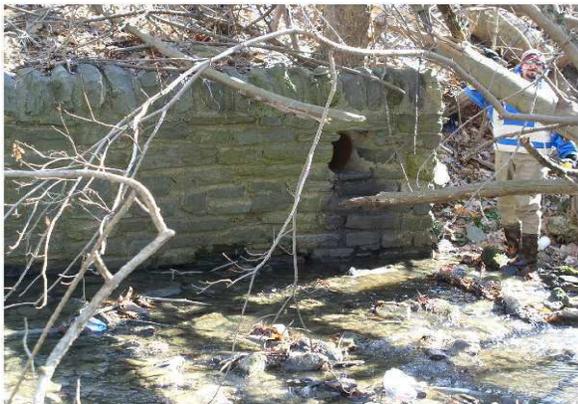
Infrastructure ID: WScha132 Channel

Condition	Material	Dimension (ft)	Length (ft)	Location
Good	Stone	4.0 x 2.0	569.0	DSL

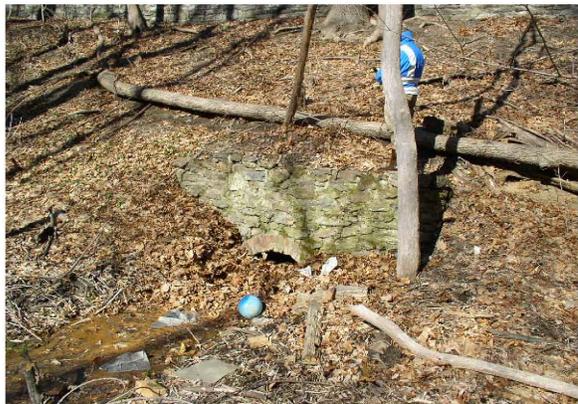
Infrastructure ID: WSout543 Outfall

Condition	Material	Location	Flow	Flow Appearance	Dimension (ft)
Good	Other	CROSS	Steady	Clear	2.0

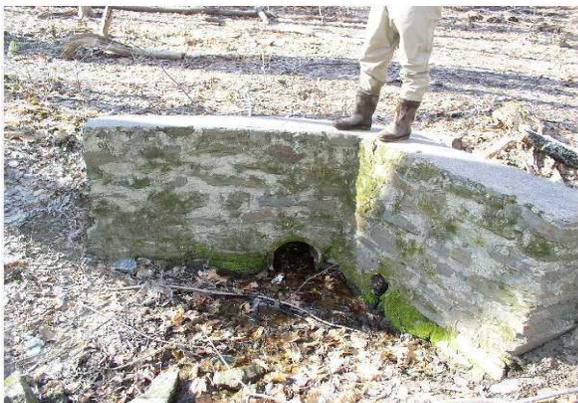
Infrastructure ID: WSout544 Outfall

Condition	Material	Location	Flow	Flow Appearance	Dimension (ft)
Good	ClayTerra	CROSS	Steady	Clear	1.0

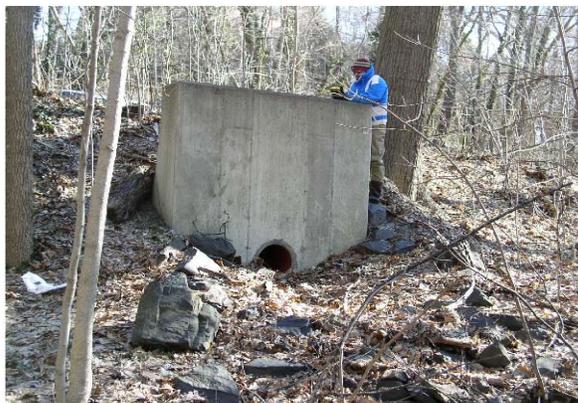
Infrastructure ID: WSout545 Outfall

Condition	Material	Location	Flow	Flow Appearance	Dimension (ft)
Good	ClayTerra	DSL	None		1.333

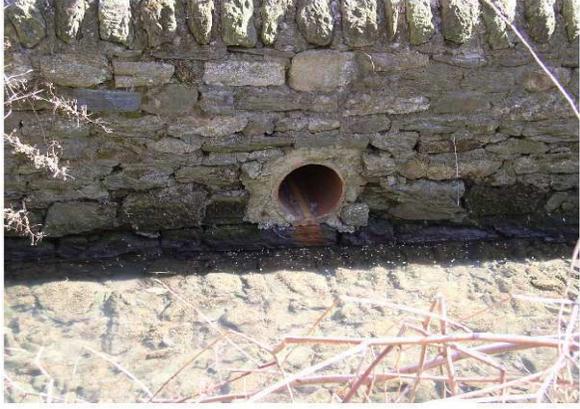
Infrastructure ID: WSout546 Outfall

Condition	Material	Location	Flow	Flow Appearance	Dimension (ft)
Good	Clay/Terra	DSL	None		1.5

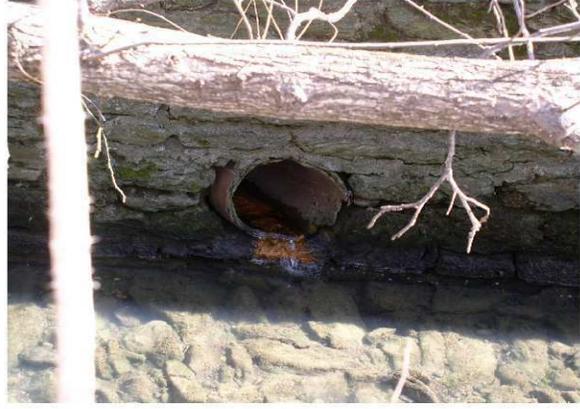
Infrastructure ID: WSout547 Outfall

Condition	Material	Location	Flow	Flow Appearance	Dimension (ft)
Good	Clay/Terra	DSL	Steady	Clear	1.0

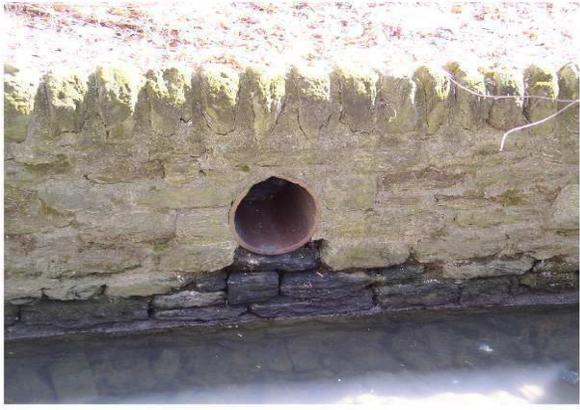
Infrastructure ID: WSout548 Outfall

Condition	Material	Location	Flow	Flow Appearance	Dimension (ft)
Good	Clay/Terra	DSL	None		1.0

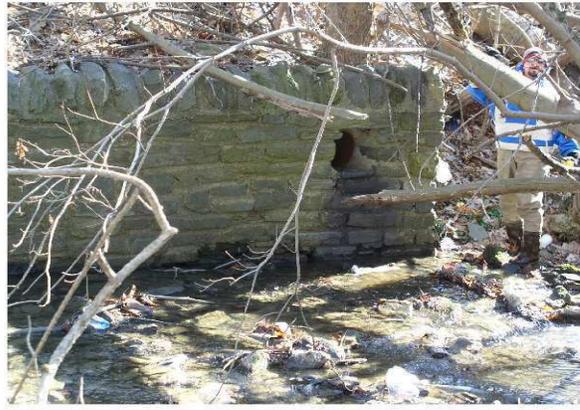
Infrastructure ID: WSout549 Outfall

Condition	Material	Location	Flow	Flow Appearance	Dimension (ft)
Good	Clay/Terra	DSL	None		1.0

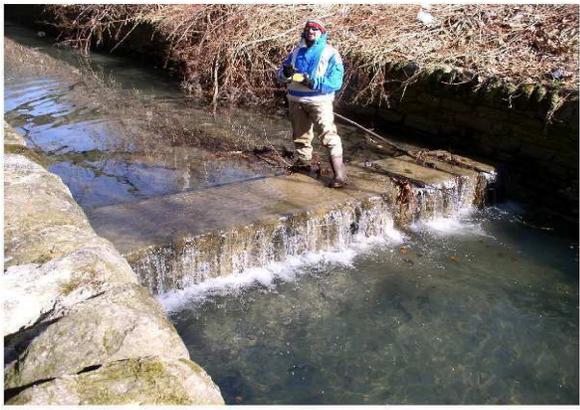
Infrastructure ID: WSDam108 Dam

Condition	Material	Width (ft)	Length (ft)	Height Exposed (ft)
Good	Concrete	2.5	15.0	2.0

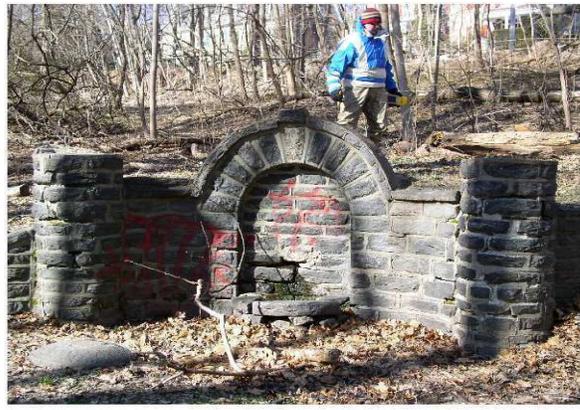
Infrastructure ID: WSmisc081 Other

Notes
springhead

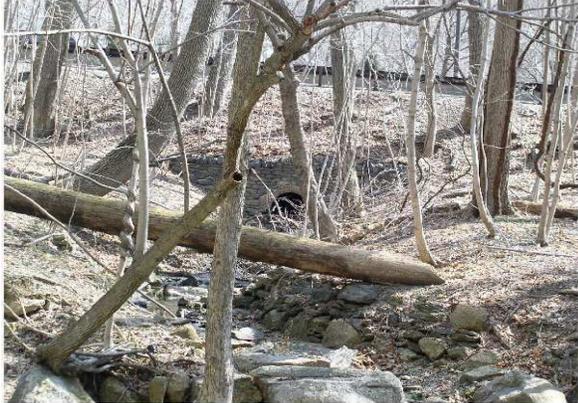
Infrastructure ID: WScul519 Culvert

Condition	Material	Dimension (ft)	Length (ft)	Location
Good	Brick	4.0	115.0	Under Lincoln Dr at Saylor's Grove

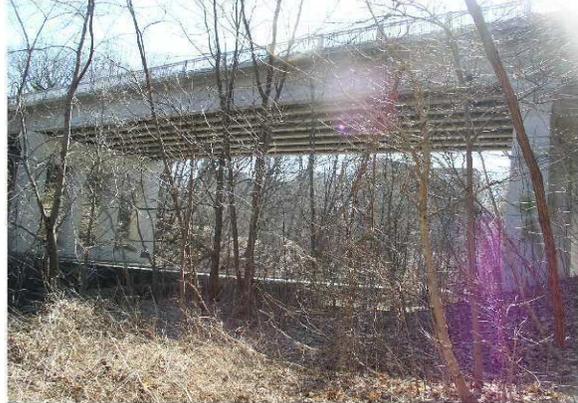
Infrastructure ID: WSbri242 Bridge

Condition	Material	Dimension (ft)	Length (ft)	Location
Good	Concrete	50.0 x 150.0	75.0	Walnut Ln over Lincoln Dr

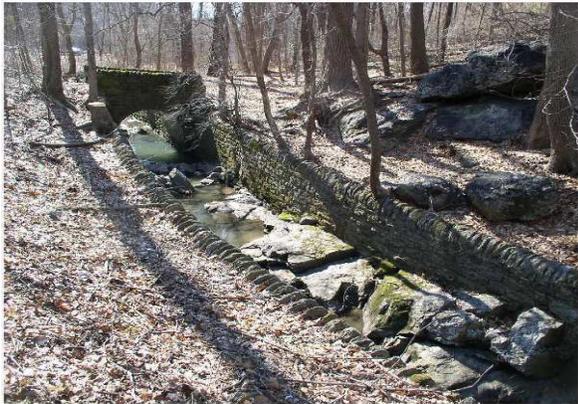
Infrastructure ID: WSbri245 Bridge

Condition	Material	Dimension (ft)	Length (ft)	Location
Good	Stone	12.0 x 15.0	30.0	Wissahickon Ave at Lincoln Dr

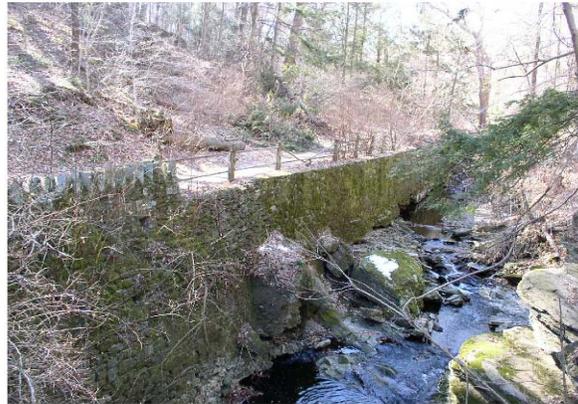
Infrastructure ID: WScha205 Channel

Condition	Material	Dimension (ft)	Length (ft)	Location
Good	Stone	14.0 x 2.0	572.0	DSL

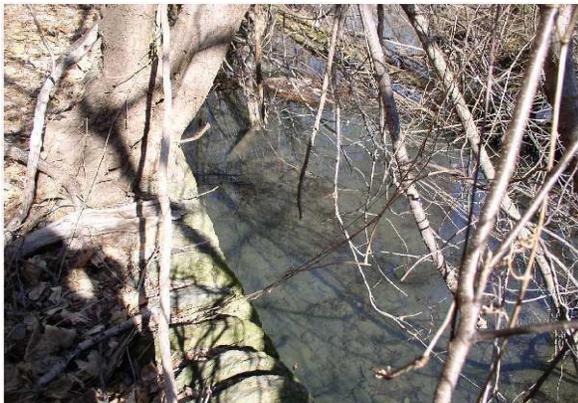
Infrastructure ID: WScha133 Channel

Condition	Material	Dimension (ft)	Length (ft)	Location
Good	Stone	8.0 x 2.0	565.0	DSR

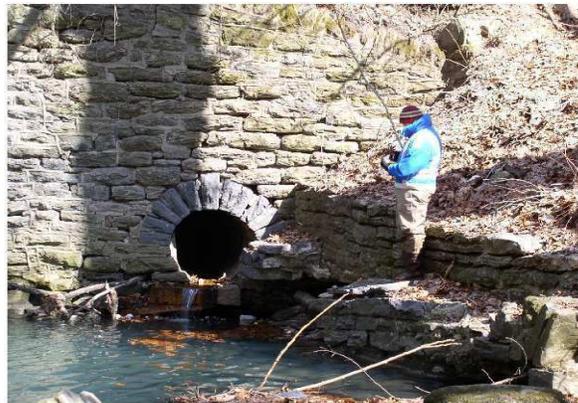
Infrastructure ID: WSout565 Outfall

Condition	Material	Location	Flow	Flow Appearance	Dimension (ft)
Good	Stone	DSL	Steady	Clear	2.5
