APPENDIX B
INFRASTRUCTURE PHOTOS

Reach WSTM02 Infrastructure Photos

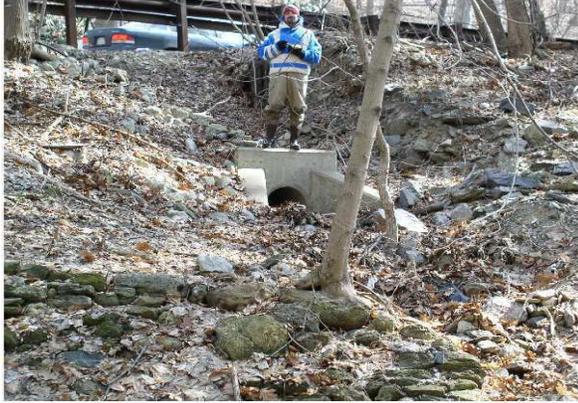
Infrastructure ID: WSout564 Outfall

Condition	Material	Location	Flow	Flow Appearance	Dimension (ft)
Good	Concrete	DSL		None	1.333

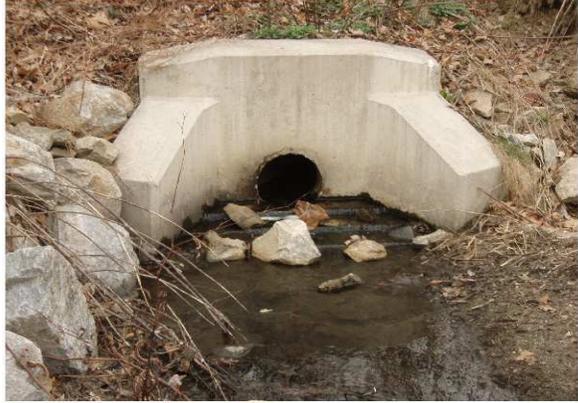
Infrastructure ID: WSout731 Outfall

Condition	Material	Location	Flow	Flow Appearance	Dimension (ft)
Good	Concrete	MID			2.0

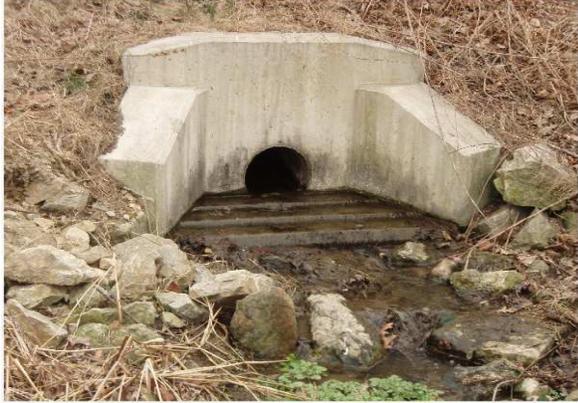
Infrastructure ID: WSout732 Outfall

Condition	Material	Location	Flow	Flow Appearance	Dimension (ft)
Good	Concrete	DSL			2.0

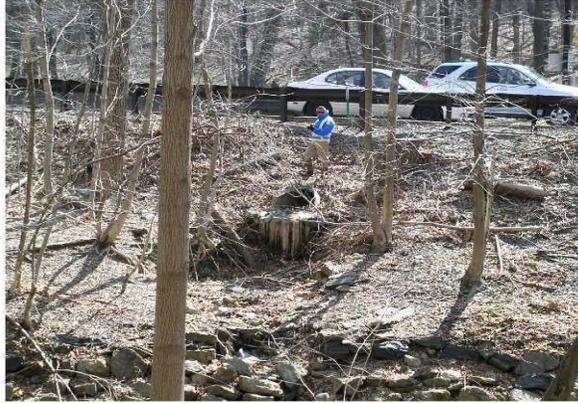
Infrastructure ID: WSout562 Outfall

Condition	Material	Location	Flow	Flow Appearance	Dimension (ft)
Good	Concrete	DSL		None	2.0

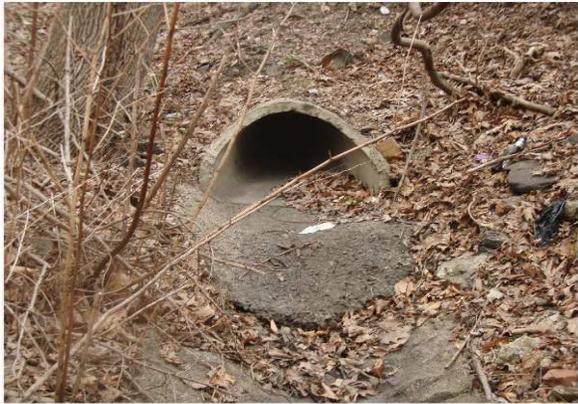
Infrastructure ID: WSout561 Outfall

Condition	Material	Location	Flow	Flow Appearance	Dimension (ft)
Good	Concrete	DSL		None	2.0

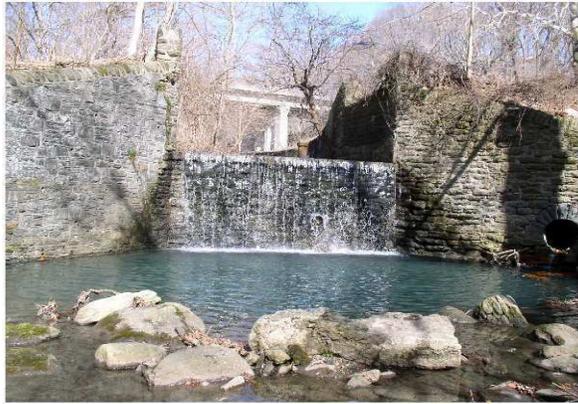
Infrastructure ID: WSDam110 Dam

Condition	Material	Width (ft)	Length (ft)	Height Exposed (ft)
Good	Stone	8.0	30.0	10.0

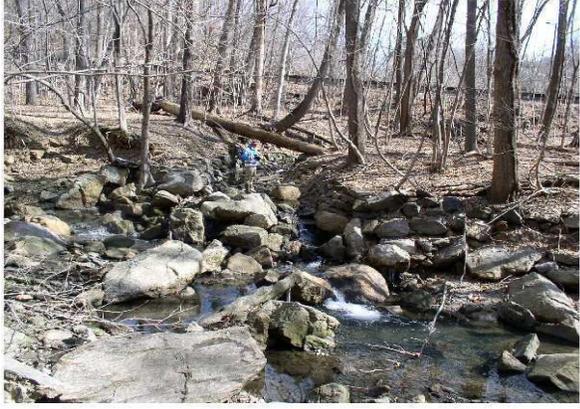
Infrastructure ID: WScn173 Confluence

Condition	Location	Width (ft)	Flow	Creeks
Good	DSL	15.0	Steady

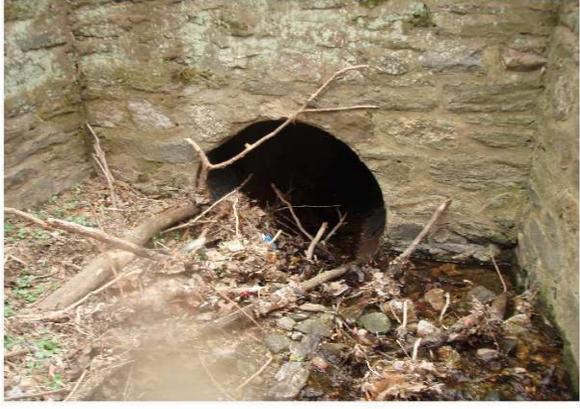
Infrastructure ID: WScul574 Culvert

Condition	Material	Dimension (ft)	Length (ft)	Location
Good	Corr-Metal	4.0	122.8	Under VR13, across from Lincoln Dr near Saylor's Grove

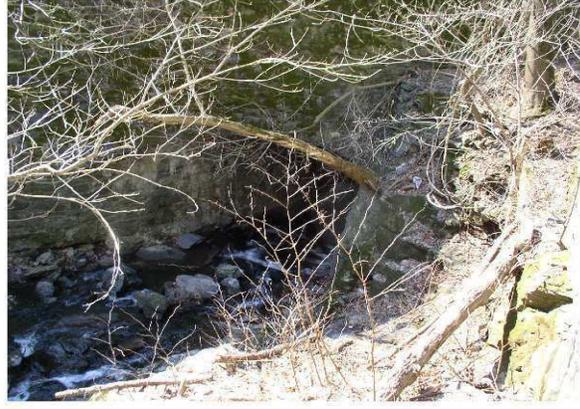
Infrastructure ID: WScul521 Culvert

Condition	Material	Dimension (ft)	Length (ft)	Location
Good	Stone	5.0 x 8.0	69.0	Under Wissahickon Ave where the Monoshone meets the Main Stem

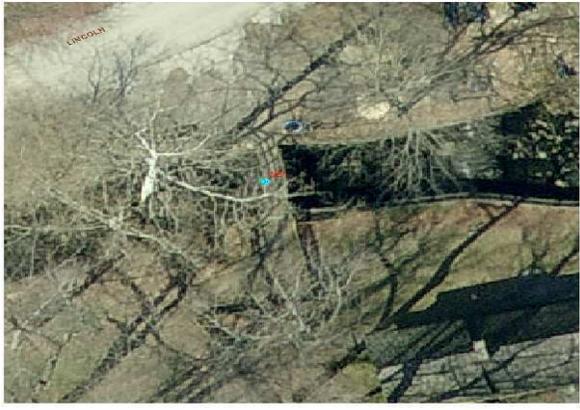
Infrastructure ID: WSbri527 Bridge

Condition	Material	Dimension (ft)	Length (ft)	Location
Good	Wood	10.0 x 17.0	5.0

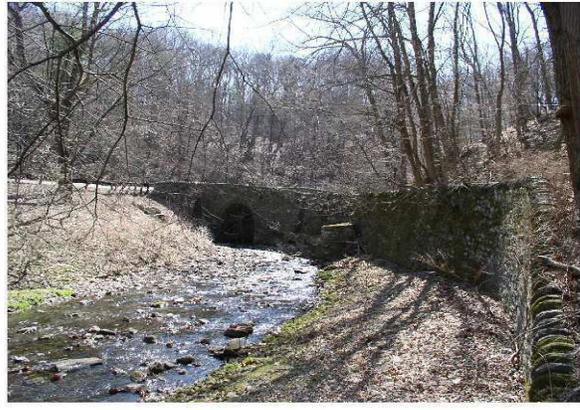
Infrastructure ID: WSbri244 Bridge

Condition	Material	Dimension (ft)	Length (ft)	Location
Good	Stone	15.0 x 10.0	25.0	Lincoln Dr

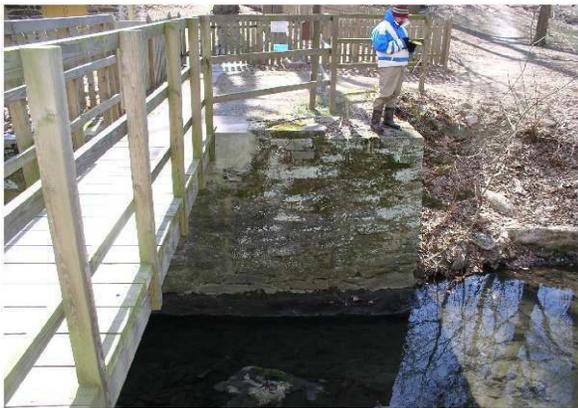
Infrastructure ID: WScha140 Channel

Condition	Material	Dimension (ft)	Length (ft)	Location
Good	Stone	8.0 x 3.0	357.0	DSL

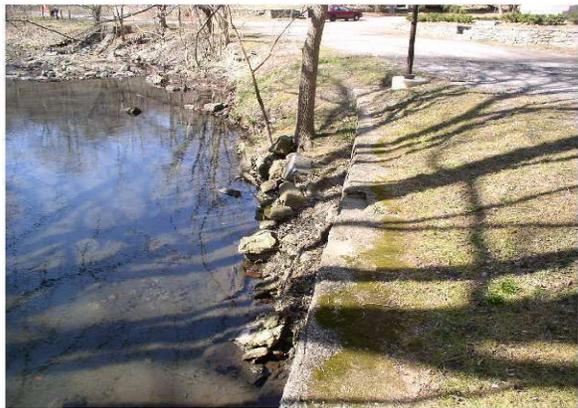
Infrastructure ID: WScha139 Channel

Condition	Material	Dimension (ft)	Length (ft)	Location
Good	Stone	8.0 x 2.0	362.0	DSR

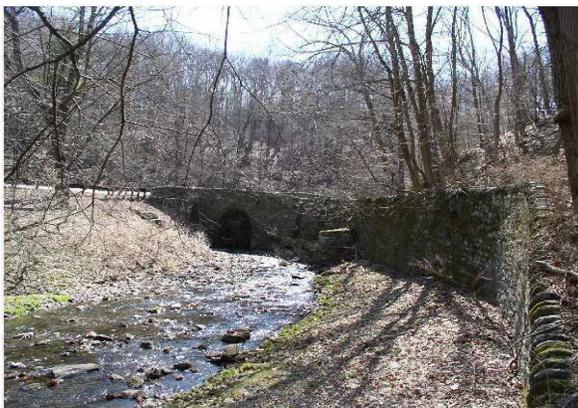
Infrastructure ID: WScha137 Channel

Condition	Material	Dimension (ft)	Length (ft)	Location
Good	Stone	14.0 x 3.0	72.0	DSL

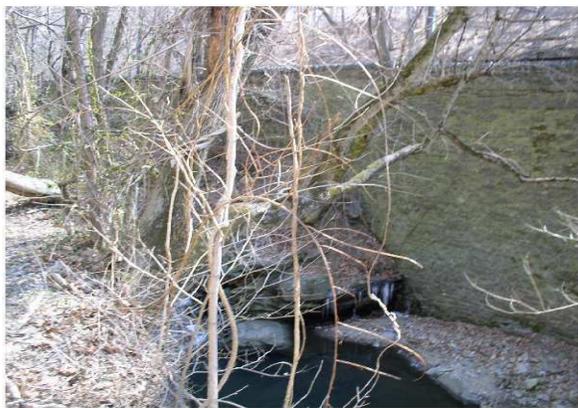
Infrastructure ID: WScha135 Channel

Condition	Material	Dimension (ft)	Length (ft)	Location
Good	Stone	20.0 x 2.0	668.0	DSL

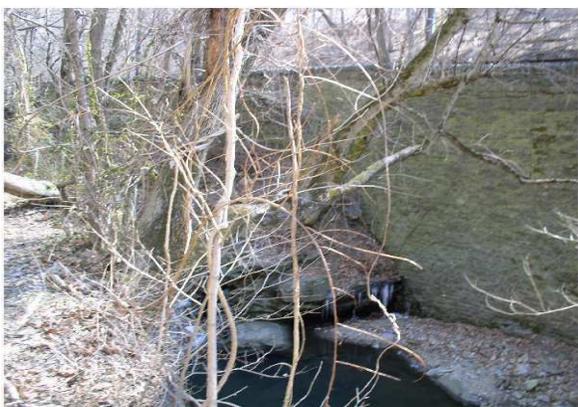
Infrastructure ID: WScha136 Channel

Condition	Material	Dimension (ft)	Length (ft)	Location
Good	Stone	20.0 x 2.0	544.0	DSR

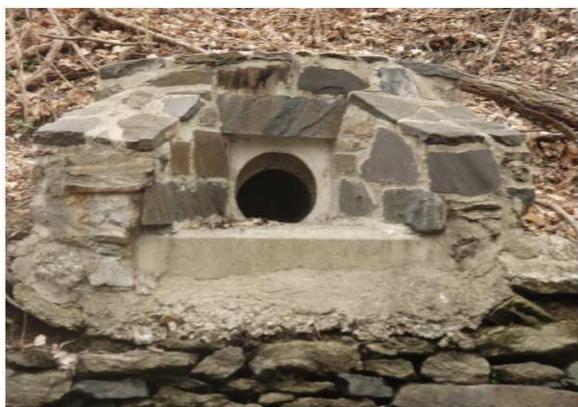
Infrastructure ID: WSout560 Outfall

Condition	Material	Location	Flow	Flow Appearance	Dimension (ft)
Good	Concrete	DSR	None		1.0

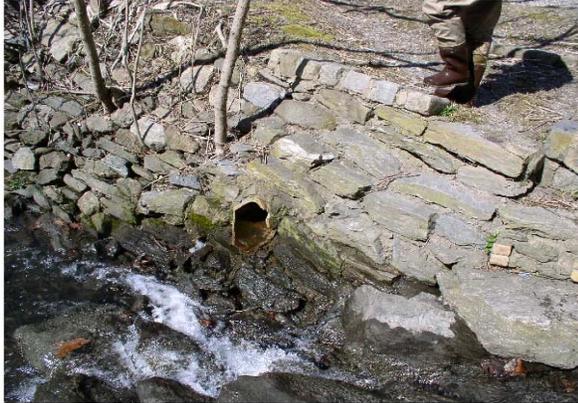
Infrastructure ID: WSout559 Outfall

Condition	Material	Location	Flow	Flow Appearance	Dimension (ft)
Good	Clay/Terra	DSR	None		0.633

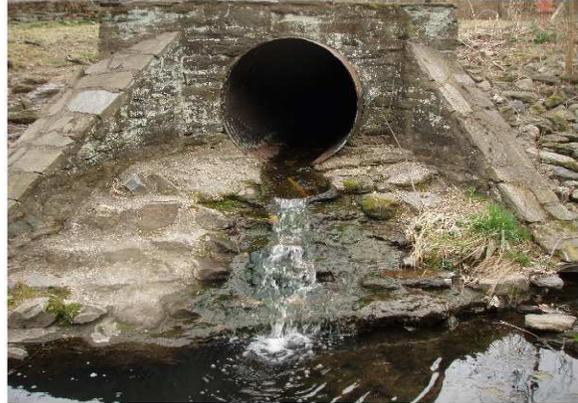
Infrastructure ID: WSout558 Outfall

Condition	Material	Location	Flow	Flow Appearance	Dimension (ft)
Good	CorrMetal	DSR	Steady	Clear	3.0

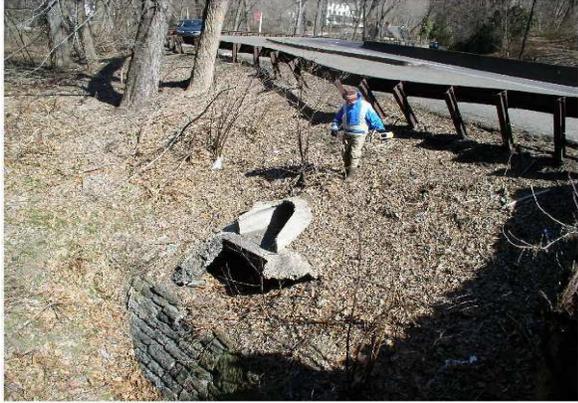
Infrastructure ID: WSout557 Outfall

Condition	Material	Location	Flow	Flow Appearance	Dimension (ft)
Good	Concrete	DSL	None		2.5

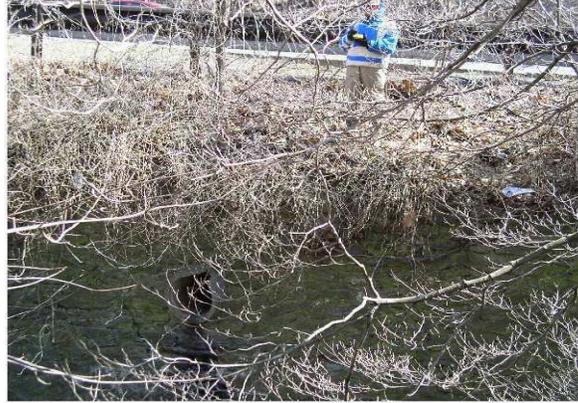
Infrastructure ID: WSout555 Outfall

Condition	Material	Location	Flow	Flow Appearance	Dimension (ft)
Good	Concrete	DSL	Trickle	Clear	2.0

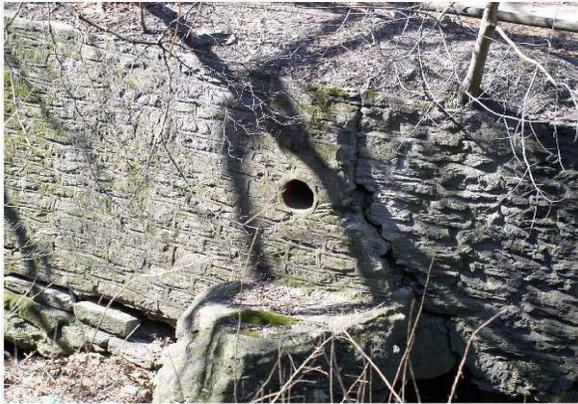
Infrastructure ID: WSout556 Outfall

Condition	Material	Location	Flow	Flow Appearance	Dimension (ft)
Good	Clay/Terra	DSR	None		1.0

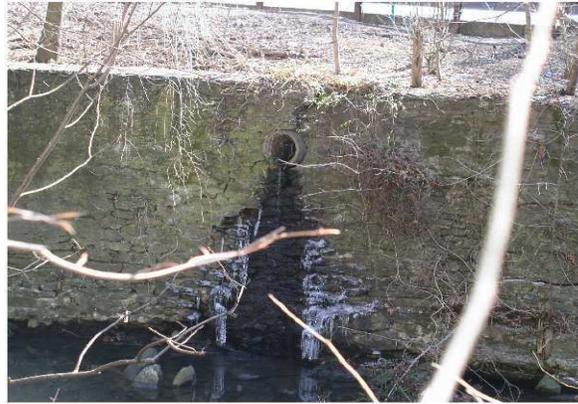
Infrastructure ID: WSout554 Outfall

Condition	Material	Location	Flow	Flow Appearance	Dimension (ft)
Good	Concrete	DSL	Steady	Clear	2.0

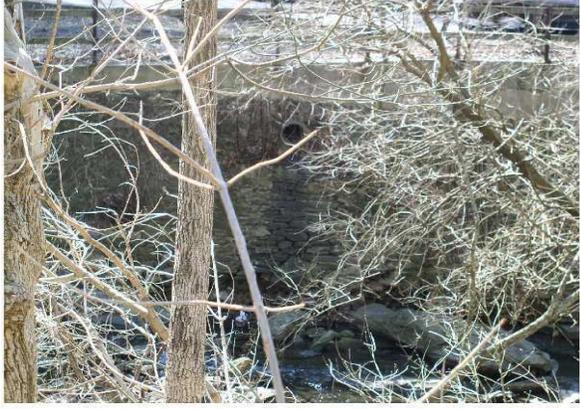
Infrastructure ID: WSout553 Outfall

Condition	Material	Location	Flow	Flow Appearance	Dimension (ft)
Good	Concrete	DSL	None		2.0

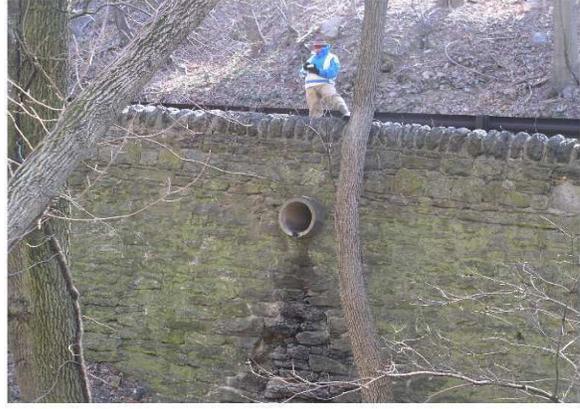
Infrastructure ID: WSout552 Outfall

Condition	Material	Location	Flow	Flow Appearance	Dimension (ft)
Good	Concrete	DSL	None		2.0

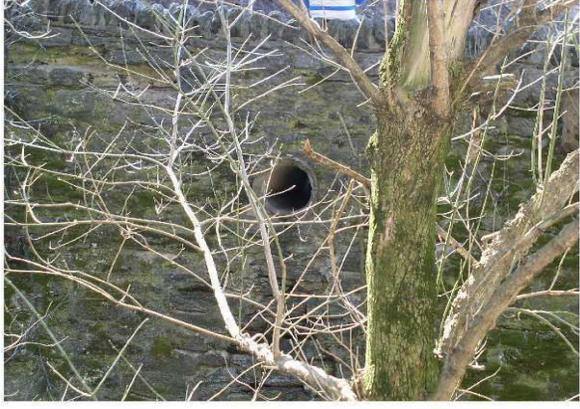
Infrastructure ID: WSout551 Outfall

Condition	Material	Location	Flow	Flow Appearance	Dimension (ft)
Good	Concrete	DSL	None		2.0

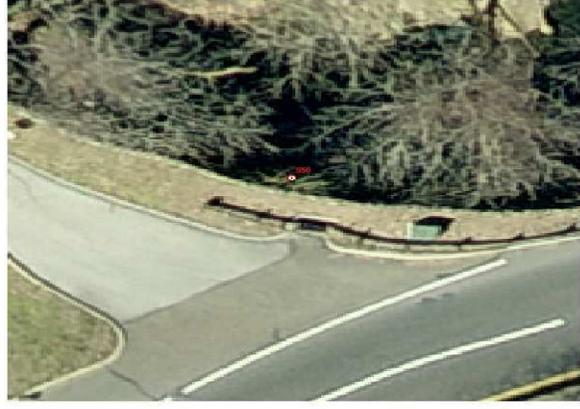
Infrastructure ID: WSout550 Outfall

Condition	Material	Location	Flow	Flow Appearance	Dimension (ft)
Good	Concrete	DSL	None		1.5

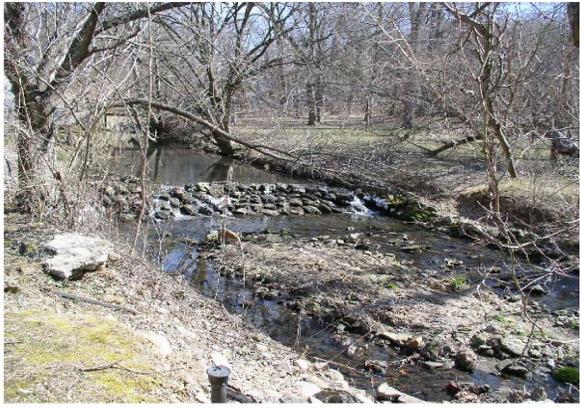
Infrastructure ID: WSdam109 Dam

Condition	Material	Width (ft)	Length (ft)	Height Exposed (ft)
Good	Stone	3.0	30.0	3.0

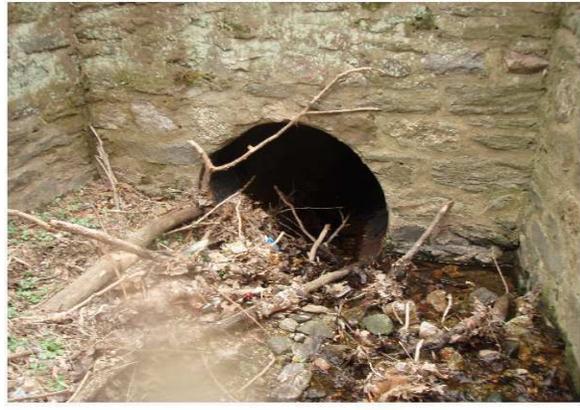
Infrastructure ID: WScon246 Confluence

Condition	Location	Width (ft)	Flow	Creeks
Good	DSR	4.0		Unnamed trib to Monoshone Creek

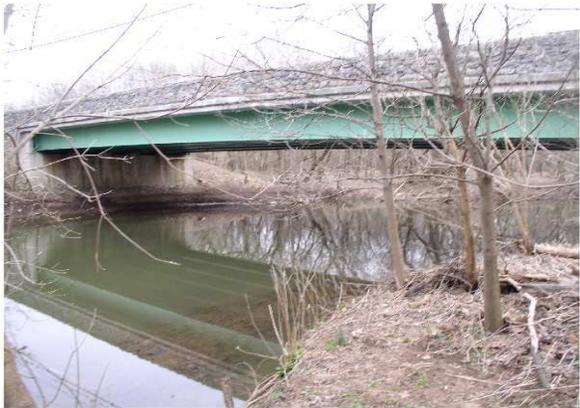
Infrastructure ID: WSbri256 Bridge

Condition	Material	Dimension (ft)	Length (ft)	Location
Good	Steel/Conc	40.0 x 100.0	50.0	Northwestern Ave

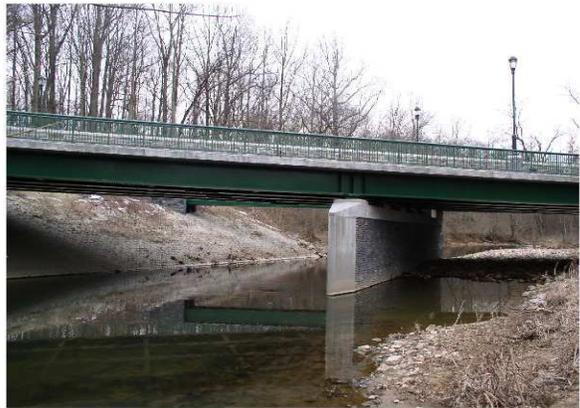
Infrastructure ID: WSbri258 Bridge

Condition	Material	Dimension (ft)	Length (ft)	Location
Good	Steel/Conc	30.0 x 100.0	50.0	Germantown Ave near Marston St

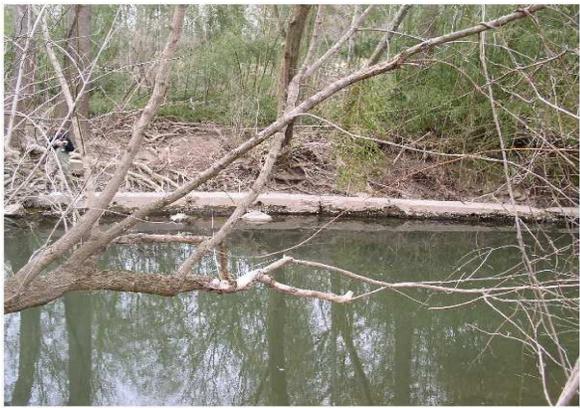
Infrastructure ID: WScha143 Channel

Condition	Material	Dimension (ft)	Length (ft)	Location
Poor	Concrete		54.0	DSL

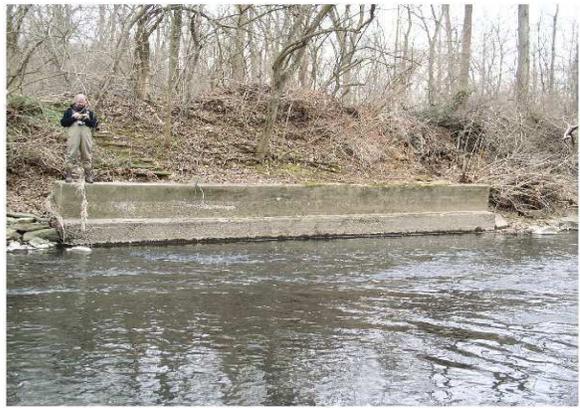
Infrastructure ID: WScha144 Channel

Condition	Material	Dimension (ft)	Length (ft)	Location
Fair	Concrete		25.0	DSL

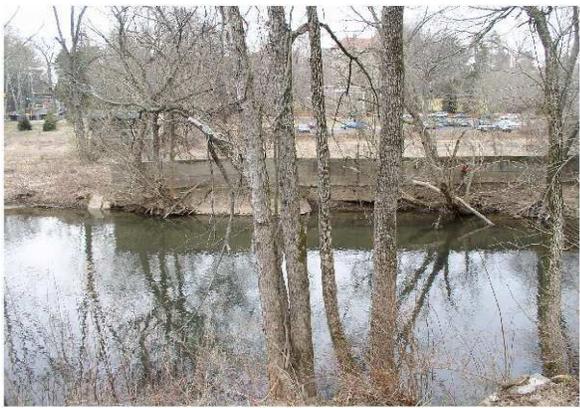
Infrastructure ID: WScha145 Channel

Condition	Material	Dimension (ft)	Length (ft)	Location
Poor	Concrete		63.5	DSR

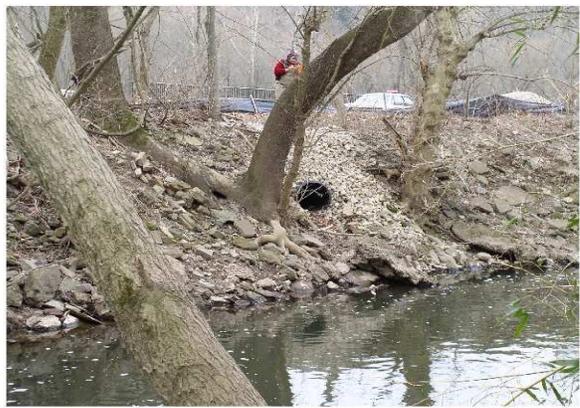
Infrastructure ID: WSout580 Outfall

Condition	Material	Location	Flow	Flow Appearance	Dimension (ft)
Good	Plastic	DSR	None		2.0

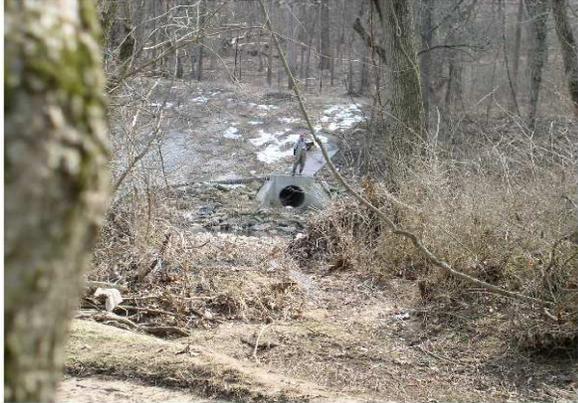
Infrastructure ID: WSout583 Outfall

Condition	Material	Location	Flow	Flow Appearance	Dimension (ft)
Good	Concrete	DSL		None	3.0

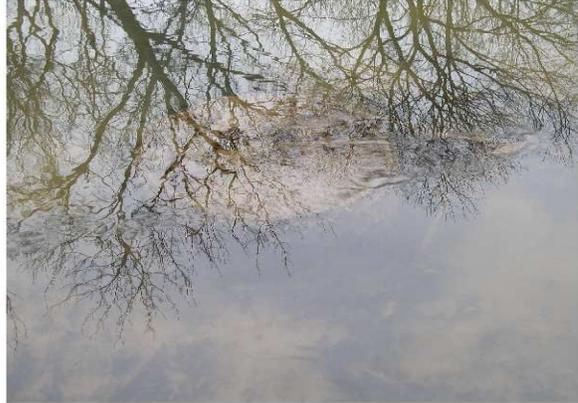
Infrastructure ID: WSman039 Manhole

Condition	Location	Height Exposed (ft)
Good	DSL	1.0

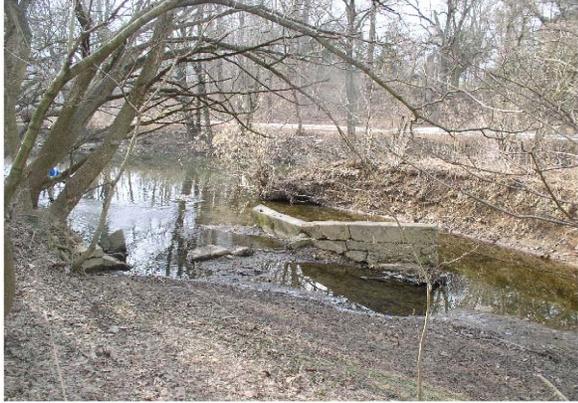
Infrastructure ID: WScon170 Confluence

Condition	Location	Width (ft)	Flow	Creeks
Good	DSL	50.0	Steady	Paper Mill Run into Wissahickon Creek

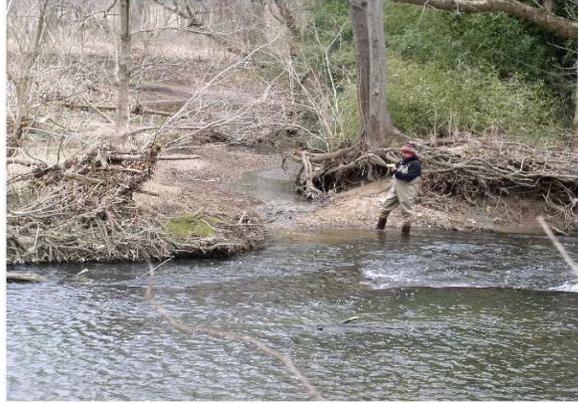
Infrastructure ID: WScon179 Confluence

Condition	Location	Width (ft)	Flow	Creeks
Good	DSL	8.0	Steady	Unnamed trib to Wissahickon Creek

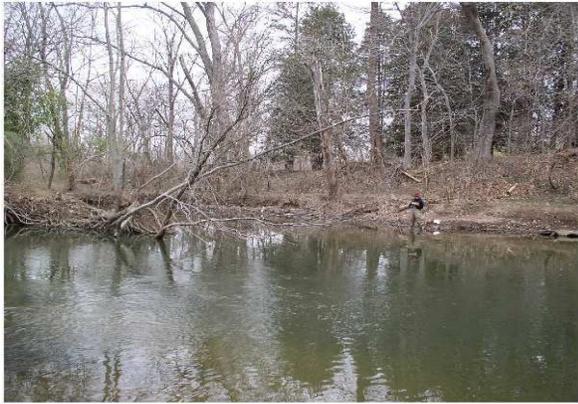
Infrastructure ID: WScon180 Confluence

Condition	Location	Width (ft)	Flow	Creeks
Good	DSL	30.0	Steady	Unnamed trib to Wissahickon Creek

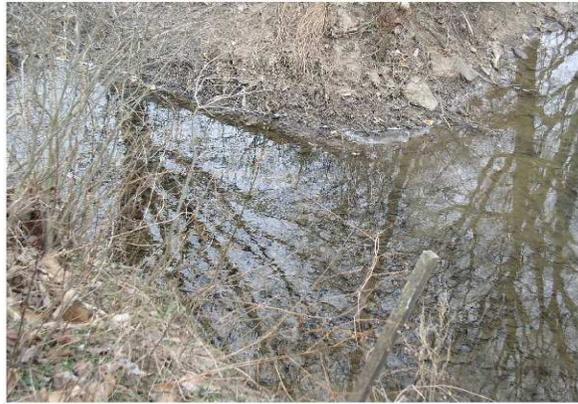
Infrastructure ID: WScon169 Confluence

Condition	Location	Width (ft)	Flow	Creeks
Good	DSL	10.0	Steady	Hill Crest Run into Wissahickon Creek

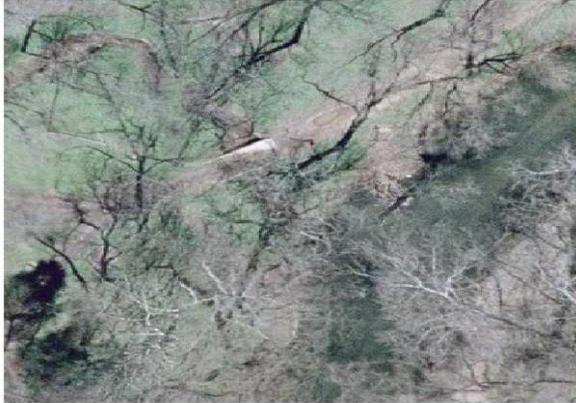
Infrastructure ID: WScon244 Confluence

Condition: Fair Location: DSR Width (ft): 11.0 Flow: Creeks Creeks: Unnamed trib to Wissahickon Creek

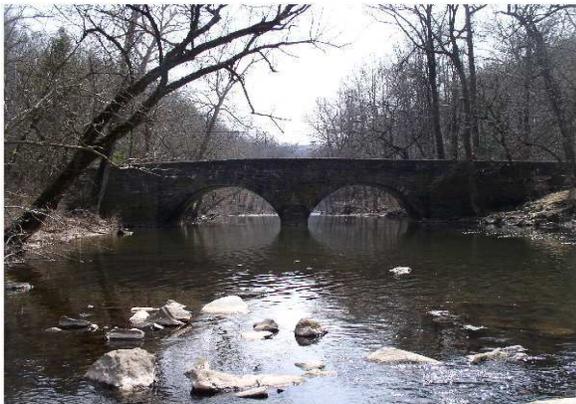
Infrastructure ID: WSbri257 Bridge

Condition: Good Material: Stone Dimension (ft): 30.0 x 100.0 Length (ft): 50.0 Location: Bells Mill Rd

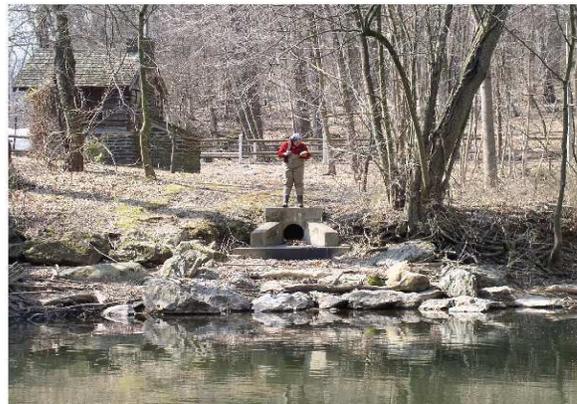
Infrastructure ID: WSout581 Outfall

Condition: Good Material: Concrete Location: DSR Flow: None Flow Appearance: None Dimension (ft): 1.5

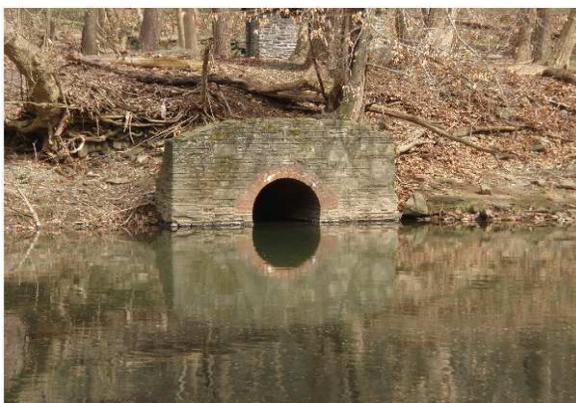
Infrastructure ID: WSout586 Outfall

Condition: Good Material: Clay/Terra Location: DSL Flow: Steady Flow Appearance: Clear Dimension (ft): 3.0

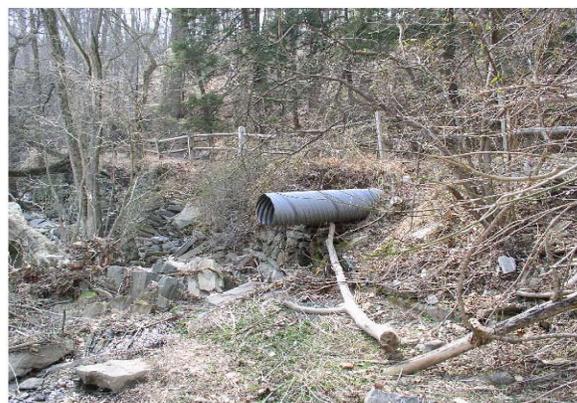
Infrastructure ID: WSout582 Outfall

Condition: Good Material: CorrMetal Location: DSR Flow: Steady Flow Appearance: Clear Dimension (ft): 1.5

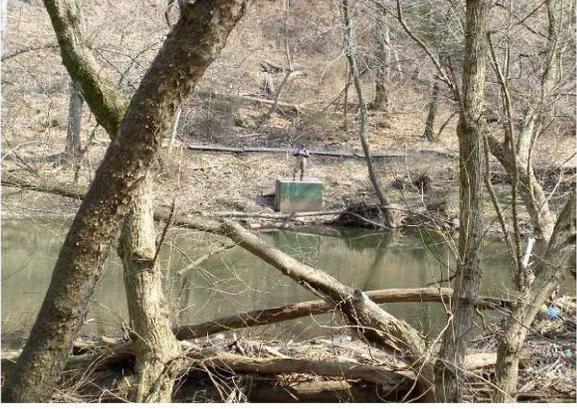
Infrastructure ID: WSmisc082 Other

Notes
4'w x 4'l x 4'h concrete box no markings

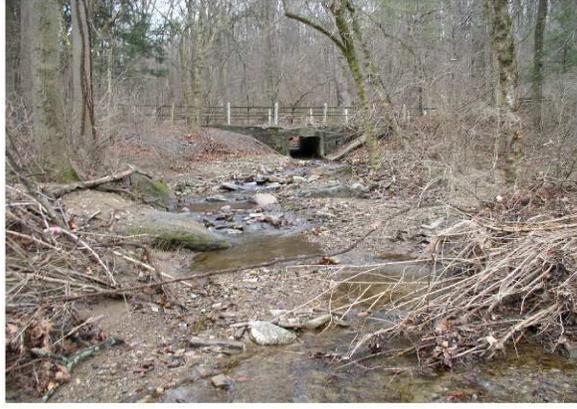
Infrastructure ID: WScn153 Confluence

Condition	Location	Width (ft)	Flow	Creeks
Good	DSR	12.0	Steady	Bells Mill into Wissahickon Creek

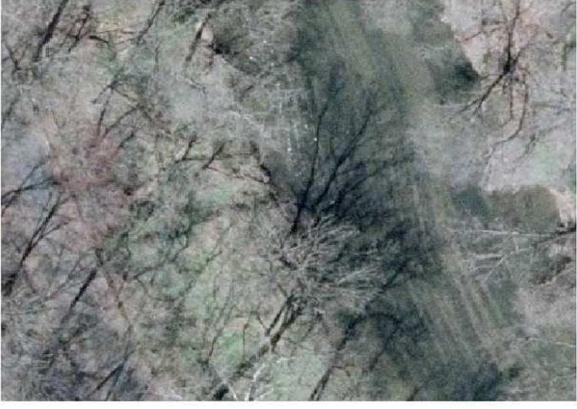
Infrastructure ID: WScn181 Confluence

Condition	Location	Width (ft)	Flow	Creeks
Fair	DSR	8.0	Trickle	Unnamed trib into Wissahickon Creek

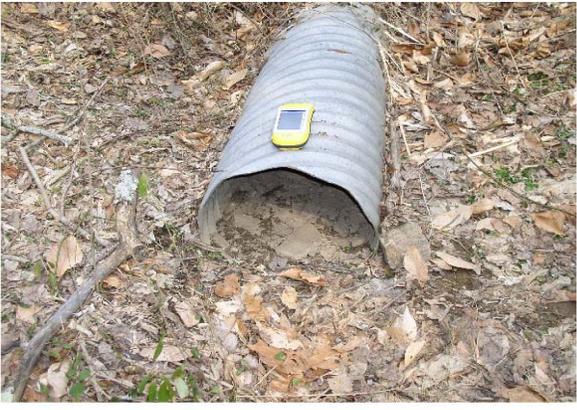
Infrastructure ID: WSout584 Outfall

Condition	Material	Location	Flow	Flow Appearance	Dimension (ft)
Good	CorrMetal	DSL	None		1.5

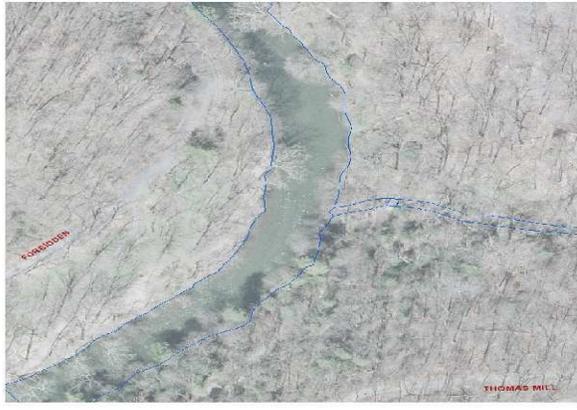
Infrastructure ID: WScn247 Confluence

Condition	Location	Width (ft)	Flow	Creeks
Good	DSL	12.0	Steady	Thomas Mill Run into Wissahickon Creek

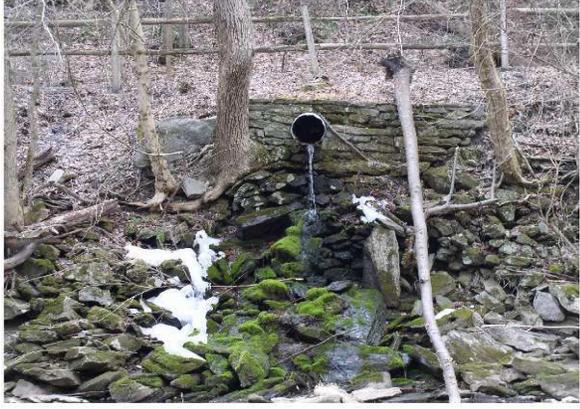
Infrastructure ID: WScul117 Culvert

Condition	Material	Dimension (ft)	Length (ft)	Location
Fair	CorrMetal	2.0	33.0	Under Wissahickon Dr just downstream of Thomas Mill Rd

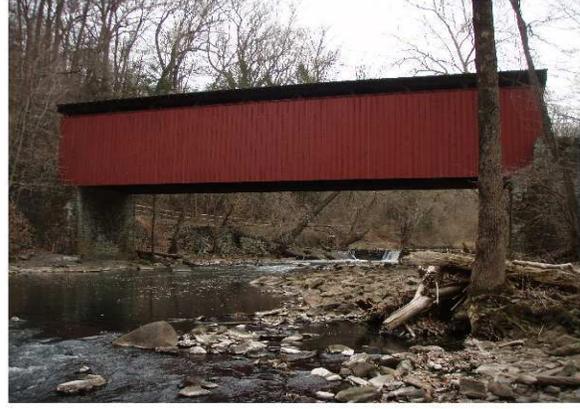
Infrastructure ID: WSbri259 Bridge

Condition	Material	Dimension (ft)	Length (ft)	Location
Good	Stone/Wood	25.0 x 100.0	20.0	Thomas Mill Rd

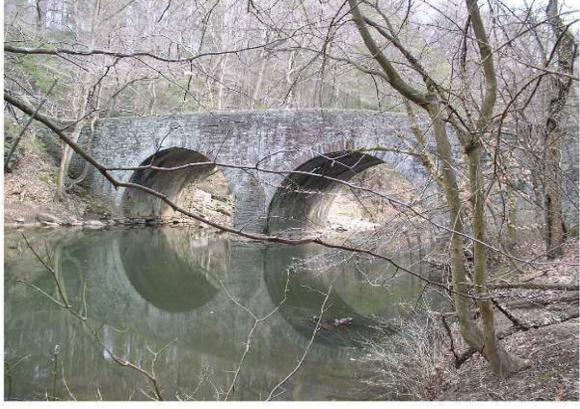
Infrastructure ID: WSbri260 Bridge

Condition	Material	Dimension (ft)	Length (ft)	Location
Good	Stone/Conc	20.0 x 25.0	30.0	Thomas Mill Rd

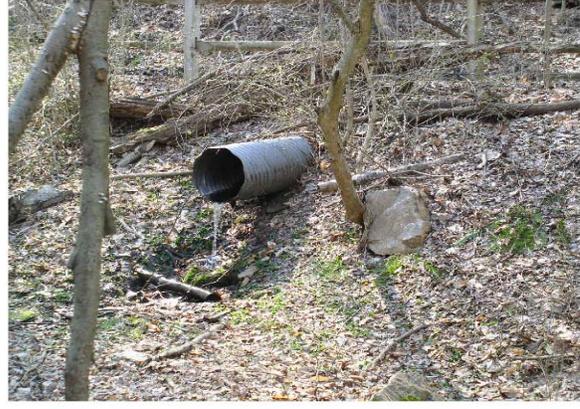
Infrastructure ID: WSout585 Outfall

Condition	Material	Location	Flow	Flow Appearance	Dimension (ft)
Good	CorrMetal	DSR	Steady	Clear	1.5

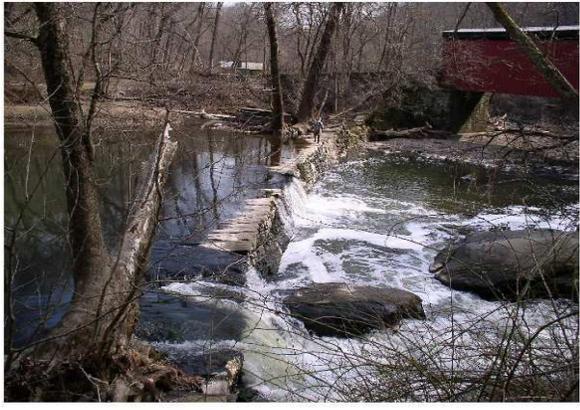
Infrastructure ID: WSdam119 Dam

Condition	Material	Width (ft)	Length (ft)	Height Exposed (ft)
Good	Stone	3.5	150.0	5.0

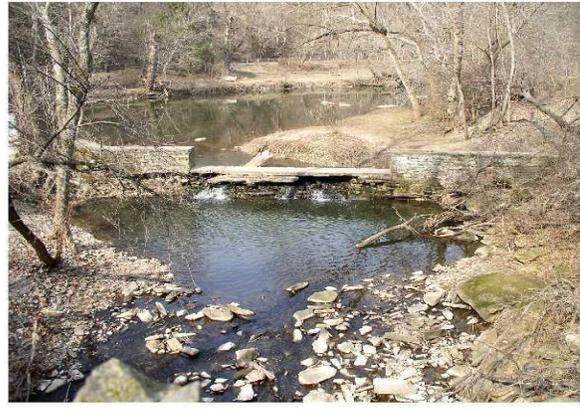
Infrastructure ID: WSdam117 Dam

Condition	Material	Width (ft)	Length (ft)	Height Exposed (ft)
Good	Stone	2.5	25.0	4.0

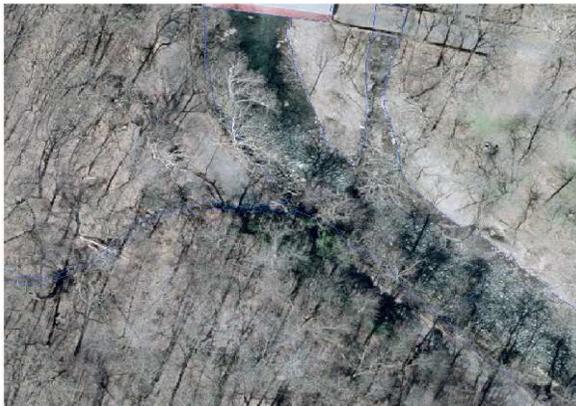
Infrastructure ID: WScn212 Confluence

Condition Location Width (ft) Flow Creeks
 Good DSR 10.0 Unnamed trib to Wissahickon Creek

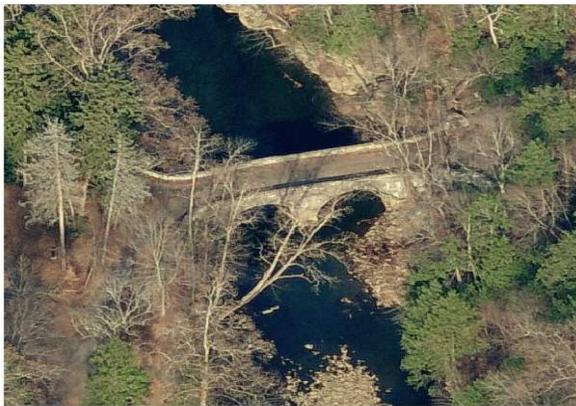
Infrastructure ID: WSbri262 Bridge

Condition Material Dimension (ft) Length (ft) Location
 Good Stone 30.0 x 50.0 30.0 Rex Ave at Wissahickon Dr

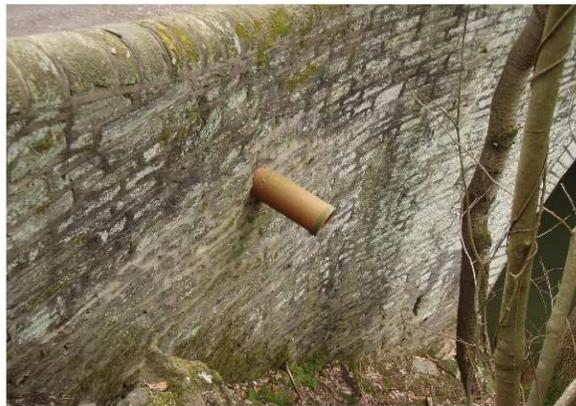
Infrastructure ID: WSout587 Outfall

Condition Material Location Flow Flow Appearance Dimension (ft)
 Good ClayTerra DSL None 1.0

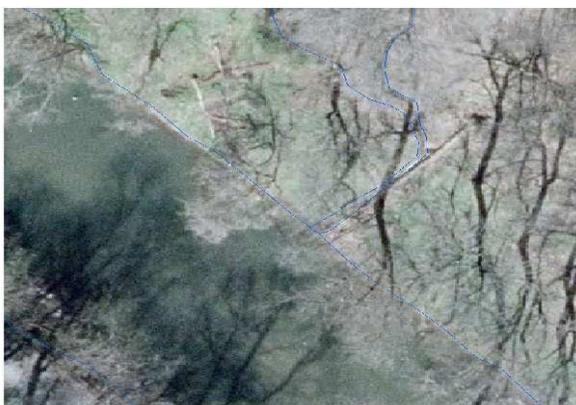
Infrastructure ID: WScn245 Confluence

Condition Location Width (ft) Flow Creeks
 Fair DSL 5.0 Unnamed trib to Wissahickon Creek

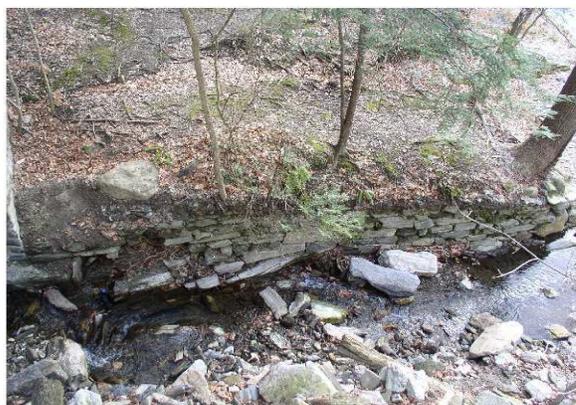
Infrastructure ID: WScn161 Confluence

Condition Location Width (ft) Flow Creeks
 Fair DSL 0.5 Rex Ave Run (Trib I) into Main Stem

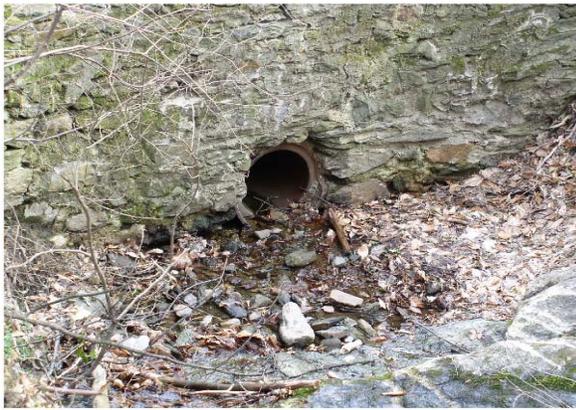
Infrastructure ID: WScul118 Culvert

Condition	Material	Dimension (ft)	Length (ft)	Location
Fair	TerraCotta	1.0	34.0	Wissahickon Dr

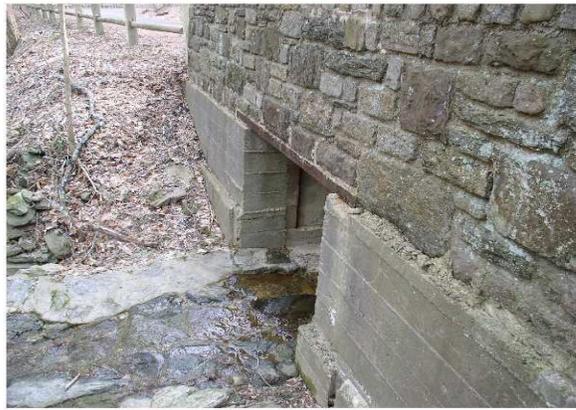
Infrastructure ID: WScul119 Culvert

Condition	Material	Dimension (ft)	Length (ft)	Location
Fair	Concrete	5.0 x 5.0	27.0	Wissahickon Dr Philadelphia

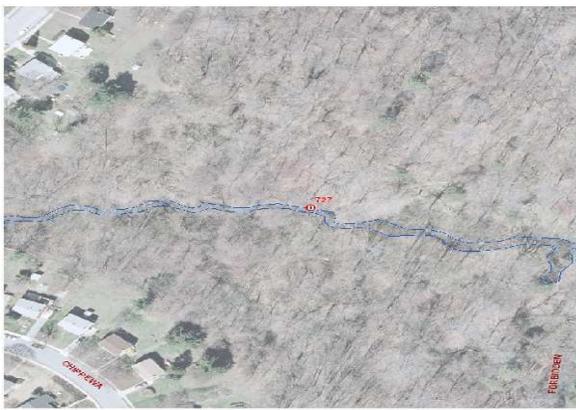
Infrastructure ID: WSout727 Outfall

Condition	Material	Location	Flow	Flow Appearance	Dimension (ft)
Fair	Concrete	DSR			2.0

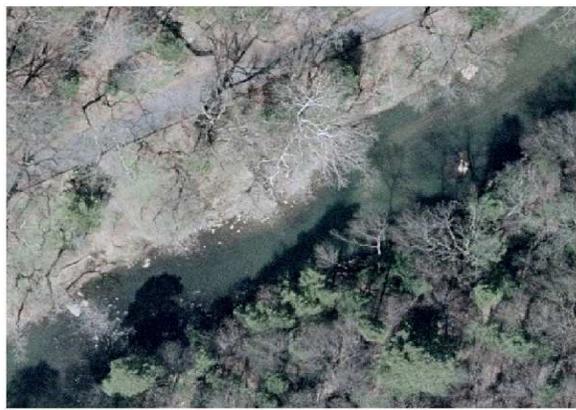
Infrastructure ID: WScon213 Confluence

Condition	Location	Width (ft)	Flow	Creeks
Good	DSR	5.0		Cathedral Run into Wissahickon Creek

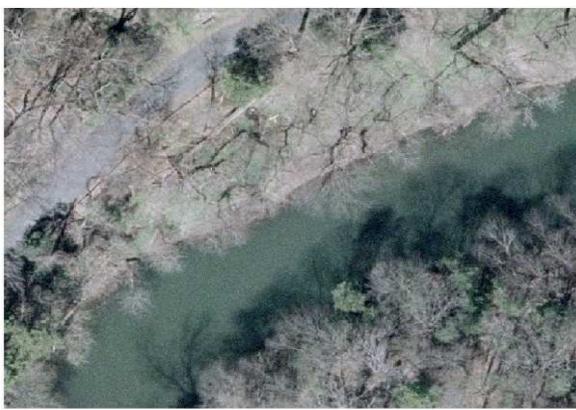
Infrastructure ID: WScon214 Confluence

Condition	Location	Width (ft)	Flow	Creeks
Good	DSR	4.0		Unnamed trib into Wissahickon Creek

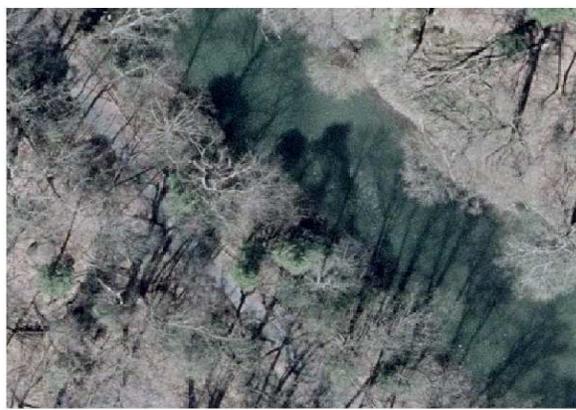
Infrastructure ID: WScon215 Confluence

Condition	Location	Width (ft)	Flow	Creeks
Good	DSR	5.0		Unnamed trib to Wissahickon Creek

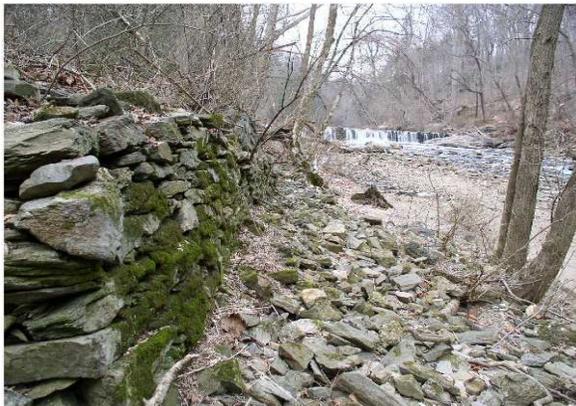
Infrastructure ID: WScha146 Channel

Condition	Material	Dimension (ft)	Length (ft)	Location
Poor	Stone		93.0	DSR

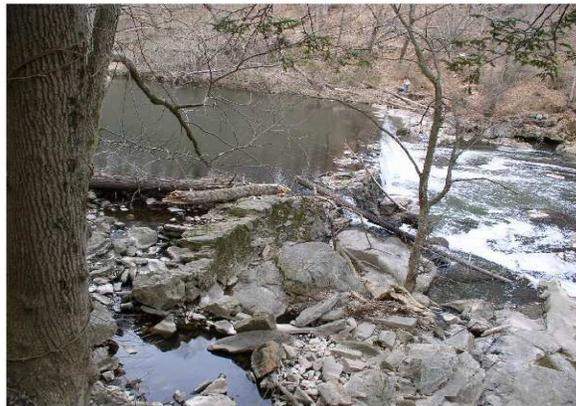
Infrastructure ID: WSdam118 Dam

Condition	Material	Width (ft)	Length (ft)	Height Exposed (ft)
Fair	Stone	3.0	75.0	6.0

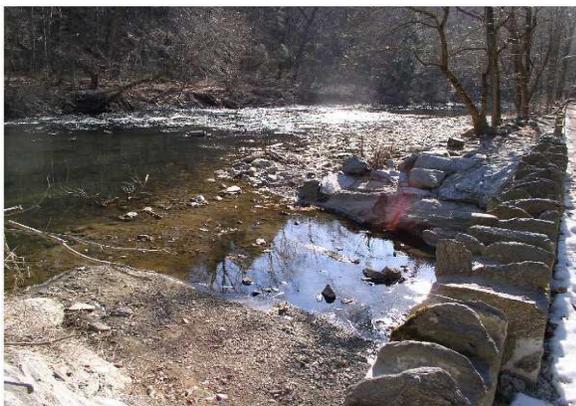
Infrastructure ID: WScon176 Confluence

Condition	Location	Width (ft)	Flow	Creeks
Good	DSR	25.0	Steady	Wises Mill Run into Wissahickon Creek

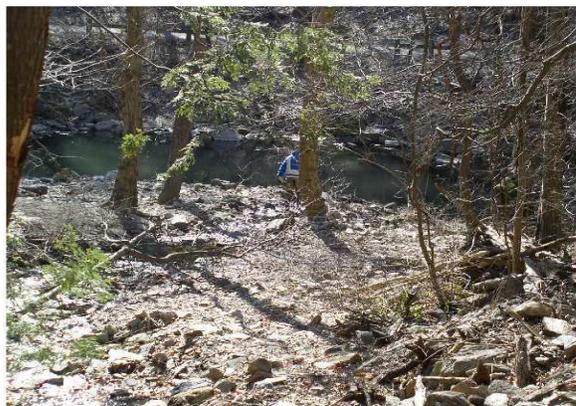
Infrastructure ID: WScon178 Confluence

Condition	Location	Width (ft)	Flow	Creeks
Good	DSL	15.0	Steady	Hartwell Run into Wissahickon Creek

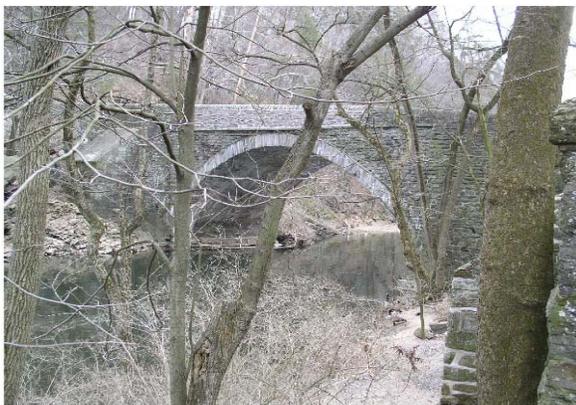
Infrastructure ID: WSbri261 Bridge

Condition	Material	Dimension (ft)	Length (ft)	Location
Good	Stone	75.0 x 75.0	50.0	Valley Green Rd

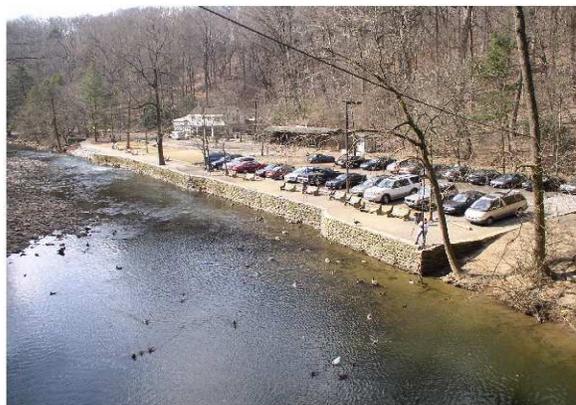
Infrastructure ID: WScha147 Channel

Condition	Material	Dimension (ft)	Length (ft)	Location
Good	Stone	8.0 x 2.0	405.0	DSR

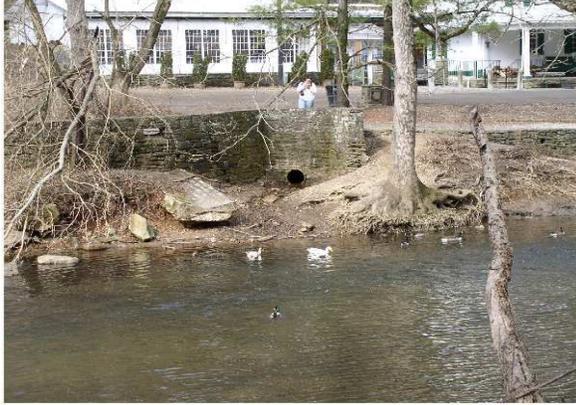
Infrastructure ID: WSout588 Outfall

Condition	Material	Location	Flow	Flow Appearance	Dimension (ft)
Fair	Clay/Terra	DSR	Steady	Clear	2.0

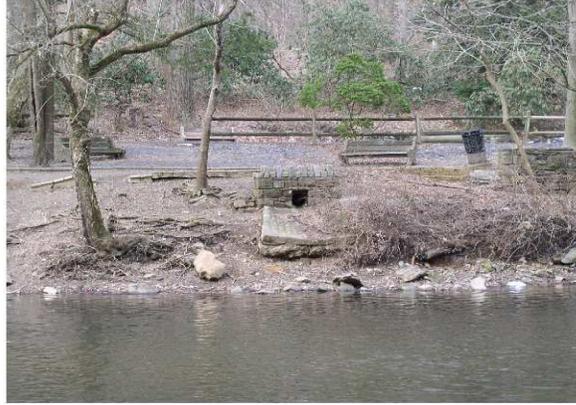
Infrastructure ID: WSout589 Outfall

Condition	Material	Location	Flow	Flow Appearance	Dimension (ft)
Good	Clay/Terra	DSR	None		1.5

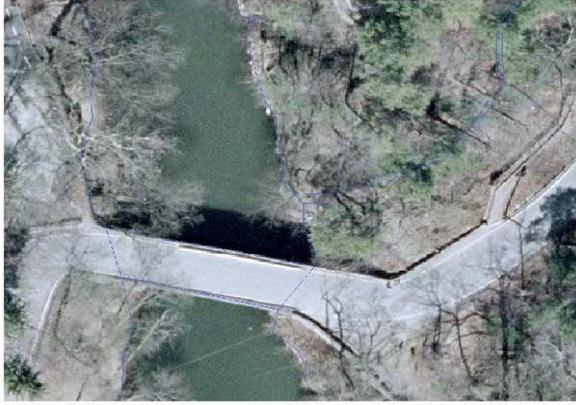
Infrastructure ID: WScon217 Confluence

Condition	Location	Width (ft)	Flow	Creeks
Good	DSL	5.0		Valley Green Run into Wissahickon Creek

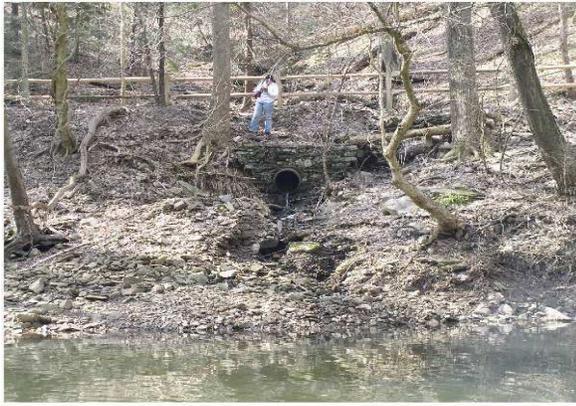
Infrastructure ID: WScul121 Culvert

Condition	Material	Dimension (ft)	Length (ft)	Location
Good	Iron	2.0	38.0	Under Wissahickon Dr in Fairmount Park

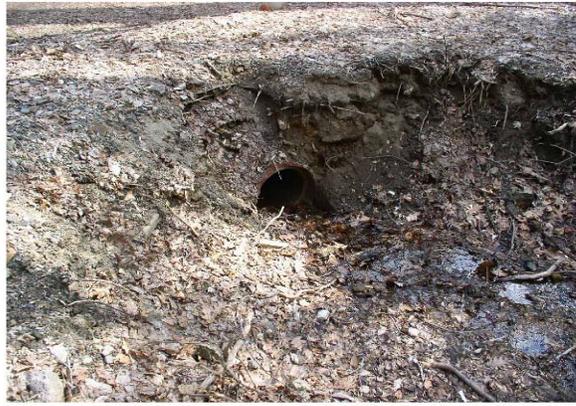
Infrastructure ID: WScul122 Culvert

Condition	Material	Dimension (ft)	Length (ft)	Location
Poor	Iron	1.0	40.0	Under Wissahickon Dr in Fairmount Park

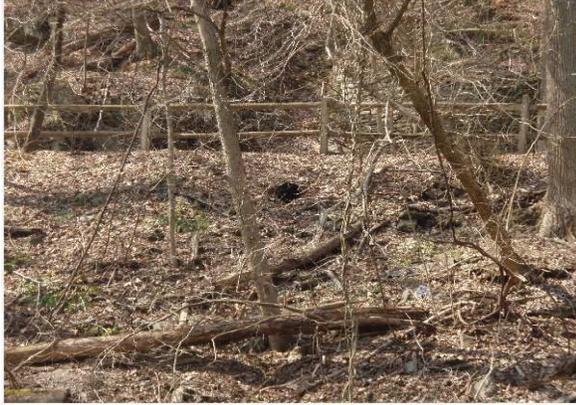
Infrastructure ID: WSout590 Outfall

Condition	Material	Location	Flow	Flow Appearance	Dimension (ft)
Good	CorrMetal	DSR	None		1.0

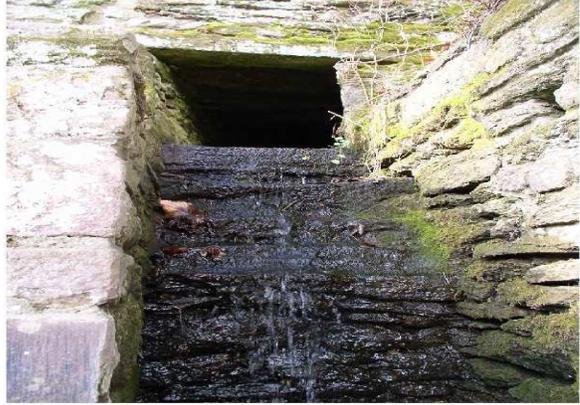
Infrastructure ID: WSout591 Outfall

Condition	Material	Location	Flow	Flow Appearance	Dimension (ft)
Good	Stone	DSR	Steady	Clear	3.0 x 3.0

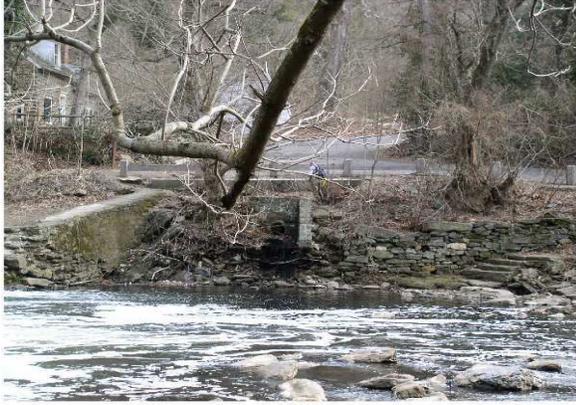
Infrastructure ID: WSout592 Outfall

Condition	Material	Location	Flow	Flow Appearance	Dimension (ft)
Good	Concrete	DSL	Steady	Clear	2.0

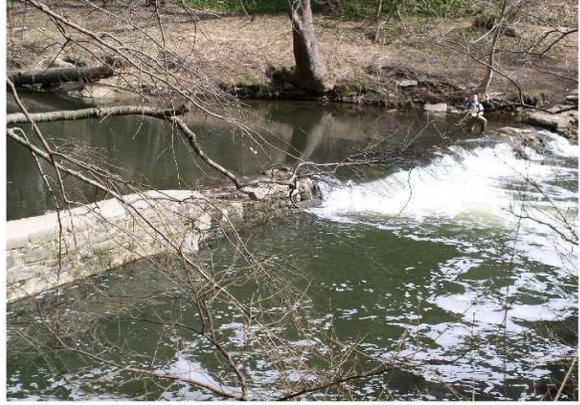
Infrastructure ID: WSDam120 Dam

Condition	Material	Width (ft)	Length (ft)	Height Exposed (ft)
Good	Stone	4.0	100.0	4.0

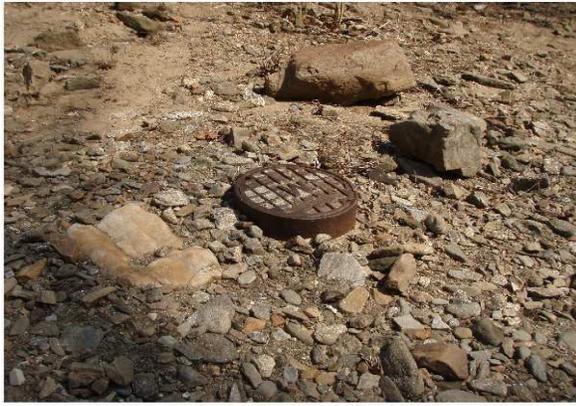
Infrastructure ID: WSman042 Manhole

Condition	Location	Height Exposed (ft)
Good	DSL	0.5

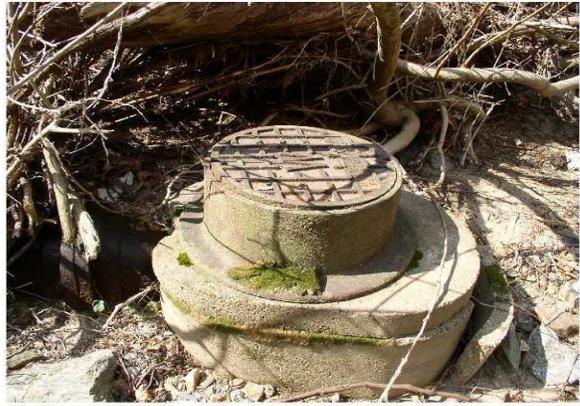
Infrastructure ID: WSman041 Manhole

Condition	Location	Height Exposed (ft)
Good	DSR	2.0
