APPENDIX B
INFRASTRUCTURE PHOTOS

Reach WSTM02 Infrastructure Photos

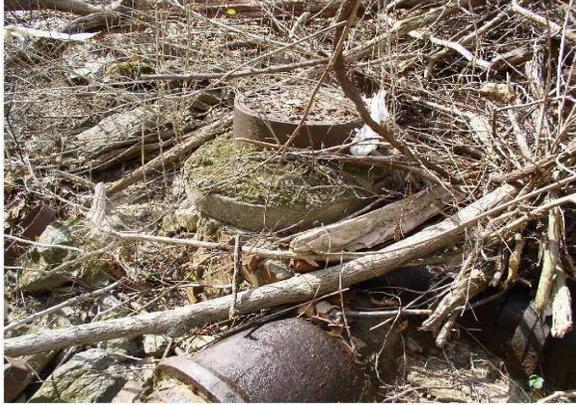
Infrastructure ID: WSman040 Manhole

Condition	Location	Height Exposed (ft)
Good	DSR	3.0

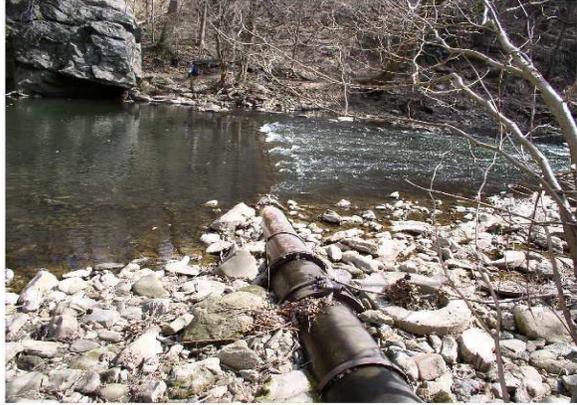
Infrastructure ID: WSpip004 PipeSewer

Condition	Material	Location	Diameter (ft)	Height Exposed (ft)	Length Exposed (ft)
Good	Iron	CROSS	2.0	0.5	50.0

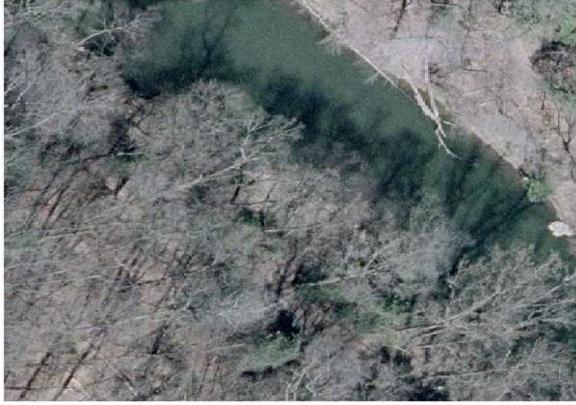
Infrastructure ID: WScon218 Confluence

Condition	Location	Width (ft)	Flow	Creeks
Fair	DSR	2.0		Unnamed trib to Wissahickon Creek

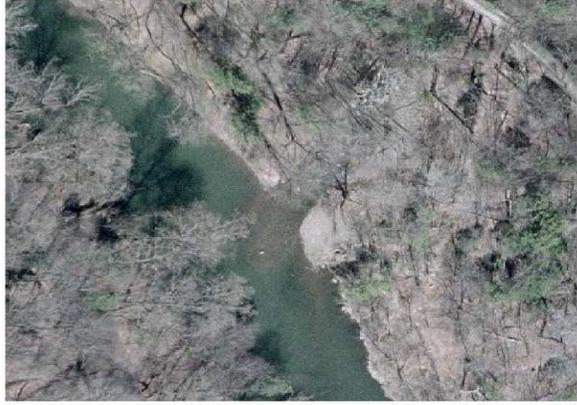
Infrastructure ID: WScon219 Confluence

Condition	Location	Width (ft)	Flow	Creeks
Good	DSL	27.0		Cresheim Creek into Wissahickon Creek

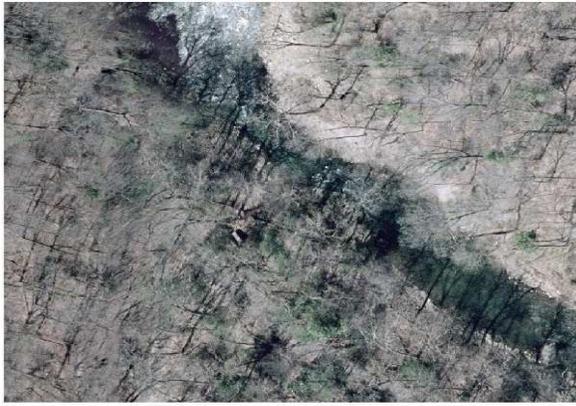
Infrastructure ID: WScon220 Confluence

Condition	Location	Width (ft)	Flow	Creeks
Fair	DSR	2.0		Unnamed trib to Wissahickon Creek

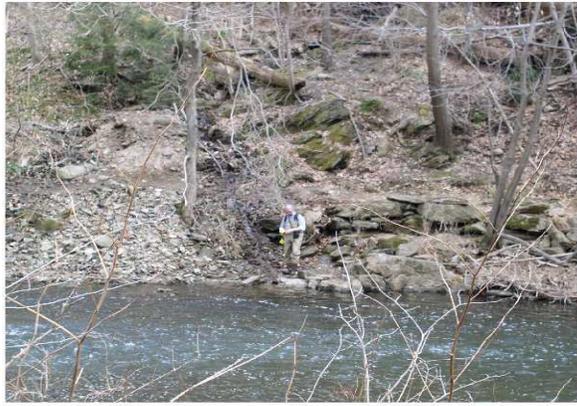
Infrastructure ID: WScon182 Confluence

Condition	Location	Width (ft)	Flow	Creeks
Good	DSL	5.0	Steady	Unnamed trib to Wissahickon Creek

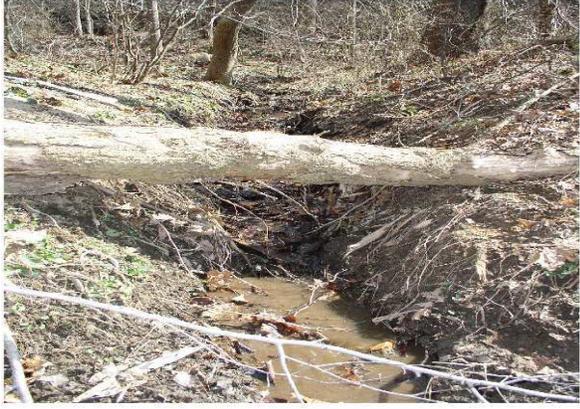
Infrastructure ID: WScon183 Confluence

Condition	Location	Width (ft)	Flow	Creeks
Good	DSL	5.0	Steady	Unnamed trib to Wissahickon Creek

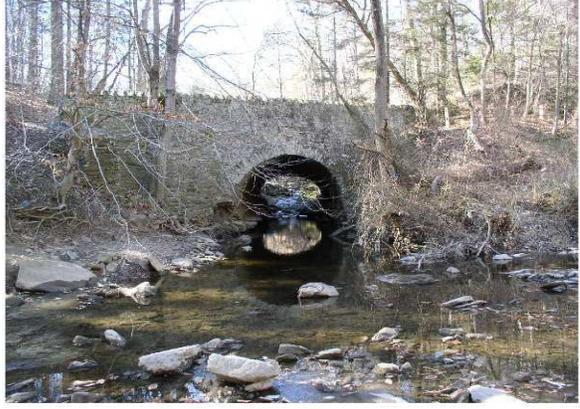
Infrastructure ID: WScon175 Confluence

Condition	Location	Width (ft)	Flow	Creeks
Good	DSR	15.0	Steady	Gorgas Run into Wissahickon Creek

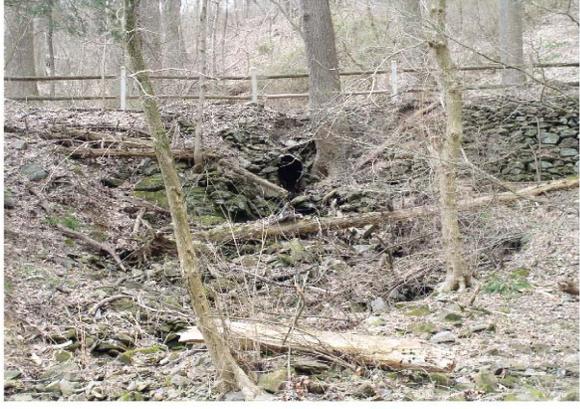
Infrastructure ID: WScul120 Culvert

Condition	Material	Dimension (ft)	Length (ft)	Location
Fair	CorrMetal	2.0	68.25	Under Wissahickon Dr in Fairmount Park

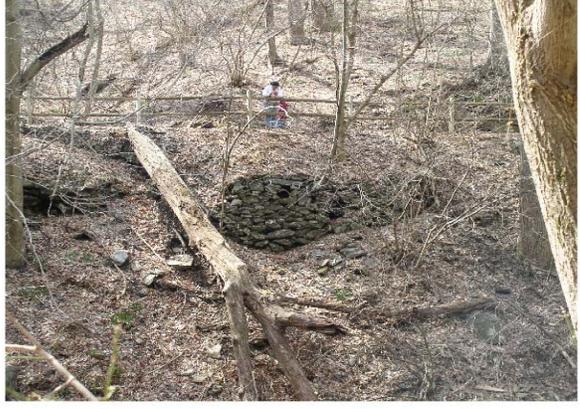
Infrastructure ID: WScul123 Culvert

Condition	Material	Dimension (ft)	Length (ft)	Location
Fair	TerraCotta	2.0	32.0	Under Wissahickon Dr in Fairmount Park

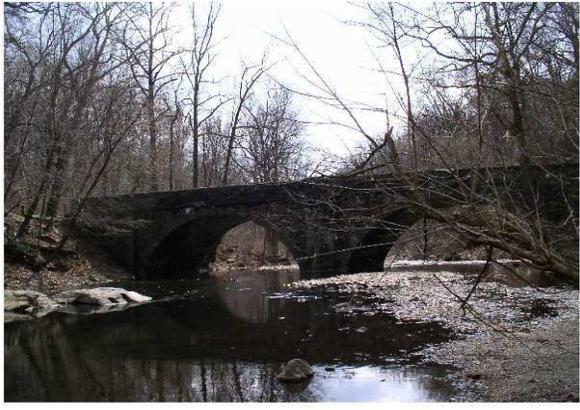
Infrastructure ID: WSbri264 Bridge

Condition	Material	Dimension (ft)	Length (ft)	Location
Good	Stone	30.0 x 100.0	30.0	Mt Alrey Ave at Wissahickon Dr

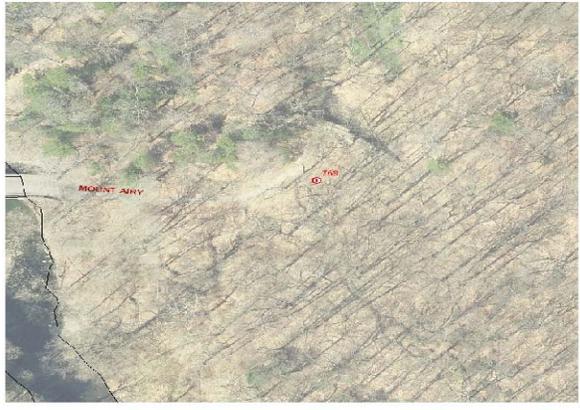
Infrastructure ID: WSout769 Outfall

Condition	Material	Location	Flow	Flow Appearance	Dimension (ft)
	Concrete	DSL			3.0

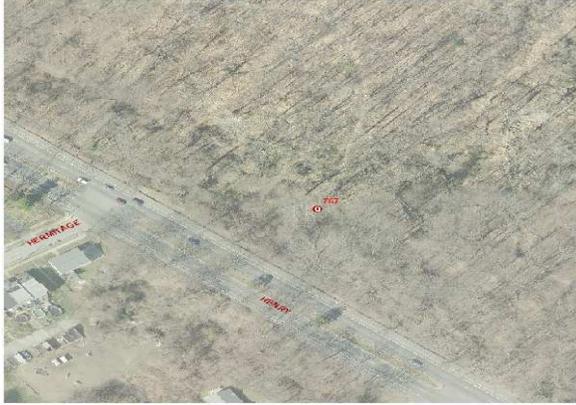
Infrastructure ID: WSout767 Outfall

Condition	Material	Location	Flow	Flow Appearance	Dimension (ft)
	Concrete	DSR			1.5

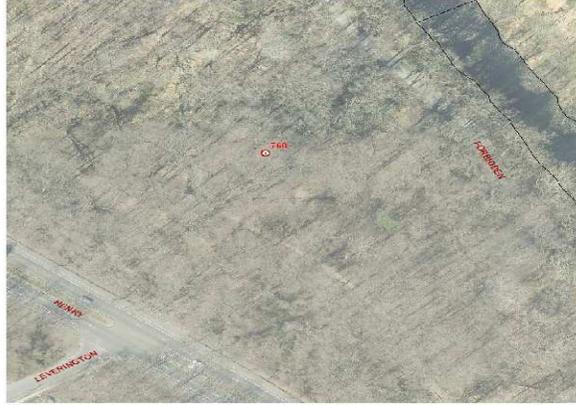
Infrastructure ID: WSout768 Outfall

Condition	Material	Location	Flow	Flow Appearance	Dimension (ft)
	Concrete	DSR			2.33

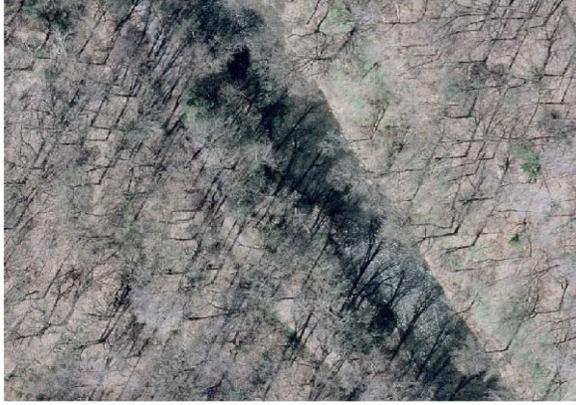
Infrastructure ID: WScon221 Confluence

Condition	Location	Width (ft)	Flow	Creeks
Poor	DSR	2.0		Unnamed Trib to Wissahickon Creek

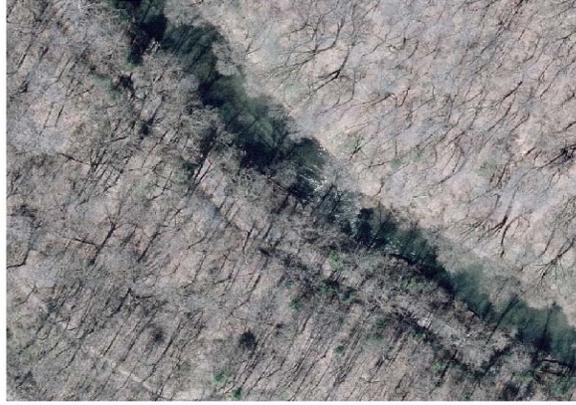
Infrastructure ID: WScon222 Confluence

Condition	Location	Width (ft)	Flow	Creeks
Fair	DSR	1.0		Unnamed Trib to Wissahickon Creek

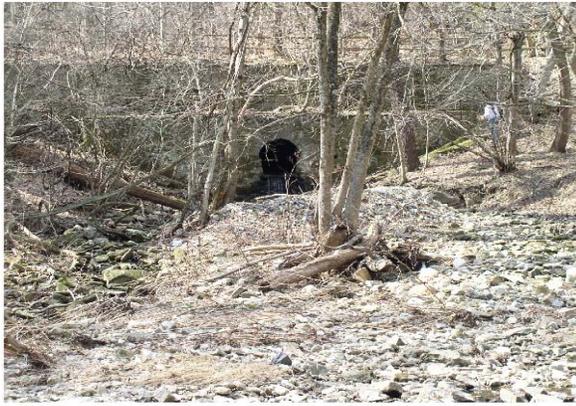
Infrastructure ID: WSout593 Outfall

Condition	Material	Location	Flow	Flow Appearance	Dimension (ft)
Fair	Stone	DSR	Steady	Clear	3.0

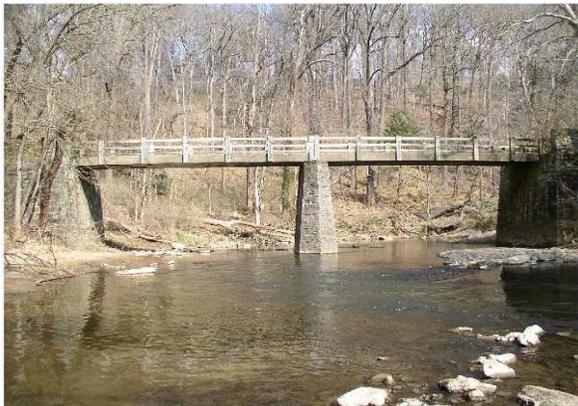
Infrastructure ID: WSbri263 Bridge

Condition	Material	Dimension (ft)	Length (ft)	Location
Good	Stone/Conc	30.0 x 100.0	25.0	Trail off Wissahickon Dr.

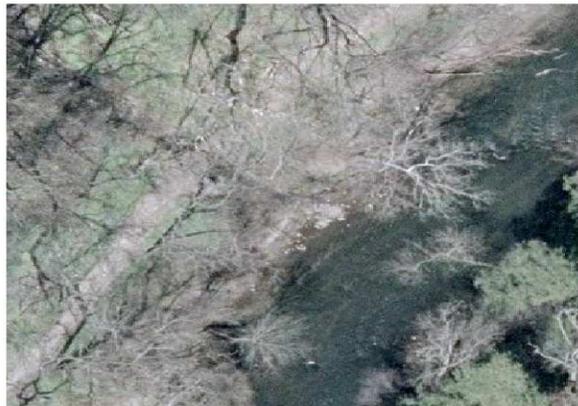
Infrastructure ID: WScon237 Confluence

Condition	Location	Width (ft)	Flow	Creeks
Fair	DSL	10.0	Steady	Kitchens Lane Run into Wissahickon Main Stem

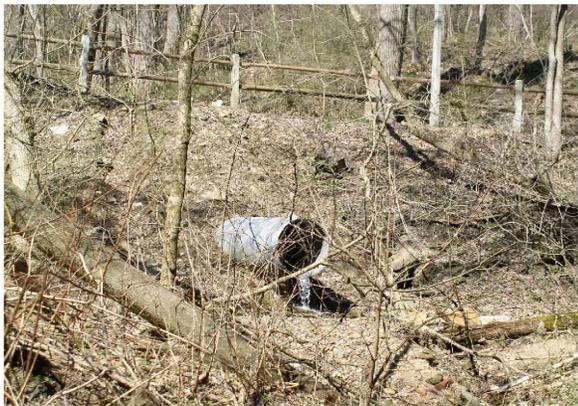
Infrastructure ID: WScul136 Culvert

Condition	Material	Dimension (ft)	Length (ft)	Location
Fair	CorrMetal	3.0	31.0	Near Wissahickon Dr and Walnut Ln

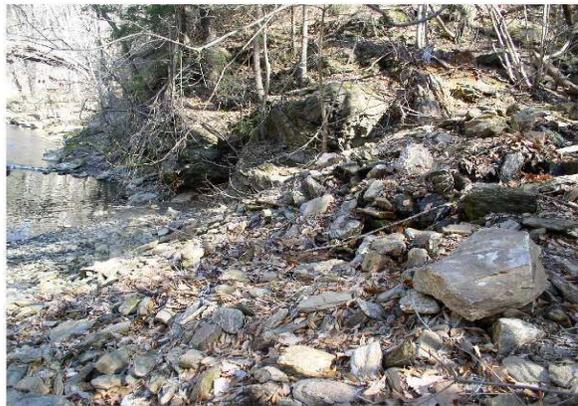
Infrastructure ID: WScon186 Confluence

Condition	Location	Width (ft)	Flow	Creeks
Fair	DSL	8.0	Steady	Unnamed trib to Wissahickon Creek

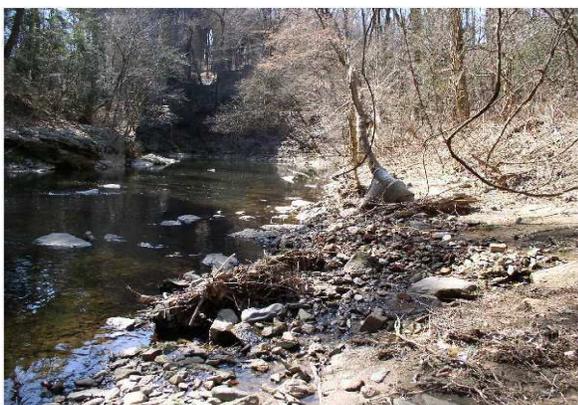
Infrastructure ID: WScon195 Confluence

Condition	Location	Width (ft)	Flow	Creeks
Fair	DSR	4.0	Steady	Unnamed trib to Wissahickon Creek

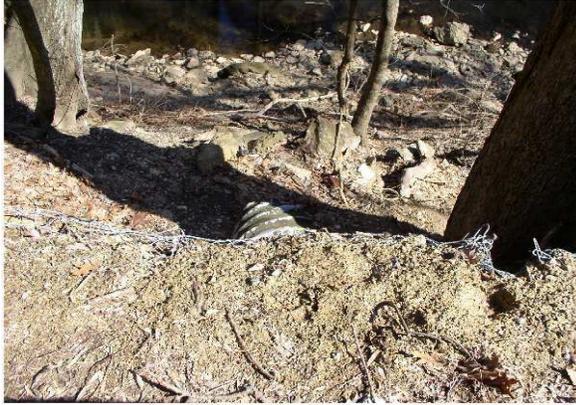
Infrastructure ID: WScul145 Culvert

Condition	Material	Dimension (ft)	Length (ft)	Location
Fair	CorrMetal	2.0	35.0	Under Wissahickon Dr in Fairmount Park

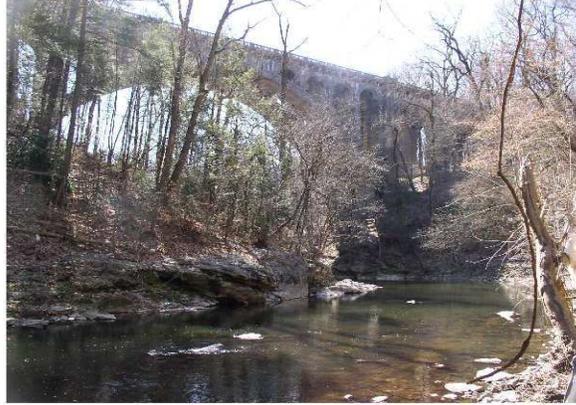
Infrastructure ID: WSbri314 Bridge

Condition	Material	Dimension (ft)	Length (ft)	Location
Good	Stone	150.0 x 75.0	100.0	Walnut Ln

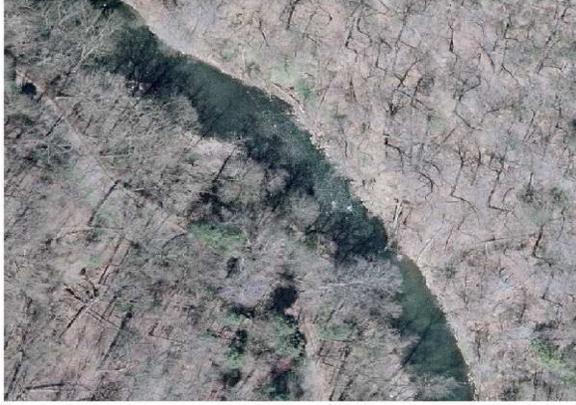
Infrastructure ID: WScn223 Confluence

Condition	Location	Width (ft)	Flow	Creeks
Fair	DSR	2.0		Unnamed trib to Wissahickon Creek

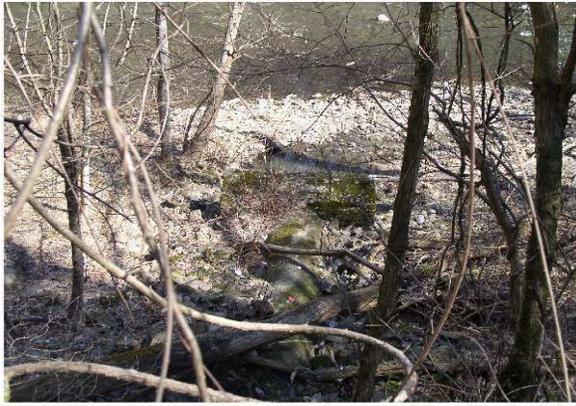
Infrastructure ID: WScul144 Culvert

Condition	Material	Dimension (ft)	Length (ft)	Location
Fair	Concrete	3.0	51.0	Under Wissahickon Dr in Fairmount Park

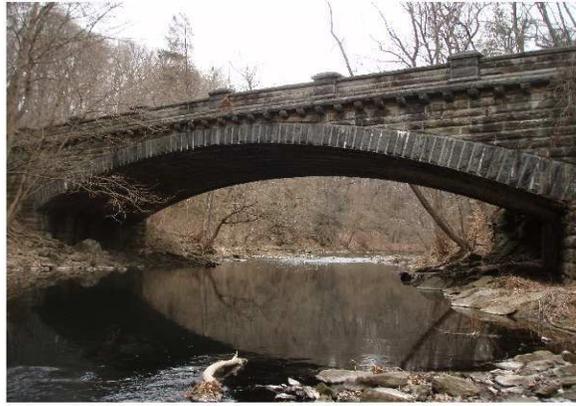
Infrastructure ID: WSbri313 Bridge

Condition	Material	Dimension (ft)	Length (ft)	Location
Good	Stone	50.0 x 25.0	75.0	Wissahickon Dr between Lincoln Dr and Walnut Ln

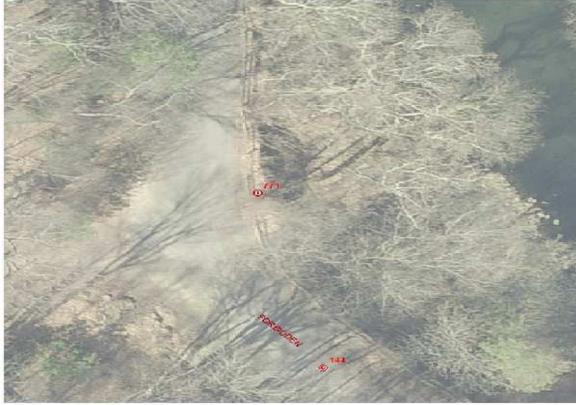
Infrastructure ID: WSout771 Outfall

Condition	Material	Location	Flow	Flow Appearance	Dimension (ft)
Fair	Brick	DSR			4.0

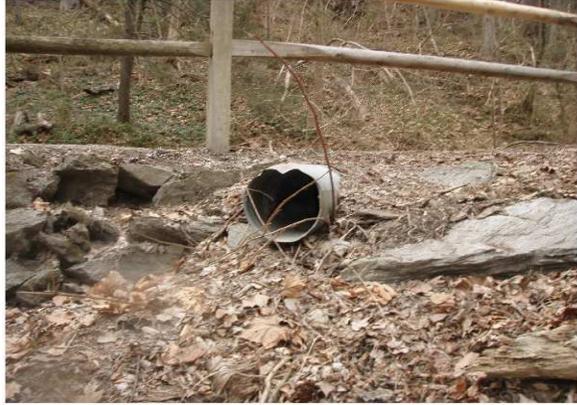
Infrastructure ID: WSout596 Outfall

Condition	Material	Location	Flow	Flow Appearance	Dimension (ft)
Fair	CorrMetal	DSL	None		1.0

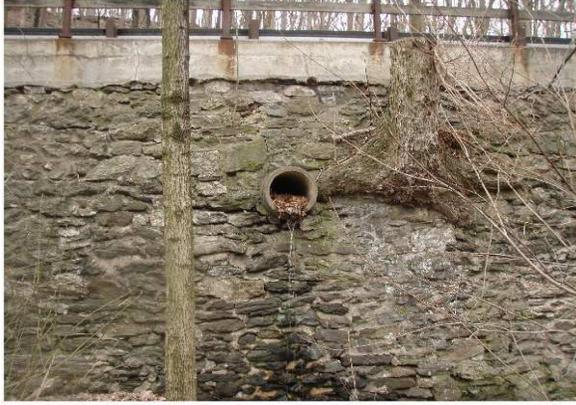
Infrastructure ID: WSout597 Outfall

Condition	Material	Location	Flow	Flow Appearance	Dimension (ft)
Fair	Concrete	DSL	Trickle		1.0

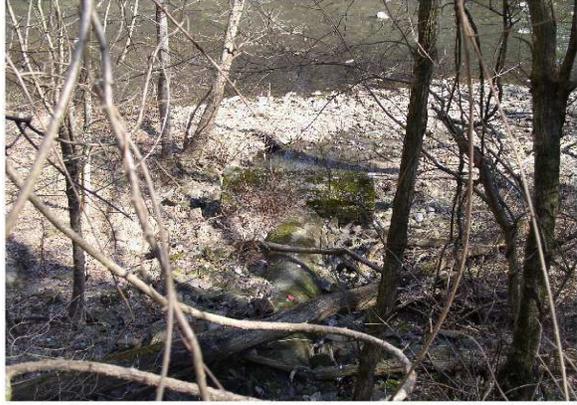
Infrastructure ID: WScon198 Confluence

Condition	Location	Width (ft)	Flow	Creeks
Fair	DSR	6.0	Steady	Unnamed trib to Wissahickon Creek

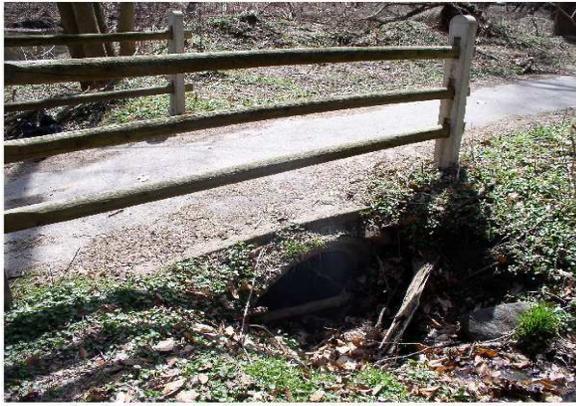
Infrastructure ID: WScul143 Culvert

Condition	Material	Dimension (ft)	Length (ft)	Location
Fair	Iron	2.0	30.0	Under trail in Fairmount Park

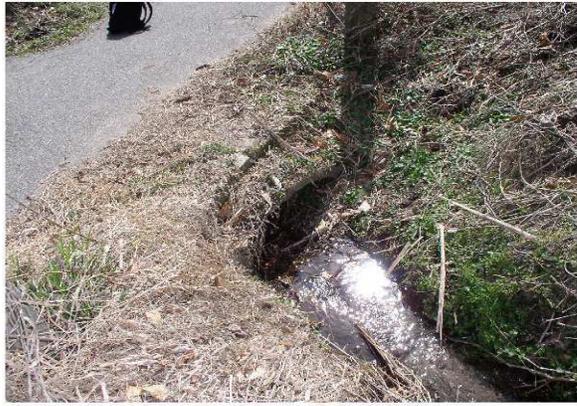
Infrastructure ID: WScul142 Culvert

Condition	Material	Dimension (ft)	Length (ft)	Location
Fair	Iron	2.0	30.0	Under trail near Vicaris St

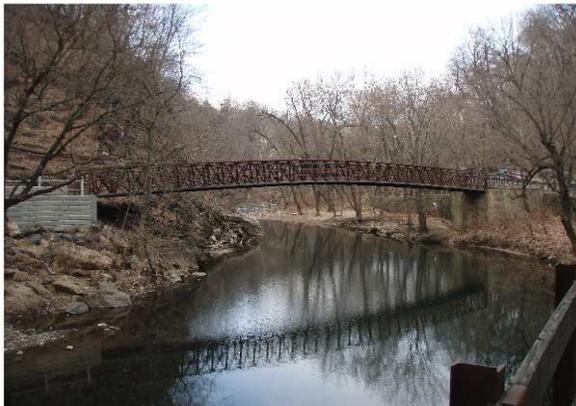
Infrastructure ID: WSbri423 Bridge

Condition: Good Material: Steel/Wood Dimension (ft): 40.0 x 122.0 Length (ft): 8.0 Location: Lincoln Dr under Henry Ave

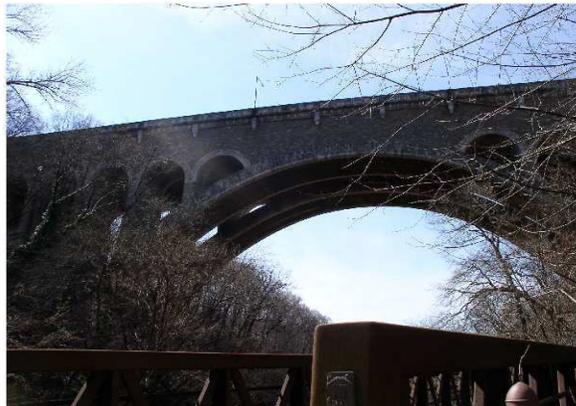
Infrastructure ID: WSbri311 Bridge

Condition: Good Material: Stone Dimension (ft): 100.0 x 50.0 Length (ft): 150.0 Location: Henry Ave over Lincoln Dr

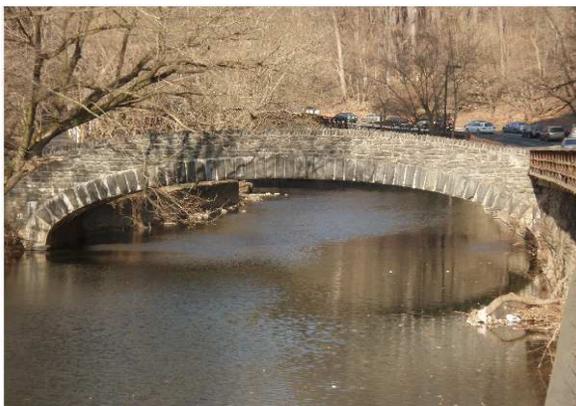
Infrastructure ID: WSbri312 Bridge

Condition: Good Material: Stone Dimension (ft): 20.0 x 15.0 Length (ft): 50.0 Location: Next to the Lincoln Dr at Henry Ave

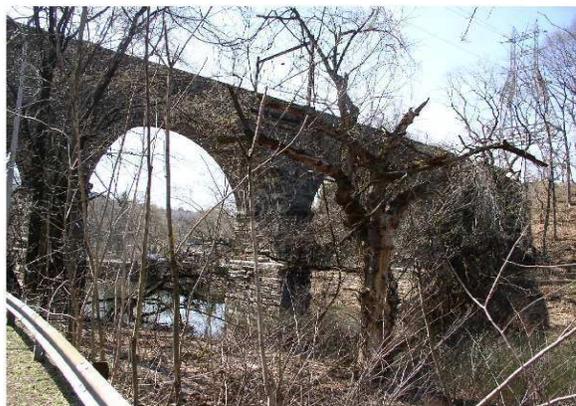
Infrastructure ID: WSbri310 Bridge

Condition: Good Material: Stone Dimension (ft): 100.0 x 60.0 Length (ft): 100.0 Location: Railroad tracks at Lincoln Dr and Ridge Ave

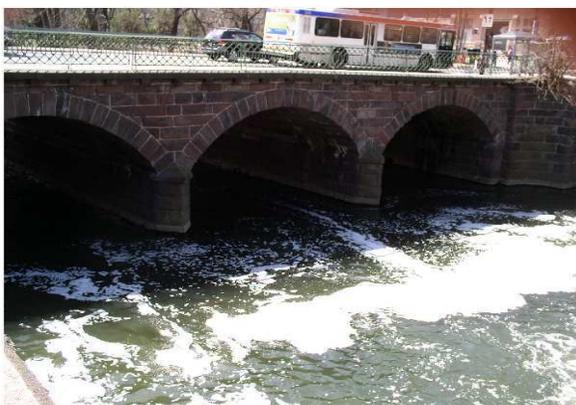
Infrastructure ID: WSbri265 Bridge

Condition: Good Material: Stone Dimension (ft): 50.0 x 100.0 Length (ft): 75.0 Location: Ridge Ave

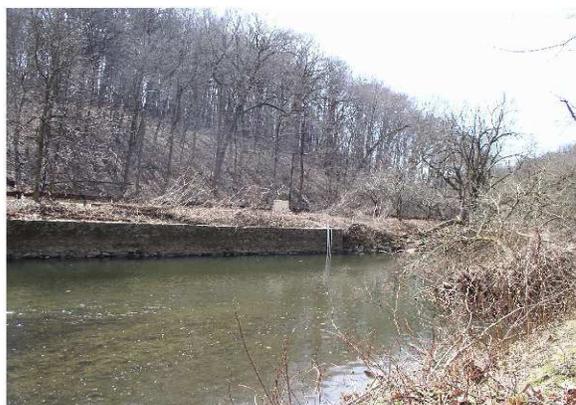
Infrastructure ID: WScha226 Channel

Condition: Good Material: Stone Dimension (ft): 8.0 x 2.0 Length (ft): Location: DSL

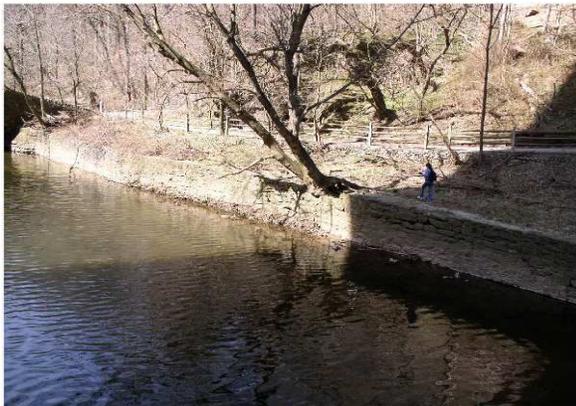
Infrastructure ID: WScha228 Channel

Condition	Material	Dimension (ft)	Length (ft)	Location
Fair	Stone	4.0 x 3.0	112.0	DSR

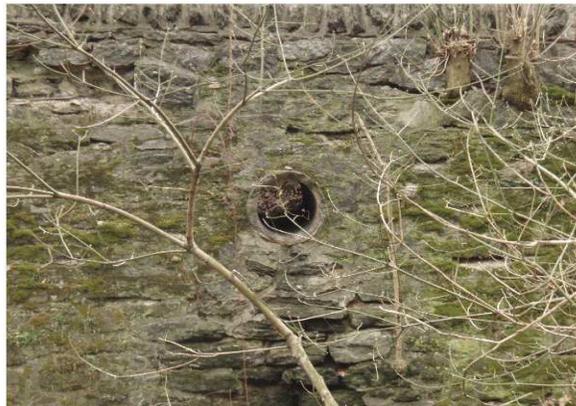
Infrastructure ID: WSout672 Outfall

Condition	Material	Location	Flow	Flow Appearance	Dimension (ft)
Good	Concrete	DSL	None		1.0

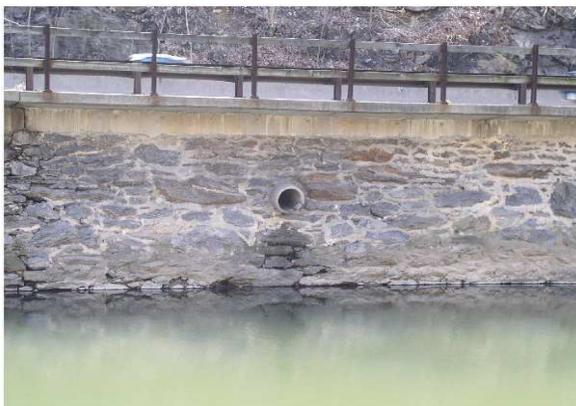
Infrastructure ID: WSout673 Outfall

Condition	Material	Location	Flow	Flow Appearance	Dimension (ft)
Good	Concrete	DSL	None		1.0

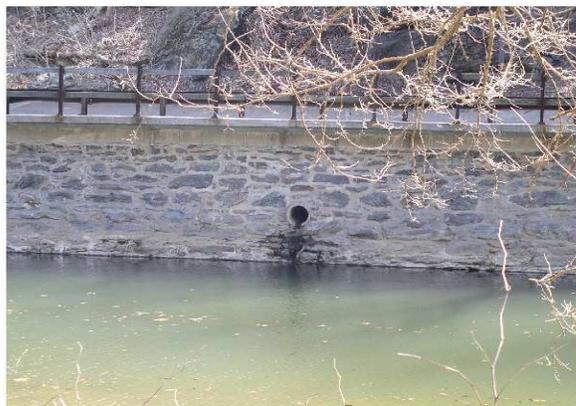
Infrastructure ID: WSout674 Outfall

Condition	Material	Location	Flow	Flow Appearance	Dimension (ft)
Good	Concrete	DSL	Trickle	Clear	1.0

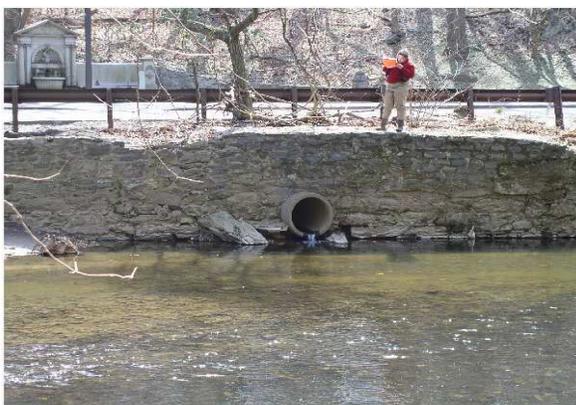
Infrastructure ID: WSout675 Outfall

Condition	Material	Location	Flow	Flow Appearance	Dimension (ft)
Good	Concrete	DSL	Steady	Clear	2.0

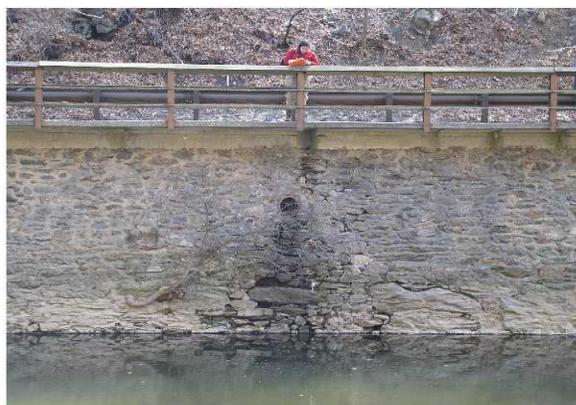
Infrastructure ID: WSout676 Outfall

Condition	Material	Location	Flow	Flow Appearance	Dimension (ft)
Good	Concrete	DSL	Trickle	Clear	1.0

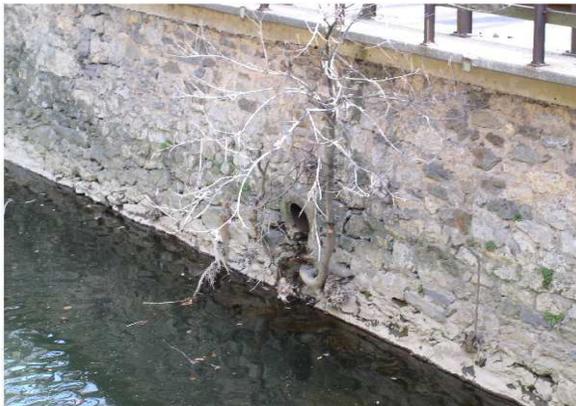
Infrastructure ID: WSout677 Outfall

Condition	Material	Location	Flow	Flow Appearance	Dimension (ft)
Good	Concrete	DSL	None		1.5

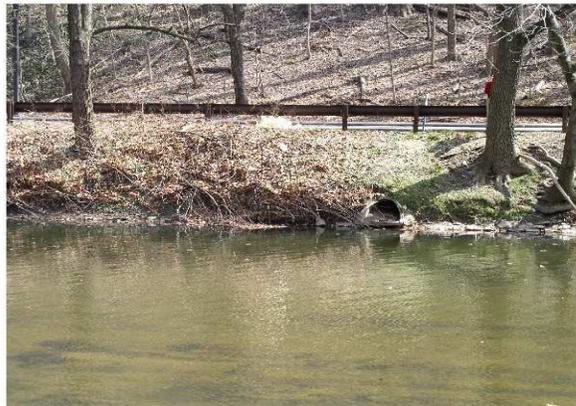
Infrastructure ID: WSout671 Outfall

Condition	Material	Location	Flow	Flow Appearance	Dimension (ft)
Fair	CorrMetal	DSL	None		1.5

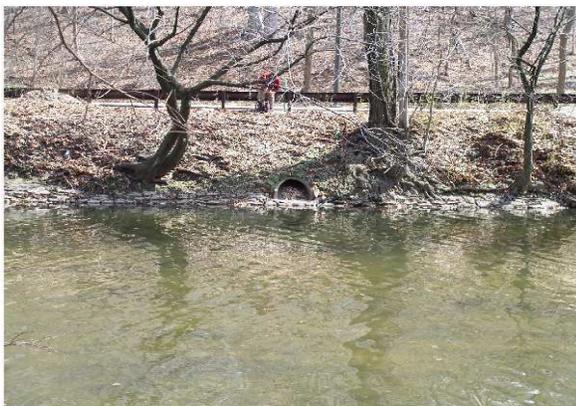
Infrastructure ID: WSout670 Outfall

Condition	Material	Location	Flow	Flow Appearance	Dimension (ft)
Fair	CorrMetal	DSL	None		1.5

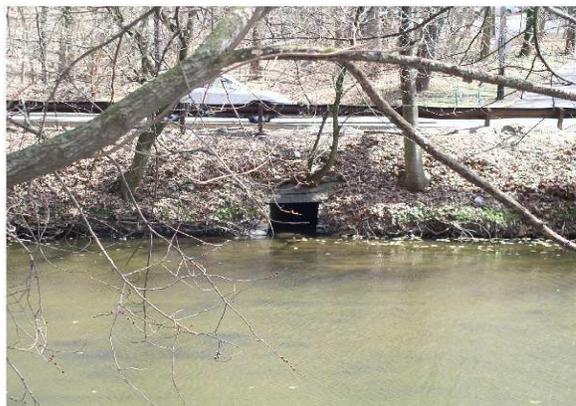
Infrastructure ID: WSout669 Outfall

Condition	Material	Location	Flow	Flow Appearance	Dimension (ft)
Fair	CorrMetal	DSL	None		1.5

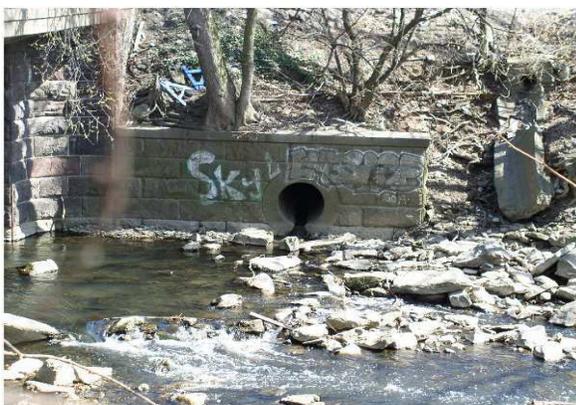
Infrastructure ID: WSout594 Outfall

Condition	Material	Location	Flow	Flow Appearance	Dimension (ft)
Good	Concrete	DSL	Trickle		2.0

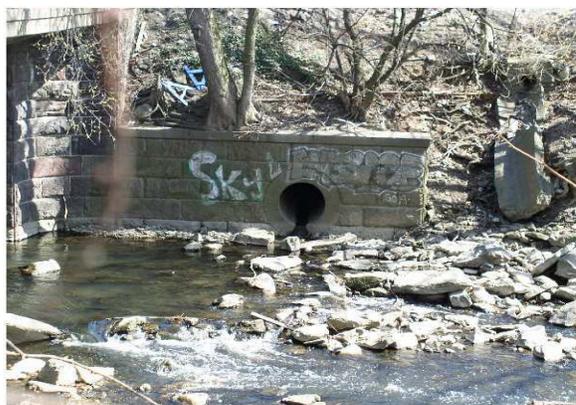
Infrastructure ID: WSout772 Outfall

Condition	Material	Location	Flow	Flow Appearance	Dimension (ft)
Fair	Concrete	DSL	None		1.25

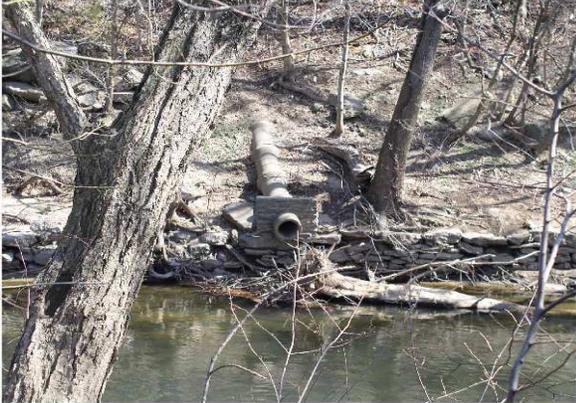
Infrastructure ID: WSout595 Outfall

Condition	Material	Location	Flow	Flow Appearance	Dimension (ft)
Good	Concrete	DSL		None	1.0

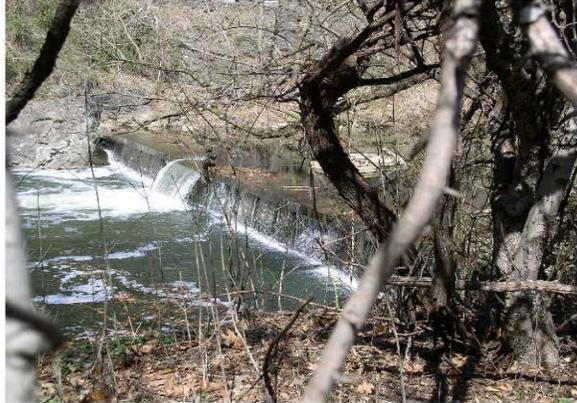
Infrastructure ID: WSdam131 Dam

Condition	Material	Width (ft)	Length (ft)	Height Exposed (ft)
Good	Concrete	120.0	5.0	8.0

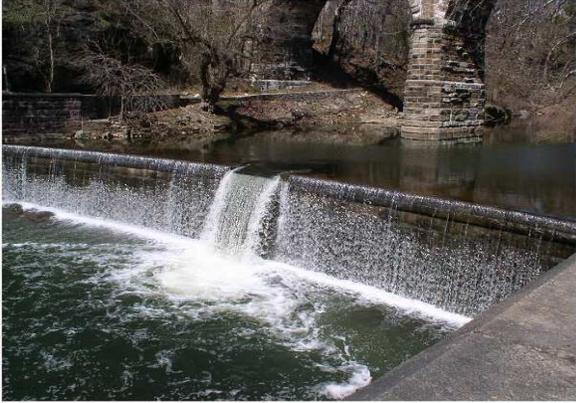
Infrastructure ID: WSdam130 Dam

Condition	Material	Width (ft)	Length (ft)	Height Exposed (ft)
Good	Concrete	10.0	100.0	12.0

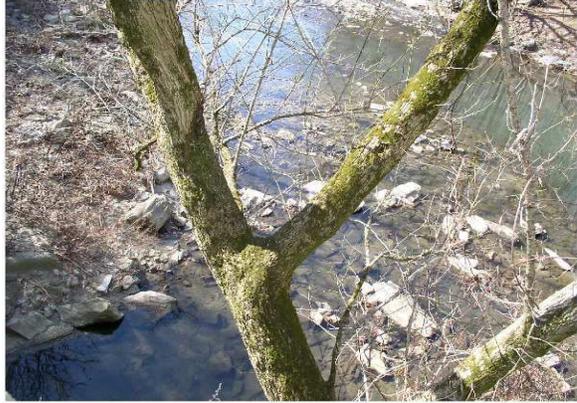
Infrastructure ID: WScon172 Confluence

Condition	Location	Width (ft)	Flow	Creeks
Good	DSL	40.0	Steady	Monoshone Creek into Wissahickon Creek

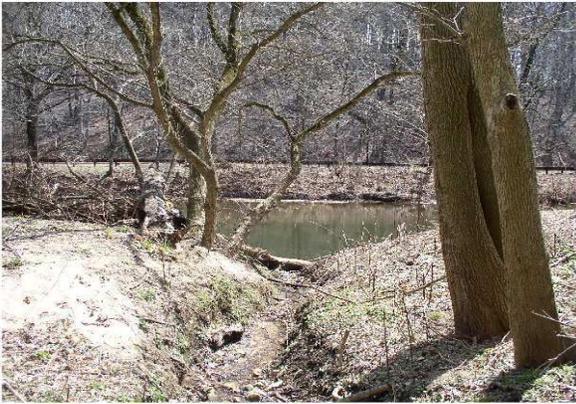
Infrastructure ID: WScon197 Confluence

Condition	Location	Width (ft)	Flow	Creeks
Good	DSR	4.0	Steady	Unnamed trib to Wissahickon Creek

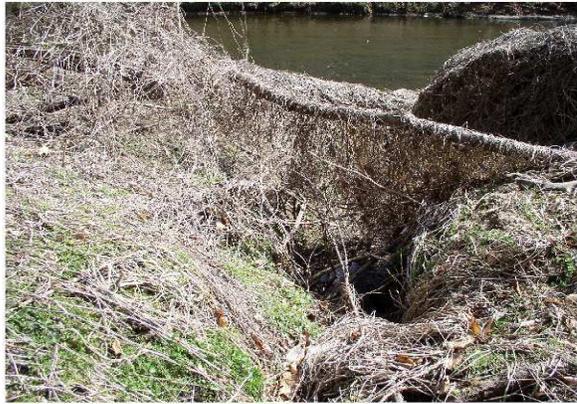
Infrastructure ID: WScon196 Confluence

Condition	Location	Width (ft)	Flow	Creeks
Good	DSR	4.0	Steady	Unnamed trib to Wissahickon Creek

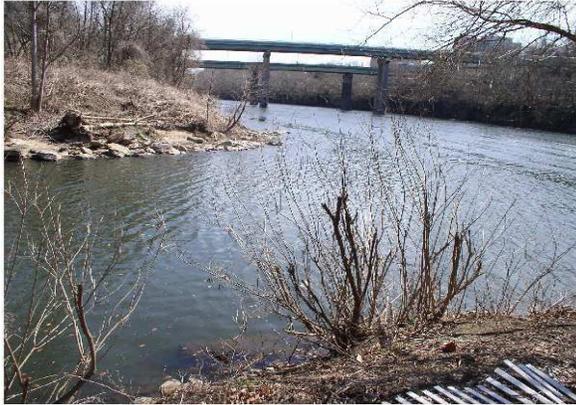
Infrastructure ID: WScon185

Condition	Location	Width (ft)	Flow	Creeks
Fair	CROSS	50.0	Steady	Wissahickon Creek into Schuylkill River
