Poquessing Creek Watershed

STORM WATER MANAGEMENT PLAN

Watershed Plan Advisory Committee (WPAC) Meeting No. 4

Watershed Plan Advisory Committee (WPAC) Meeting No. 4. Status Meeting December 8, 2011 10:00 A.M. Delaware Valley Veteran's Home Review of Problem Areas and Proposed Solutions Poquessing Hydrologic Model

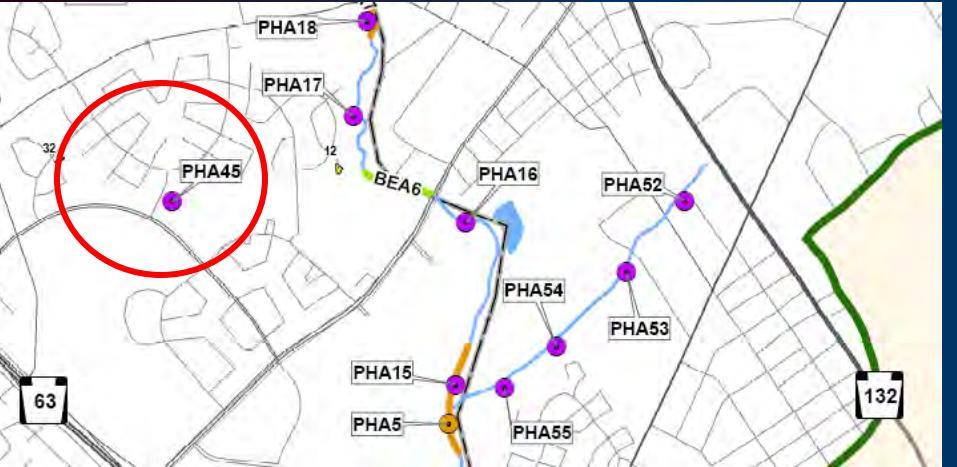
This shows another problem area.

- Invasive species have overgrown everything in the overbank area
 - Remove invasive species and replant native species
- There is also severe undercutting of the banks as seen in the photos to the right
 - Regrade stream and plant native species to protect the bank.

Problem Area - Map ID:		i obient lice intentory	
	PHA45	Comments	
Municipality:	Philadelphia	This problem area was reported by the	
Stream name:	Trib to Poquessing Creek	Philadelphia Water Department. The problem	
Inspected By/Date: DJS/BAK 10-28-2010		area is located along a tributary to Poquessing	
Checked By/Date:	JMY 04-18-2011	Creek . The reach stability was reported as	
Type of Problem (highlight	ed):	intermediate and the bank erosion was classified as high.	
1	Flooding		
2	Deficient Bridge/Culvert		
3	Erosion		
4	Sedimentation		
5	Water/Groundwater Pollution		
6	Other		
		+	
STANDATO	MAR - CAR	Description	
A AL	Complex 1	Banks were also reported as being overgrown with invasive species.	
		Description

Reduce Peak Flows, Stabilize Stream Bank, Clear Non-Native Species, 5.6.3

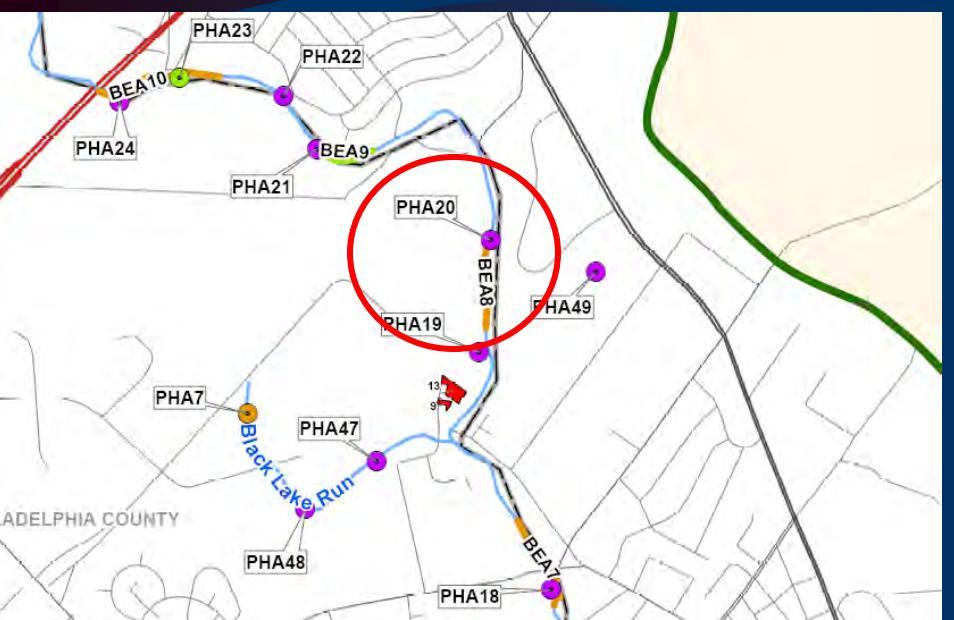
Poquessing Watershed Act 167	Problem Area Inventory
Problem Area - Map ID:	PHA20 - BEA8	Comments
Municipality:	Philadelphia / Bensalem	This section of stream was reported as a problem
Stream name:	Poquessing Creek	area by the Philadelphia Water Department and
Inspected By/Date:	DJS/BAK 10-28-2010	the city of Bensalem. The problem area is located
Checked By/Date:	JMY 04-18-2011	along Poquessing Creek within Poquessing Valley
Type of Problem (highligh	ted):	Park. The reach was reported as actively degrading and the bank erosion was classified as high.
2	Deficient Bridge/Culvert	
3	Prosion	
4	Sedimentation	
5	Water/Groundwater Pollution	
6	Other - ATV	
0	Ouler Art	
N A THERE A		Description
		The banks are eroded 4 to 5 feet along this portion of the stream.
	A CONTRACTOR	Description
		Bank instability and erosion within this area can also be attributed to the use of recreational vehicles within and along this section of stream. These vehicles can damage the riparian buffer and decrease bank stability in areas where they travel. The photo to the left shows an area where these vehicles travel and the resulting sediment deposit and degraded streambank.

Solution	Reduce P	eak Flows, Stabilize Stream Bank

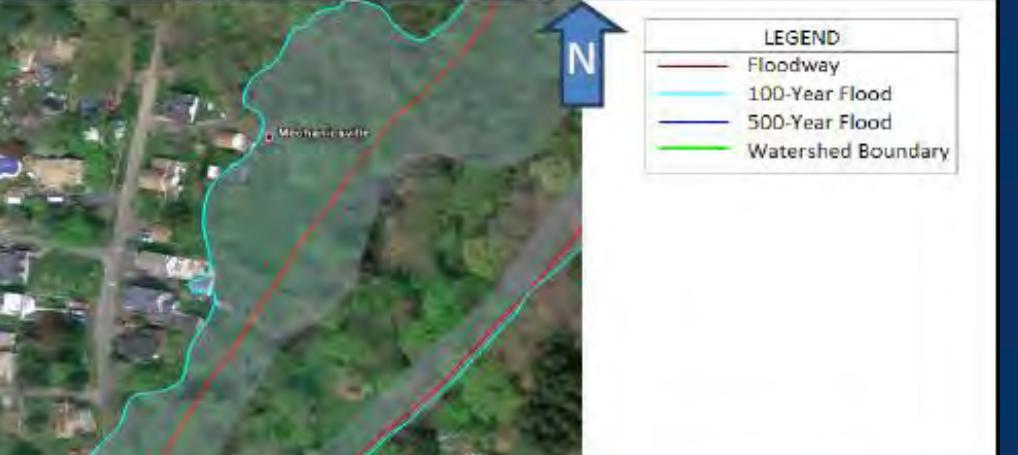
Floodplain Problem Areas

POQUESSING WATERSHED Poquessing Watershed Act 167 100-Year Floodplain Problems Problem Area - Map ID: PH-F22 Comments Number of Buildings Residential 2 Inundated Commercial High volume and backwater from BEB5 causes flooding of Type of problem (Highlighted): this residential area. **High Volume** 2 Backwater from bridge/culvert LEGEND Floodway

- Example of problem areas showing locations of inundated buildings
 - Problem PH-F22 is just upstream of Century Lane
 - Backwater from the bridge and high volume cause flooding of these 2 structures

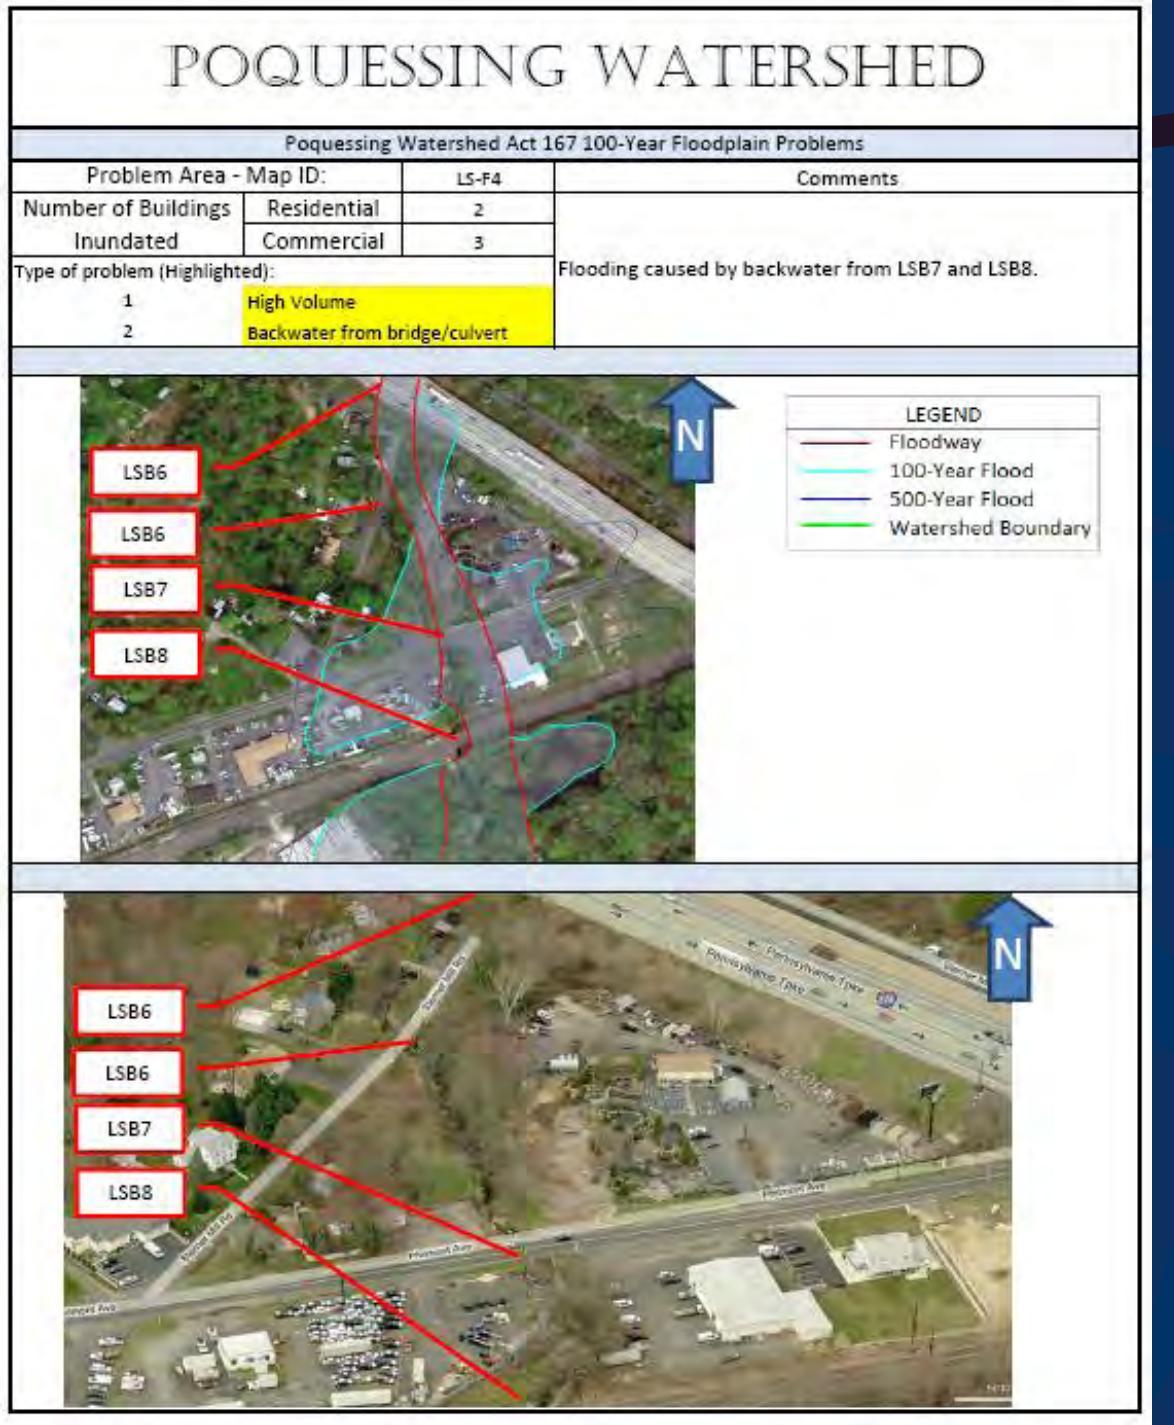
Floodplain Problem Areas

Lower Southampton just south of PA Turnpike, backwater from the Conrail floods buildings

Increase capacity of waterway opening in bridge to reduce the amount of flooding

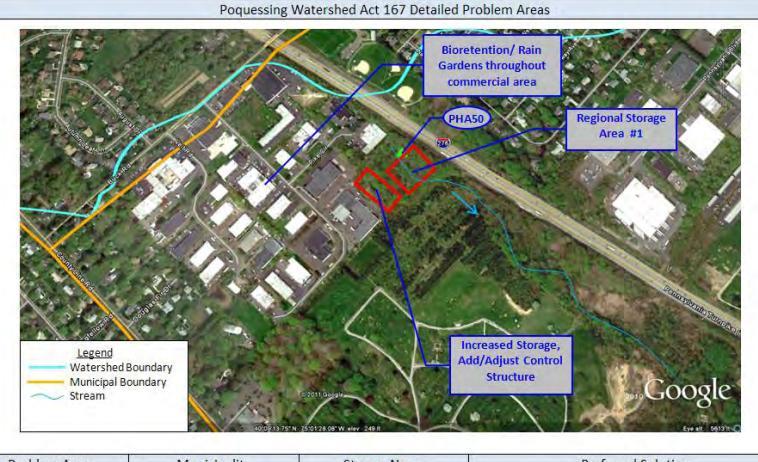
Poque	essing Watershed Act 1	67 Detailed Problem	Areas
Problem Area - Map ID:	PHA50	Inspected By/Date:	DJS, BAK/10-28-2010
Municipality:	Lower Southampton	Checked By/Date:	PAD 6-28-2011
		5

The banks of this tributary are experiencing severe erosion. As evident from the pictures above, the channel has been eroded approximately 10-12 feet below the normal channel depth.

Type of Problem	Erosion		
Drainage Area	RSA #1 - 27.8 acres		
Potential Storage	RSA#1 - 5.25 acre-ft		
Storm Frequency	Existing Peak Discharge (cfs)	Mitigated Peak Discharge (cfs)	Difference (cfs)
2			
5			
10			
50			
100			
500		1

Stream Stabilization: This would help to limit erosion and decrease sediment transport downstream.

2) Regional Storage Area 1 (Infiltration, Detention): This storage area would be constructed in the wooded area downstream of the commercial area. An embankment would be constructed near the downstream end of the wooded area and would provide storage in the undisturbed upstream area. This would require limited clearing of vegetation as construction would only occur in the area immediately surrounding the proposed embankment. This storage area has the potential to significantly reduce flow rates for both small and large storms, which would help mitigate severe erosion that is occurring in the downstream channel.

3) Increased Storage, Add/Adjust Control Structure: Increased storage capacity and adding/adjusting the outlet structure to better control release rates.

Bioretention/Rain Garden: Convert small pockets of open space within the commercial area to bioretention/rain garden type BMPs.

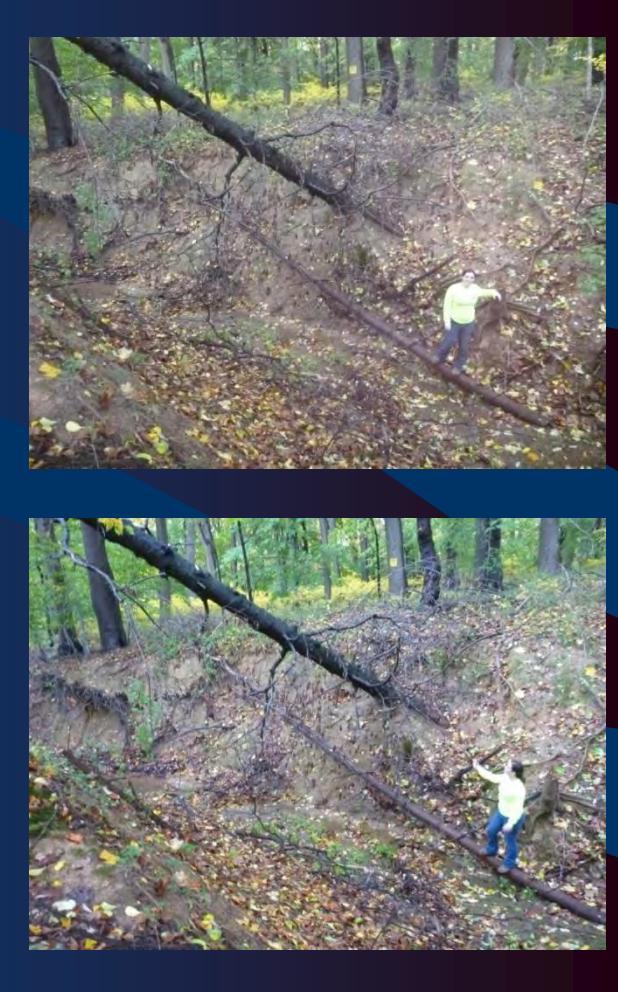
Detailed Problem Area Forms

This shows a detailed problem area.

- Significant erosion along an UNT to Poquessing Creek in Lower Southampton Township
- Possible Solutions include the construction of storage areas (detention, infiltration) within and immediately downstream of the commercial /industrial area and localized bioretention/ rain garden cells within the developed area

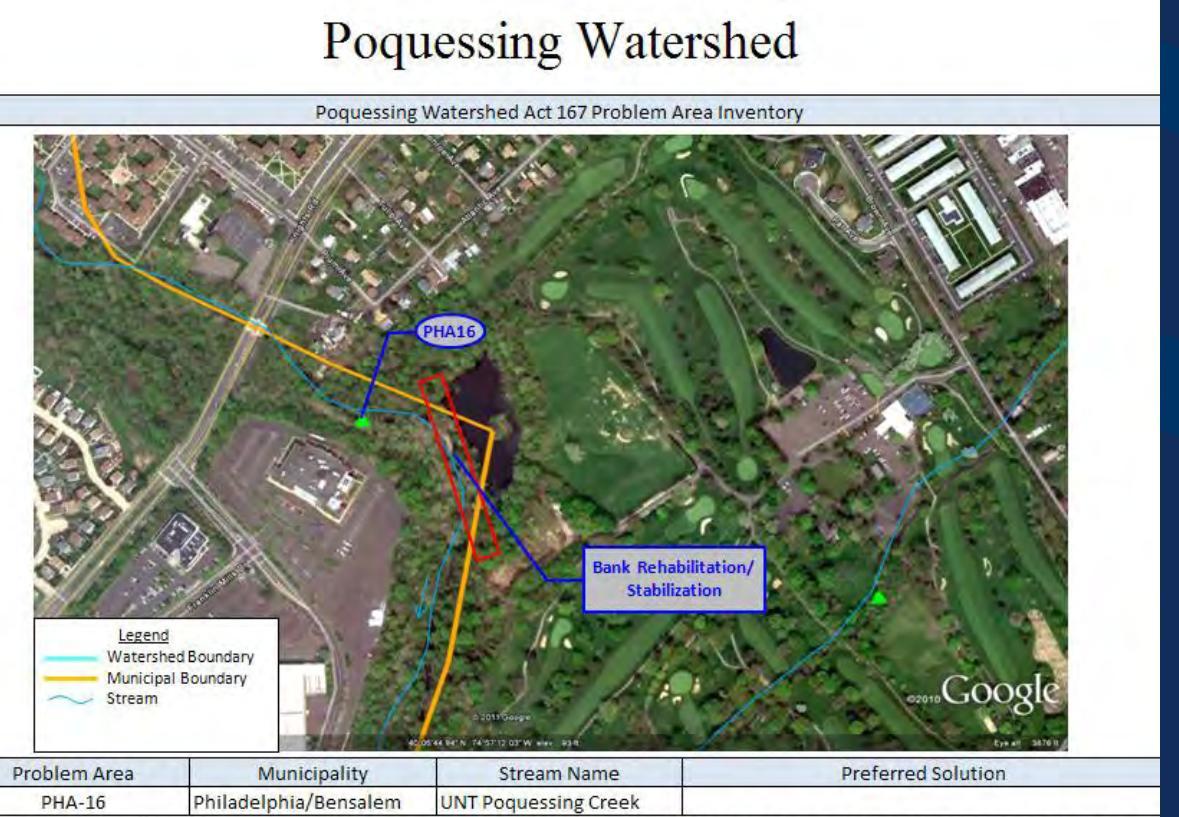
- This shows a detailed problem area.
 - Severe erosion along Poquessing Creek and shared stream/pond embankment
 - IMMEDIATE action needs to be taken to prevent the pond embankment from collapsing
 - Possible solutions in this area include bank rehabilitation/stabilization.

Description: This section of stream was reported as a problem area by the Philadelphia Water Department. The problem area is located along Poquessing Creek south of Knights Road. The reach stability was reported as intermediate and the bank erosion was classified as high. A pond within this section of stream shares a bank with Poquessing Creek. This embankent is experiencing significant erosion that will eventually lead to a embankment faliure. Therefore, this problem area should be a high priortity because it creates incrased risk to life, property, and the environment.

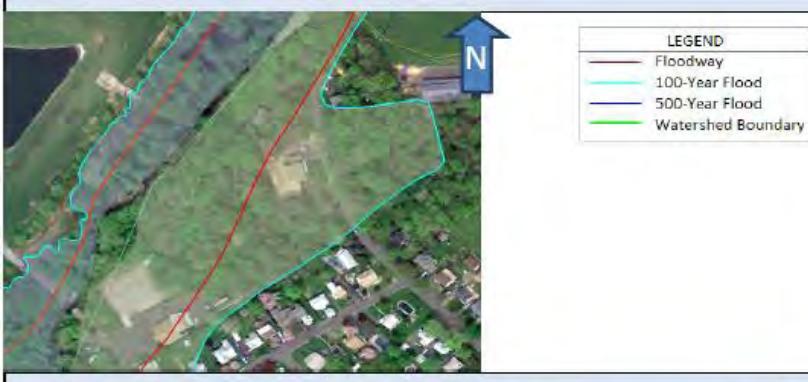
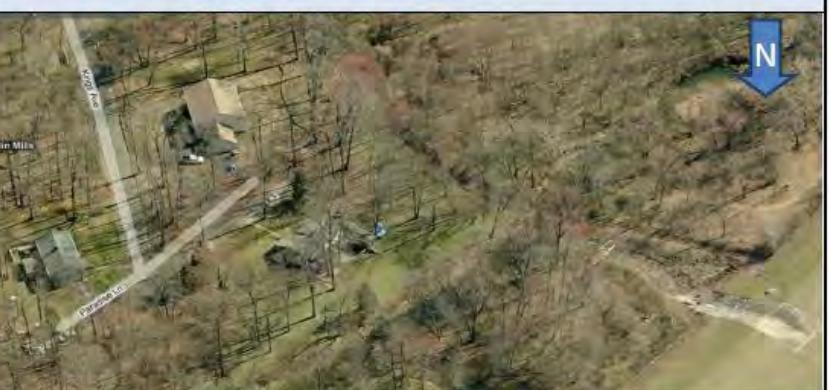
Poquessing W	atershed Ac	t 167 100-Year Floodplain Problems						
Problem Area -	Map ID:	PH-F14	Comments						
Number of Buildings	Residential	2							
Inundated	Commercial		Floreding served by backwater from DEDS and birth uplu						
Type of problem (Highlight	ed):		Flooding caused by backwater from BEBo and high volume.						
1	High Volume		Some buildings also seem to be built within the hoodplains.						
2	Backwater from brid	dge/culvert

- Problem PH-F14 shows where there has been 7 flood claims on one property
- House appears to be built on/near floodway

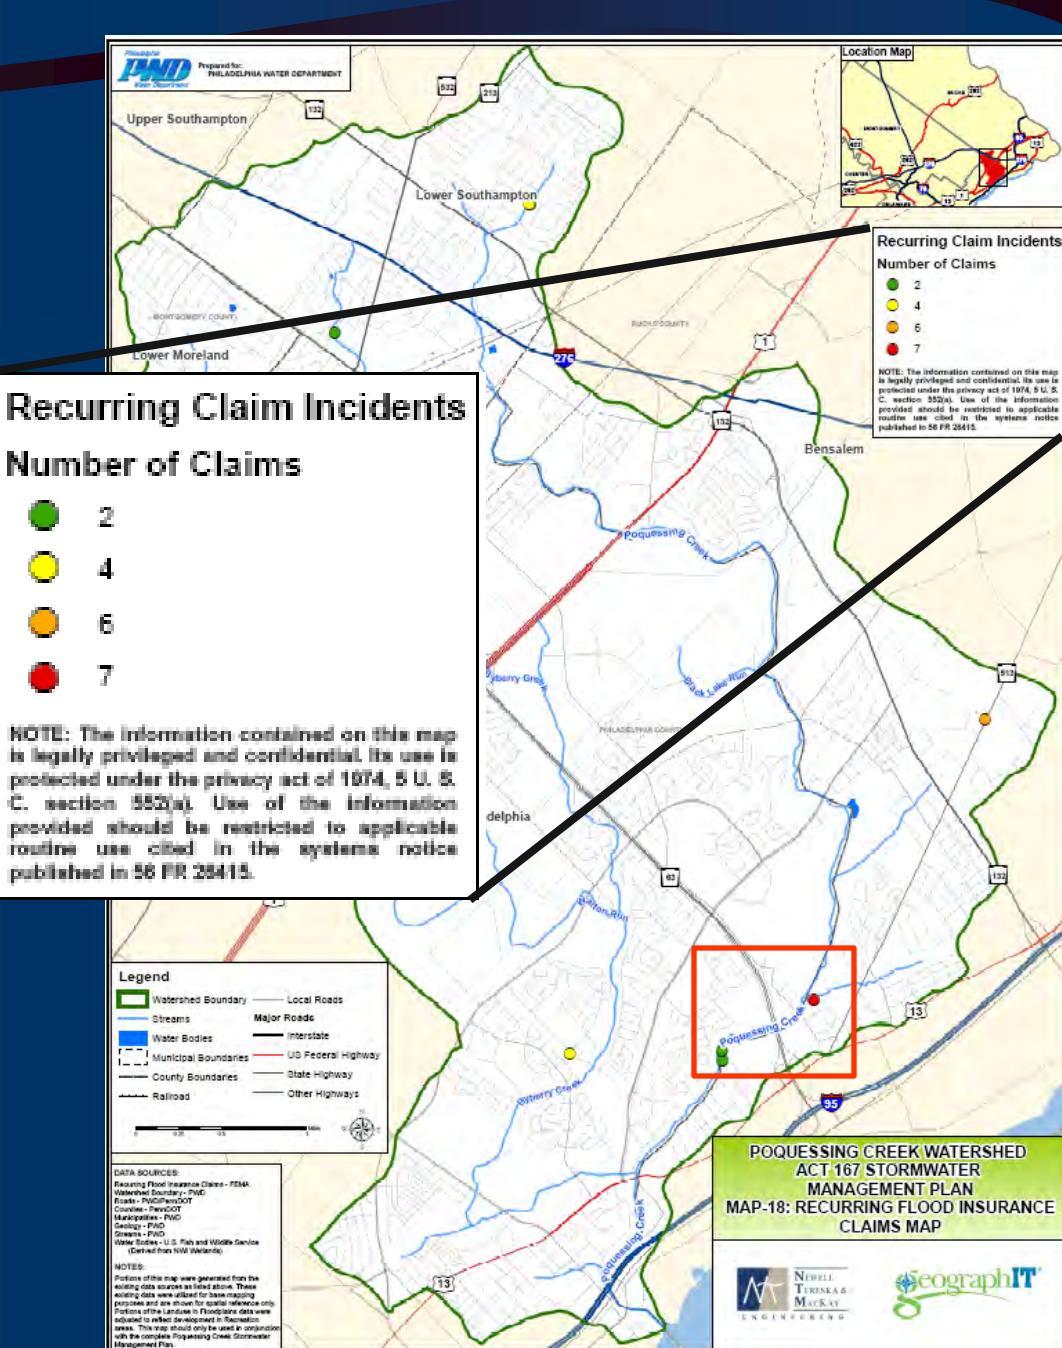
Total Flood Insurance Claims, 2010 Claim Value (US Dollars)

- Shows location and monetary value of all claims.
- Locations away from stream signify localized drainage problems
- Locations on/near stream typically signify regional problems

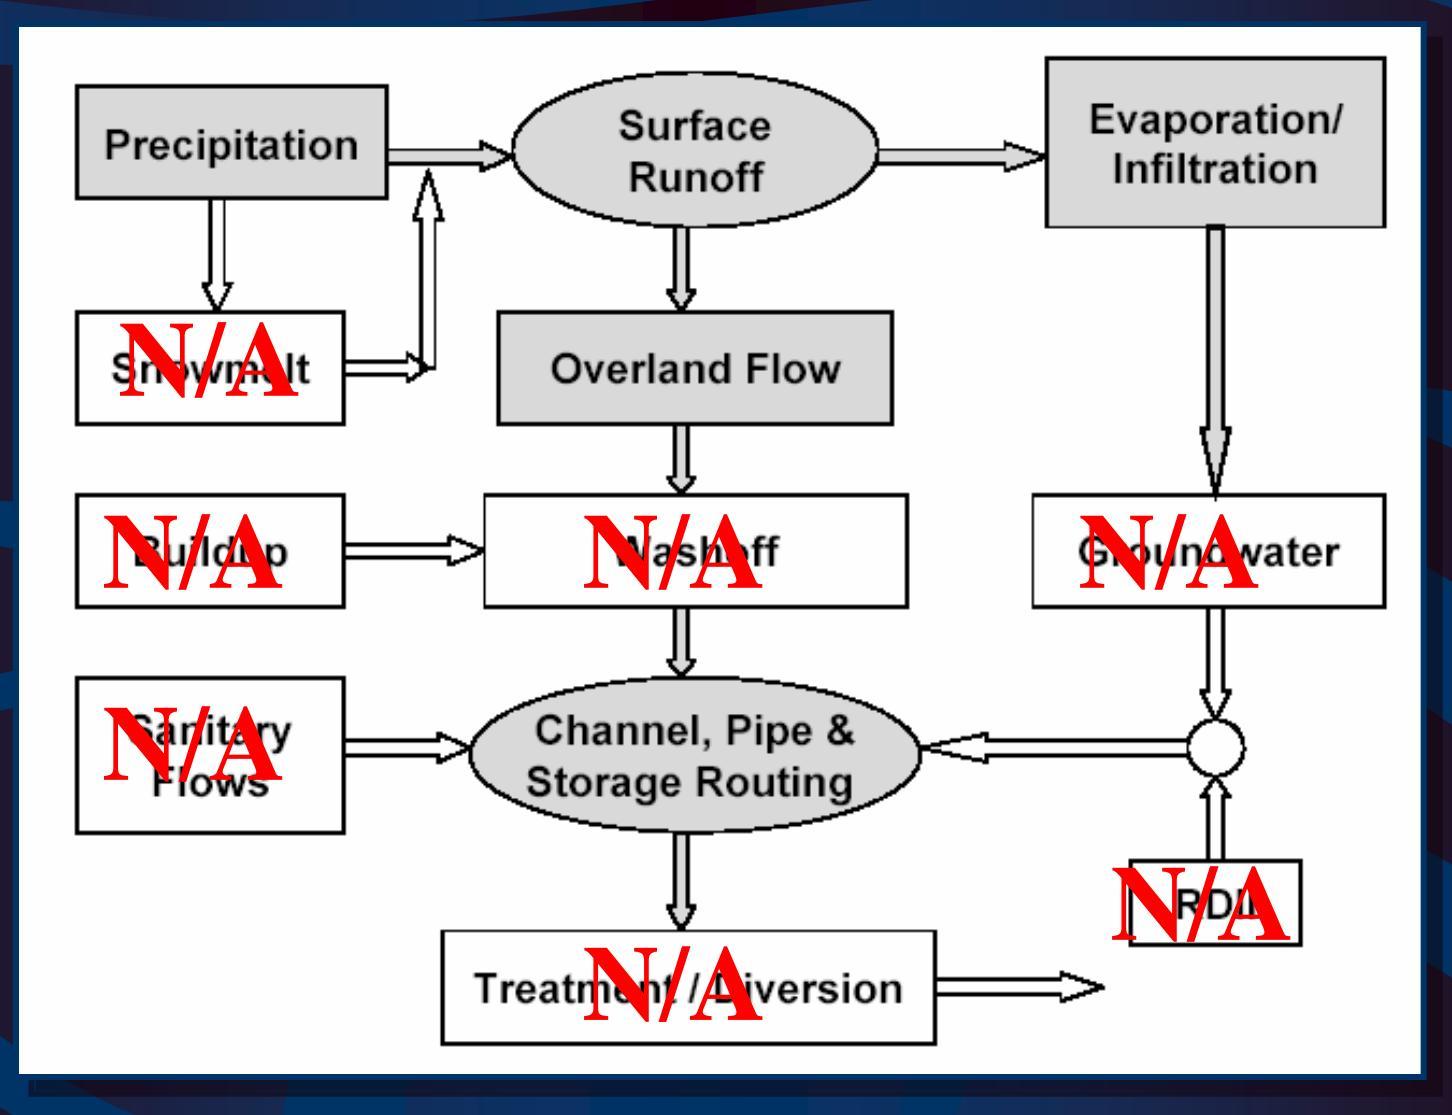
SWMM Process Model

SWMM is a dynamic rainfall-runoff simulation model, primarily but not exclusively for urban areas, for single-event or long-term (continuous) simulation.

PWD set up SWMM Model and calibrated it

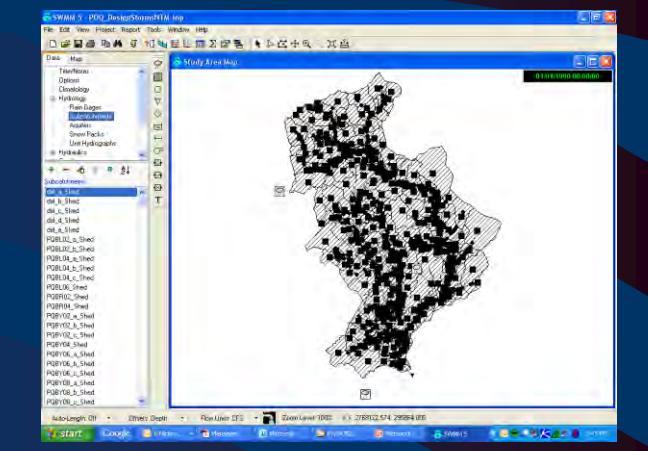
- Hydrology Inputs
 - Rain gages 3 are used
 - Subcatchments (Subareas)
 - Area
 - Slope of area
 - % impervious
 - Manning "n"-values

Infiltration – Green Ampt

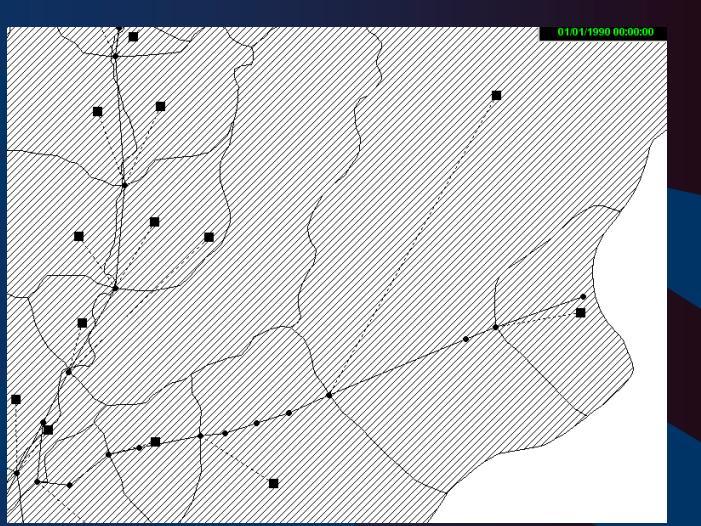
- Hydraulic Inputs
- Links -> Conduits
 - Channel data
 - XS data (Transect)
 - Length
 - Max Depth
- Nodes -> Junctions
 - Invert Elevations

Accept runoff from subcatchments

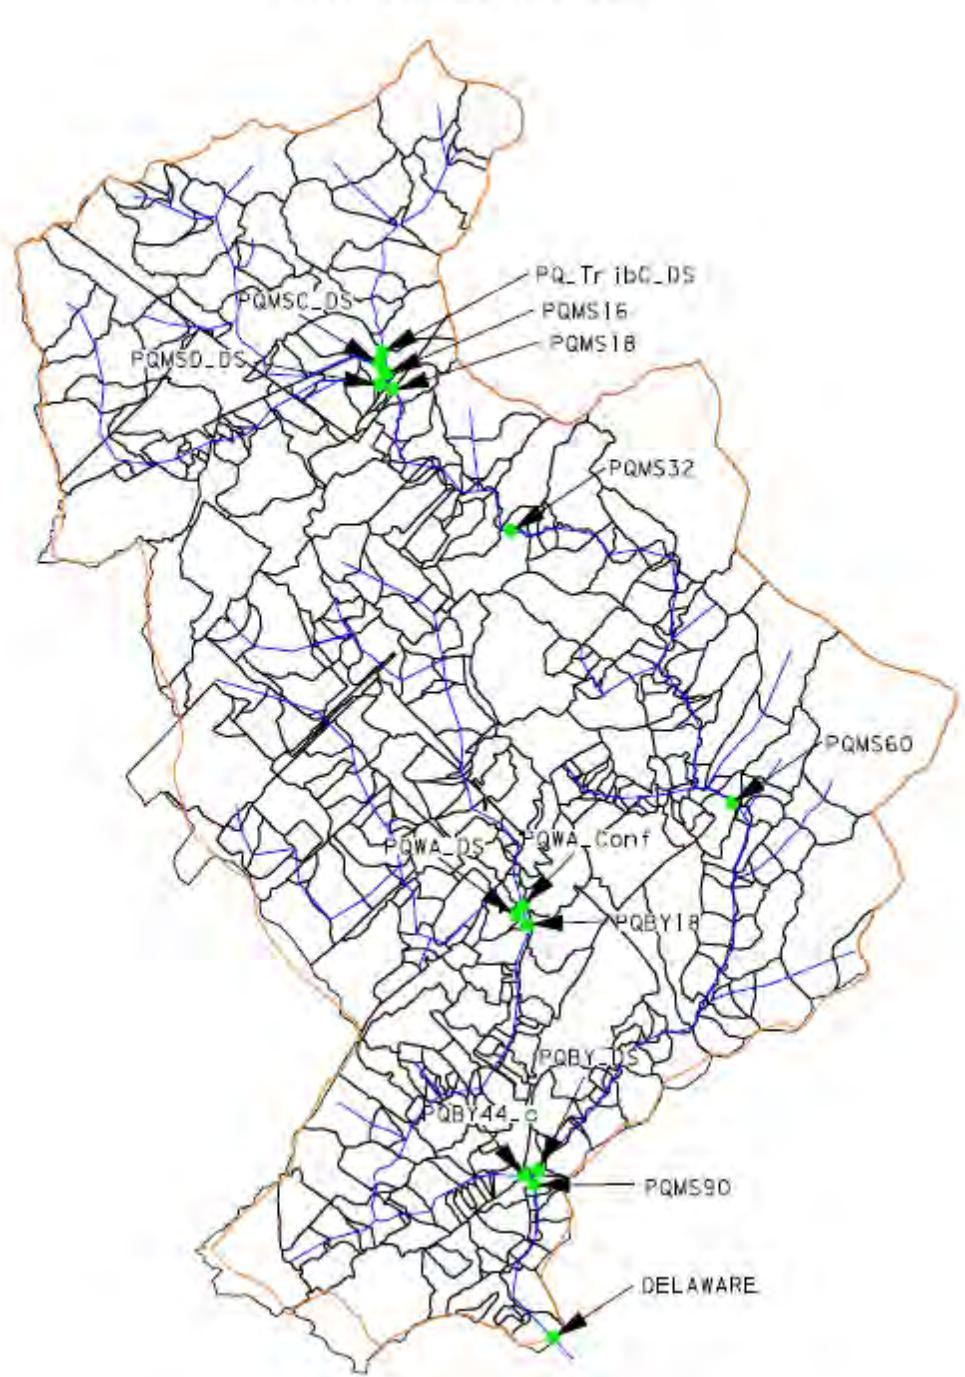
POI LOCATION MAP

POI's used to compute the hydrographs and release rates for Poquessing

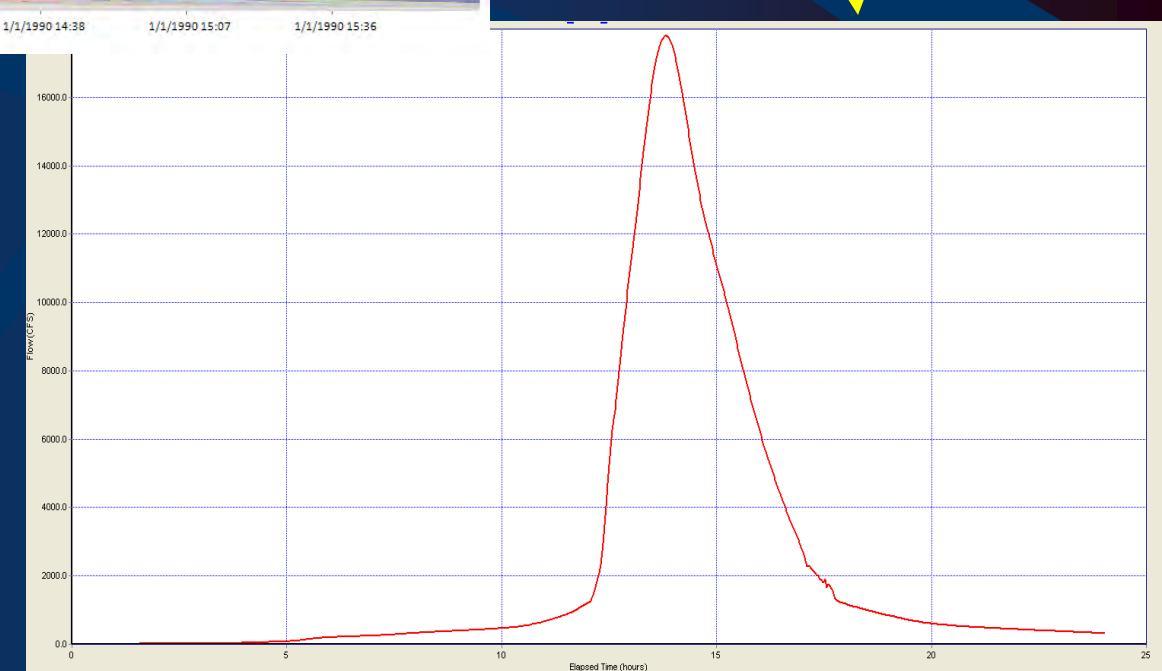
Individual subcatchments lagged to POI Delaware

Watershed Peak - 14:02

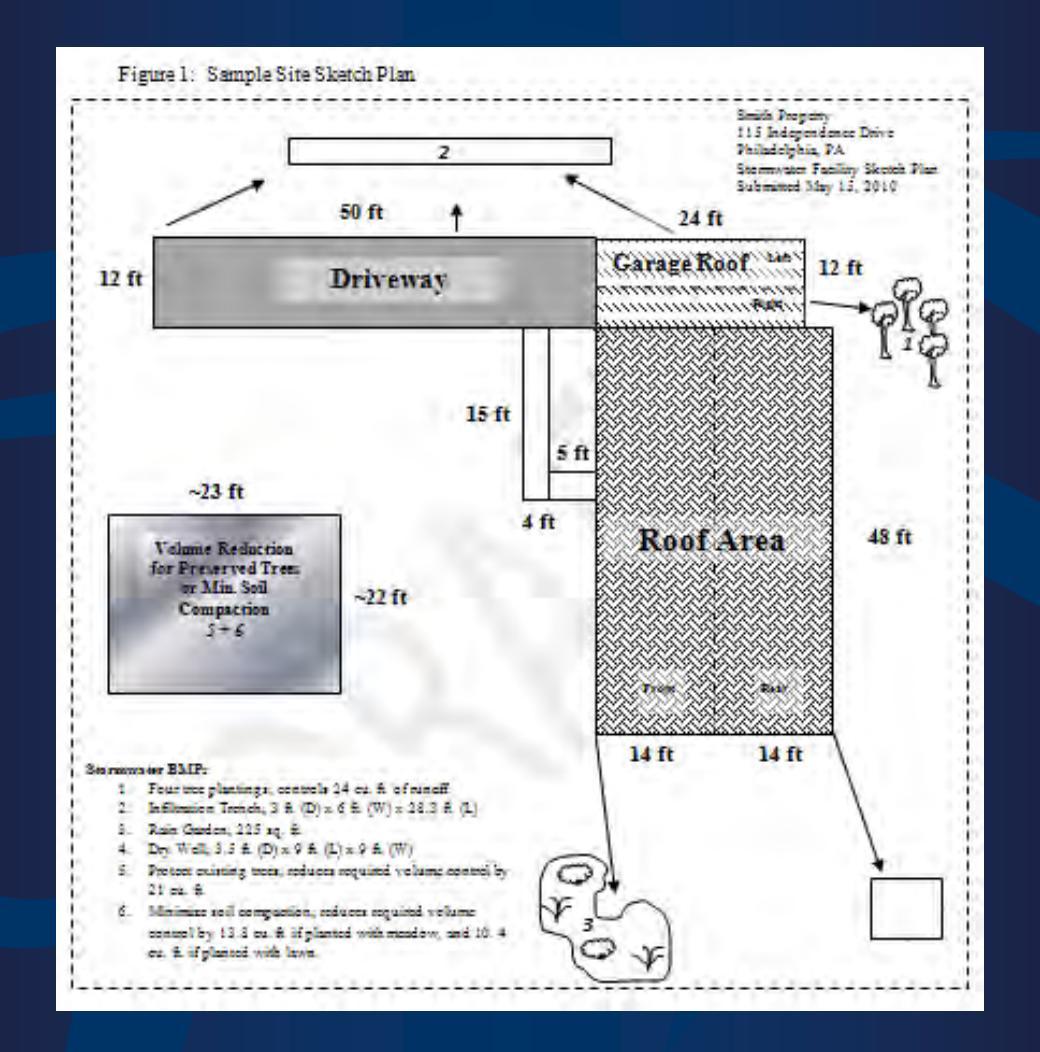
Suggestion for Peak Rate Control for Small Projects Volume Control as a Surrogate

1500 Square Ft. of new impervious surfaceCN=981500 Square Ft. of original surfaceCN=75

For 100 Year Storm with runoff = 8.5 inches Runoff Volume for CN=75 is 5.5 inches Runoff Volume for CN=98 is 8.5 inches

Store 3 inches of runoff volume to reduce to pre-development volume. For an area of 1500 square ft., this is **375** cubic ft. or 2,812 gallons. Construct infiltration trenches to provide at least **350** cubic ft. of storage. Use stacking block storage 3 ft deep and 10'x15' in area. ~ 400 cubic ft.

For an area of 1500 square ft., this is 500 cubic ft. or 3750 gallons. Construct infiltration trenches to provide at least 500 cubic ft. of storage Use stacking block storage 3 ft. deep and 10'x18' in area ~ 500 cubic ft.
