PROBLEM CONDITIONS

PROJECT OBJECTIVES

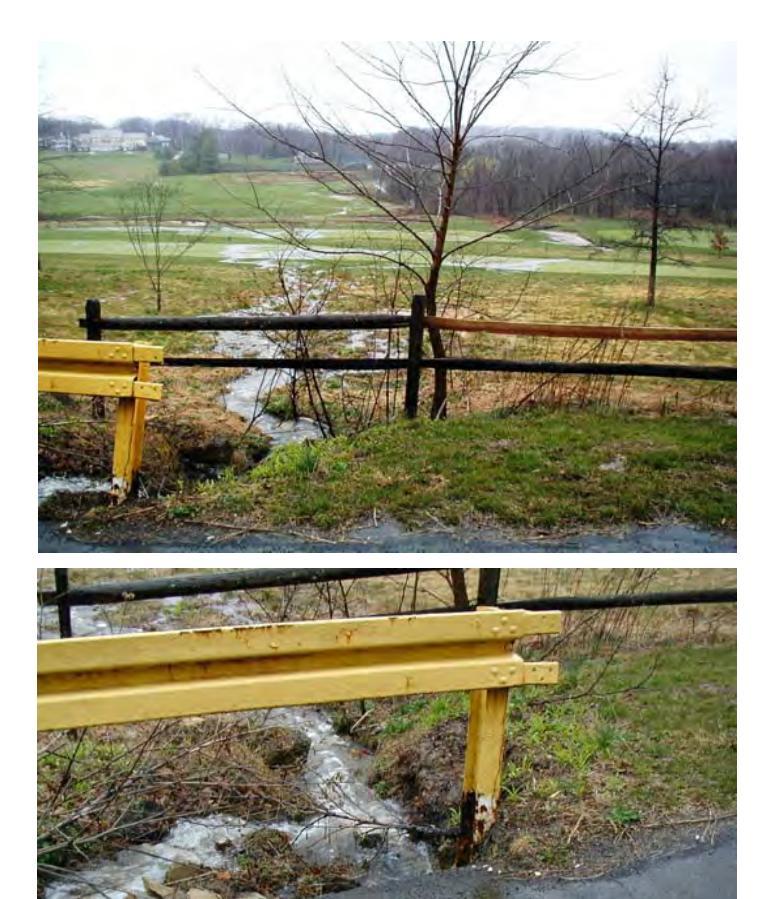
- Stormwater run-off from the high ground to the south of the HVCC site and from Paper Mill Road cascades onto the club's property.
- From there, stormwater travels down the valley slope to Terwood Run which joins the Pennypack Creek at Bethayres.
- During and after heavy rain events, this storm water run-off adds a significant amount of flow to Terwood Run and the Pennypack Creek
- The stormwater also transports lawn and road chemicals directly into Terwood Run and eventually into the Pennypack Creek

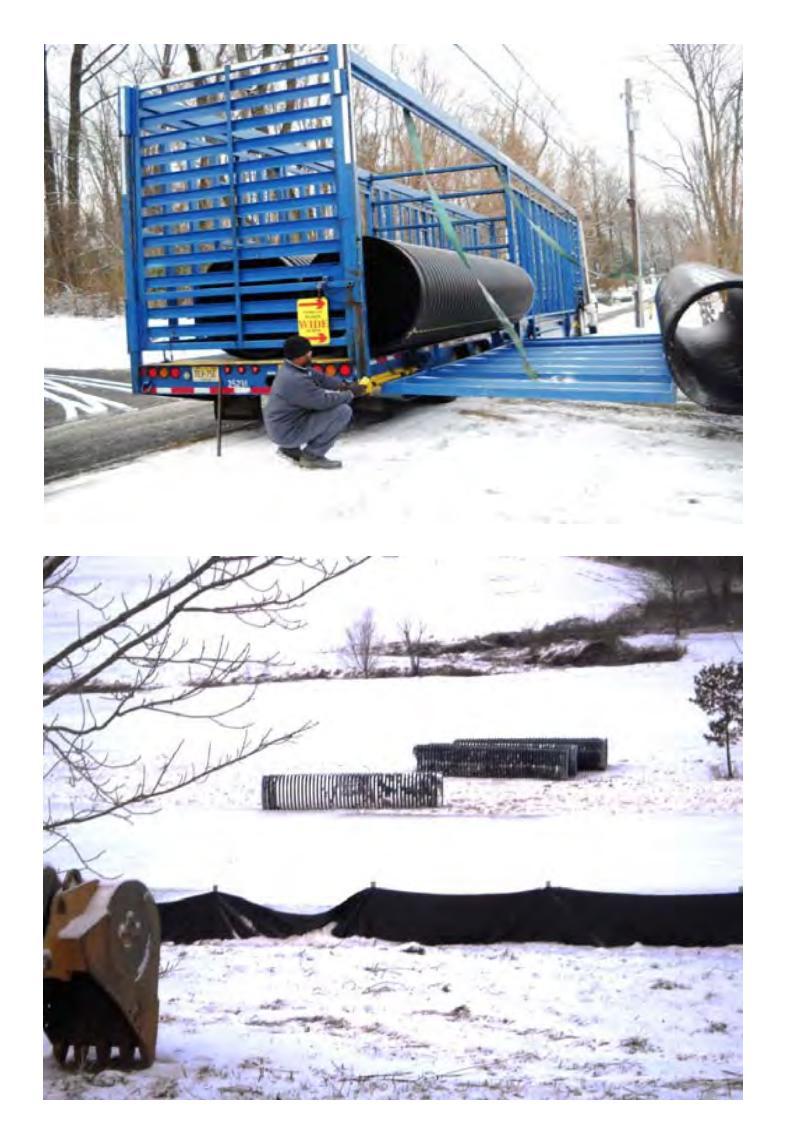
- Fifteen 20' lengths of 42" diameter perforated pipe were delivered to the project site from Paper Mill Road (*neat delivery truck*)
- The last five lengths of pipe broke loose and rolled all the way to the bottom of the valley
- It was amazing to see how well something of that size and weight rolls down a 15% grade, and how fast as well.
- Scott Anderson, our course superintendant, didn't think it was funny, because he and his people had to spend two hours moving them back to where they belonged.

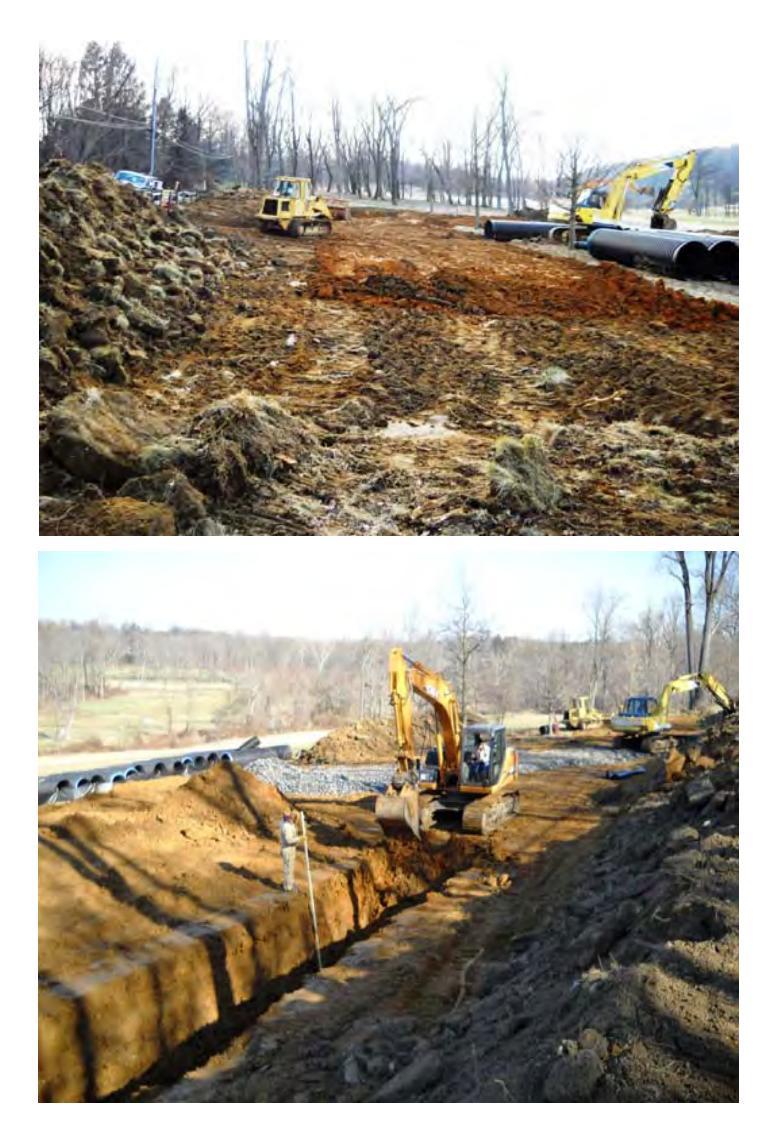
- The entire trench site was rough graded to strip off the topsoil for later use and to provide a relatively level working platform. (note pipes have been returned to their intended location)
- The 300' long x 8' wide x 6' deep trench excavation was completed in two working days and 12" of crushed stone was installed in the bottom of the excavation below the line of the pipe.
- The material excavated from the trench was stock piled on the downhill side of the trench for future use in constructing a 2' high berm to keep run-off from bypassing the trench area.
- We maintained a constant depth of 6' to avoid the expense of more complex excavation protection measurers

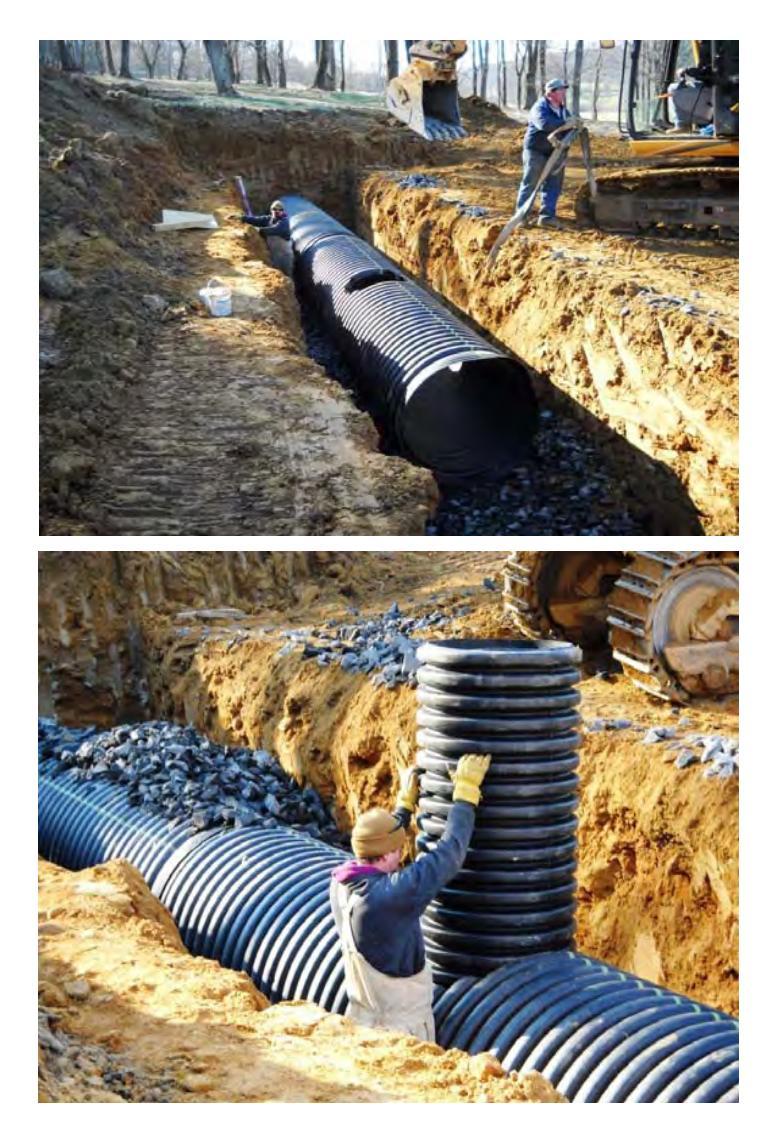
- Immediately behind the excavation and the first layer of stone came the installation 20' long sections of 42" diameter perforated pipe and the chemical sealing of the joints.
- We installed three 24" vertical inlet pipes, one near the mid-point of the horizontal run and one near each end of the 42"pipe, to provide direct inflow to the pipe during heavy stormwater conditions
- The pipe installation took approximately two days to complete and was finished within hours of the final excavation work

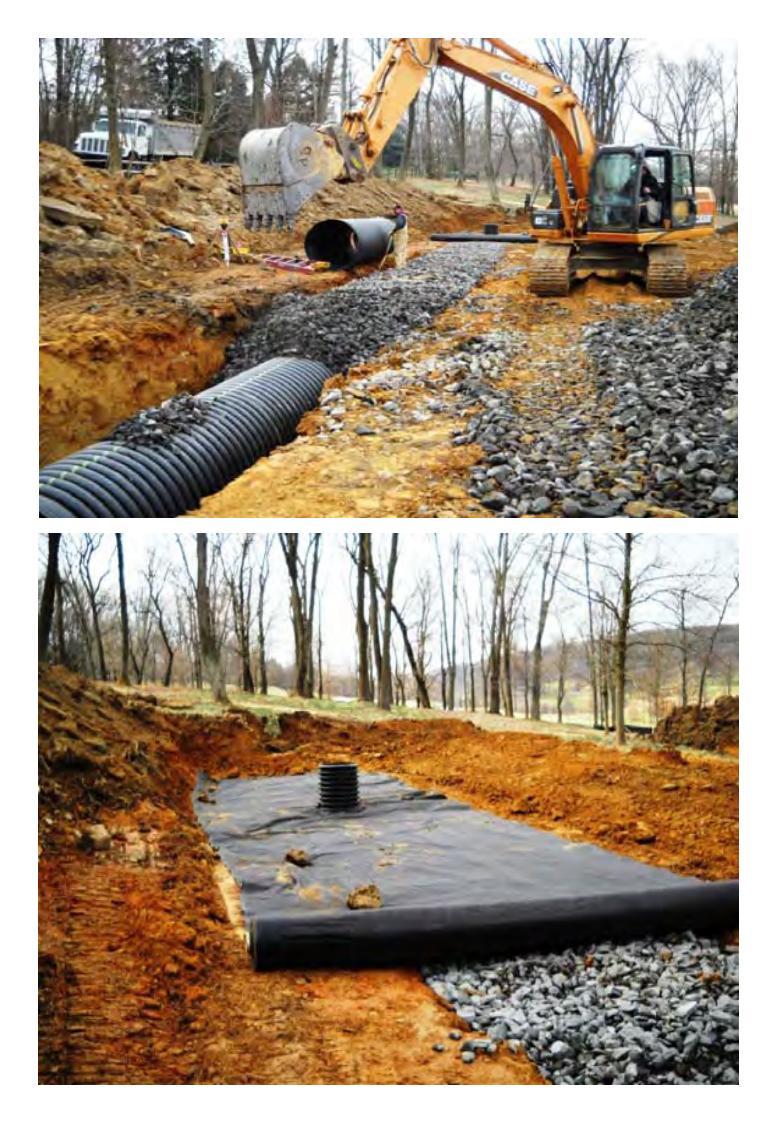
- As soon as the pipe sections were aligned and the joints sealed, the sides and top of the trench were back filled with 4" crushed stone to stabilize the pipe assembly and provide storage capacity for the infiltrated stormwater.
- Next came the installation of a 12' wide layer of geotextile fabric intended to reduce the migration of sediment into the crushed stone and pipe below.
- We considered installing geotextile fabric at the bottom and sides of the trench as well, but we had a concern that the fabric could become clogged with sediment and impede the infiltration of water from the trench to the surrounding soil. We decided to install the material on the top only.

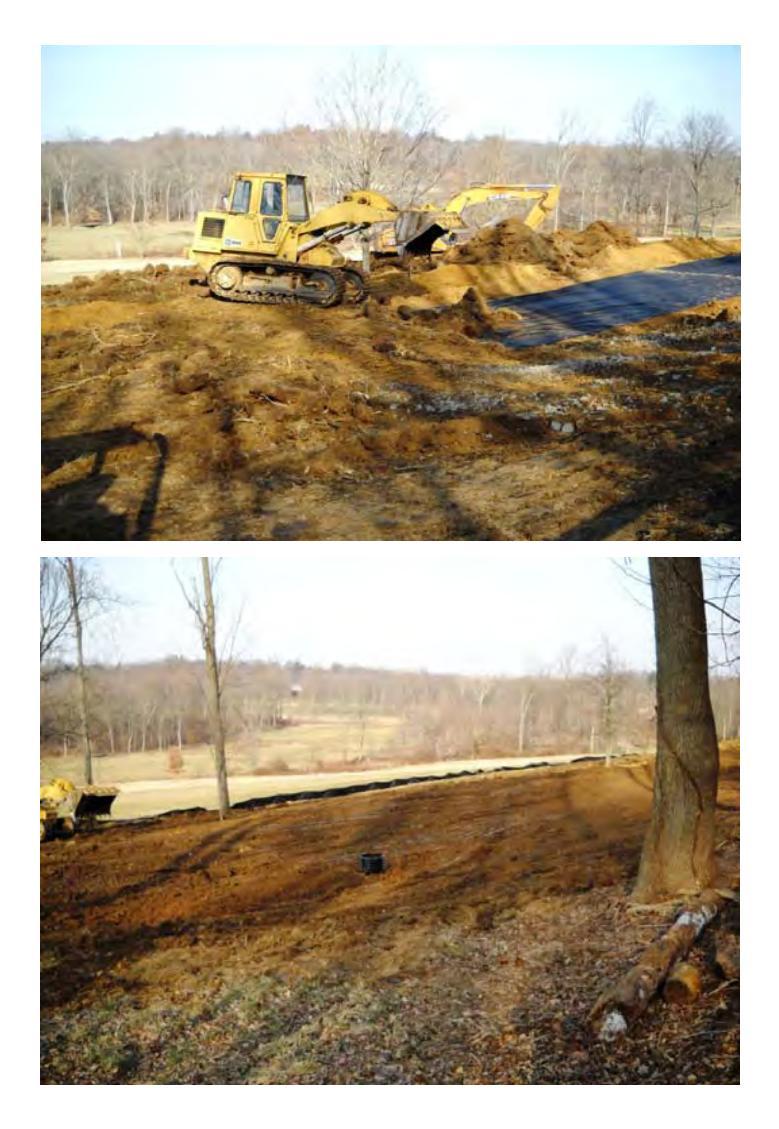
- Once the geotextile material was in place, a 12" layer of topsoil was placed over the trench to permit the re-vegetation of the disturbed area.
- The entire project site was re-graded to better direct stormwater flow from Paper Mill Road to the trench area and to create the 2' high berm on the down hill side of the trench. One of the 24" inlets can be seen in the lower photograph.
- The entire earthwork and pipe installation part of the construction, which was done by an outside contractor, took about a week to complete. Following that, HVCC undertook the final grading and replanting of the site and the repair of several storm water features along Paper Mill Road. The total construction cost was \$52,000.

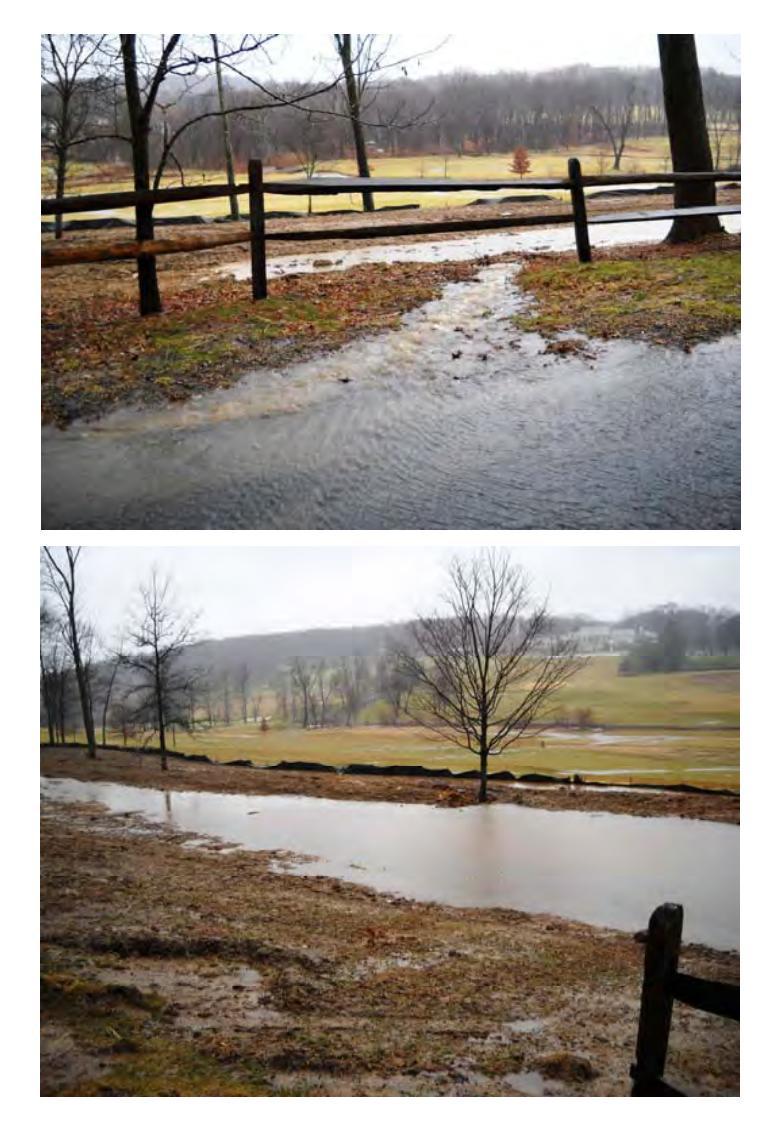
- Stormwater flows from Paper Mill Road into the trench area at several planned locations along the street and some minor grading adjustments put the water where we want it to go not where it wants to go.
- The stormwater collects above the trench and the downhill berm keeps it from bypassing the area. The three inlet grates are set at approximately 6" above the finished grade to allow direct flow into the pipe during heavy rain events.
- A graded swale was also provided at the lower end of the detention area to allow water to escape in the event of extraordinary rain fall and flow to an area away from the golf course and Terwood Run.
- Through several firsthand observations, we've noted that as much as 12" of water will collect behind the berm and that within three hours it will totally infiltrate into the trench. We're still fine tuning the operation of the system.

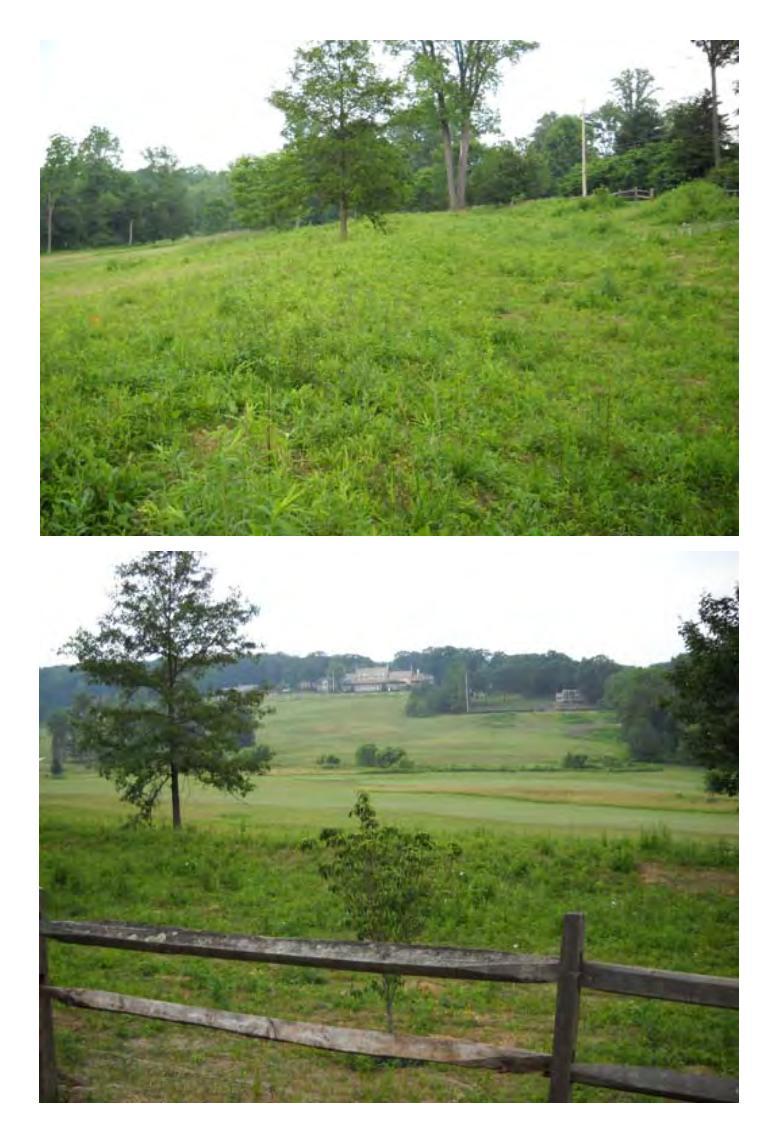
- While we've only been through one growing cycle, we've been able to establish a good cover of plant materials across the entire project site. The goal is to make the area appear exactly as it did before the trench was constructed.
- The routing of the trench was planned to minimize the removal of trees and only three had to be taken down. We have now replaced those with new trees and an example can be seen in the lower photo.
- As part of the project scope, we will install educational signs along Paper Mill Road to document the problem conditions, the project objectives, the project design & construction and the results. It is hoped that others will learn from the HVCC- PERT Infiltration Trench Project and will employ similar stormwater management measures where they're appropriate.
